RE: Inspection Site  
Inspection Address

# Inspection Report

Inspection Site  
Inspection Address

Prepared by: Brothers' Inspection Inc.  
636 Shadowood Ct.  
Grand Junction, CO 81505  
970-640-0214

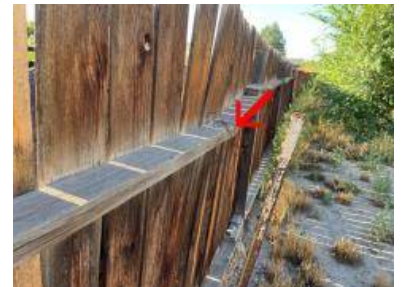
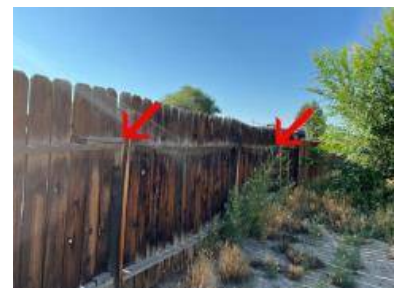
Fencing Materials: Vinyl, wood, wire, chain link.  
Fence Materials Condition: Varying condition. The fencing in the back of the property is in functional condition but there is warping and damage to a large portion. This section requires repairs or replacement.

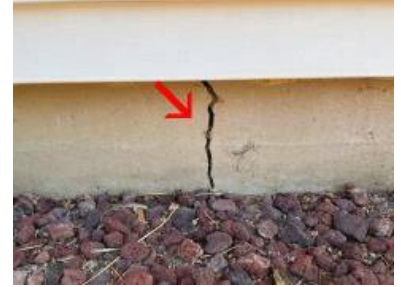
<i>Type of Foundation:</i>	Raised Foundation with a crawlspace - Refers to a foundation wall with a footer below without a finished floor.
<i>Foundation Materials:</i>	Poured in place concrete, 8 inches or more thick.
<i>Visible Portions of Exterior Foundation Walls:</i>	Satisfactory - The exposed portions of the perimeter foundation walls appear to be adequate.
<i>Visible Foundation Wall Cracks Noted From Exterior:</i>	Yes - Cracking in the vertical foundation walls was noted from the exterior. <b>Action Necessary</b> - Cracks of 1/4" and wider were noted in the foundation walls. This condition warrants further investigation and analysis by a professional structural engineer and/or a licensed qualified foundation contractor to determine the cause and course of action.

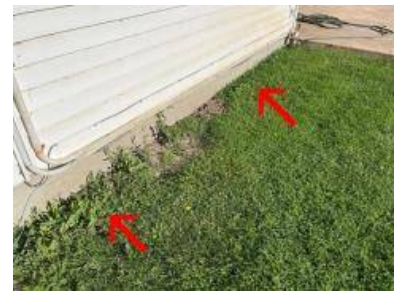
<i>Location of Wall Cracks and Description:</i>	Angular cracking was noted in at least one exterior wall.
<i>Evidence of Recent Movement:</i>	No - There is no evidence of any recent movement.
<i>Perimeter Foundation Drainage Surface:</i>	<b>Attention</b> - The drainage around the foundation should slope away from the foundation at a rate of 1/2 inch per foot for 6 feet away from the foundation. Portions of the ground around the perimeter may not meet this minimum standard. <b>Attention</b> - A dry zone of 3-4 feet is recommended around the perimeter of the house.

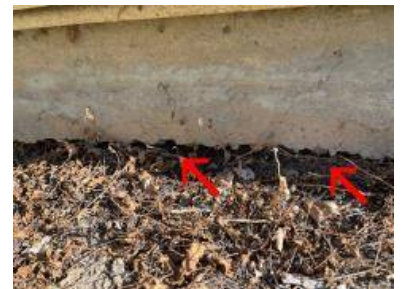
<i>Type of Foundation:</i>	Slab on grade - Refers to a concrete slab poured on a prepared gravel or sand base at grade level.
<i>Foundation Materials:</i>	Poured in place concrete, A minimum of 8 inches thick and 16 inches deep at the footing around the outer edge of the slab and 4 inches deep through out the non-structural portion of the slab.
<i>Visible Portions of Exterior Foundation Walls:</i>	<b>Attention Needed</b> - The exposed portions of the perimeter foundation walls need maintenance. This is needed to prevent further deterioration. The soil is eroding away from the exterior.

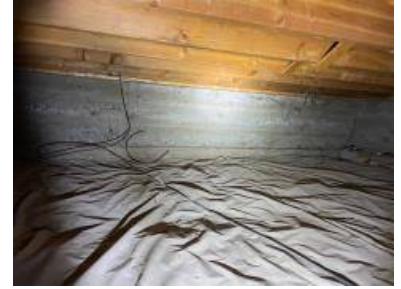
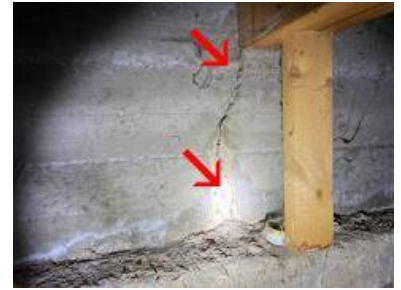
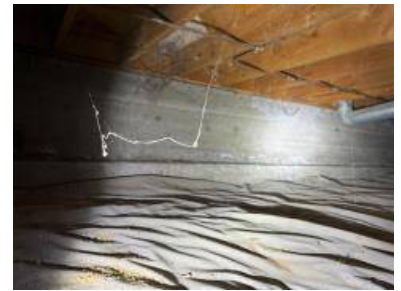
Vertical cracks were noted in at least one exterior wall. This does not appear to be a recent crack but should be monitored.

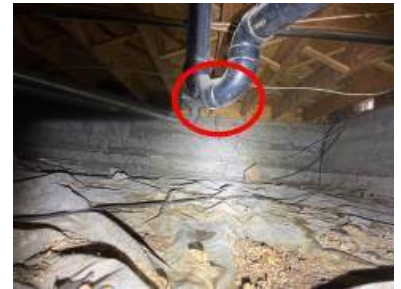
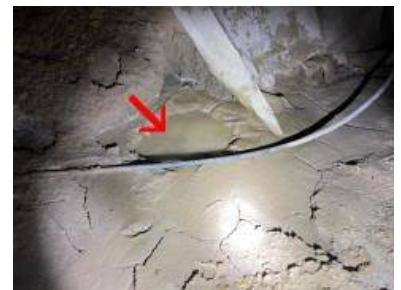
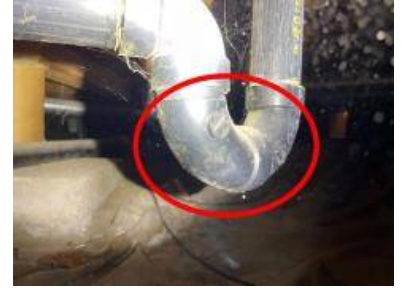
There is evidence of water entry or damage in the crawlspace level. **Action Necessary** - At the time of the inspection there was water present. Immediate action is necessary to make repairs and to stop further damage. Estimates from reputable contractors are needed.

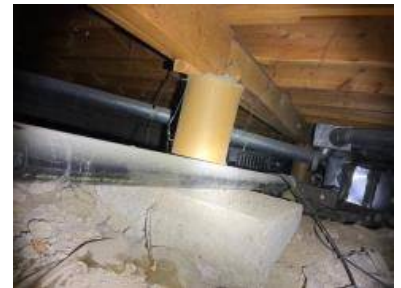
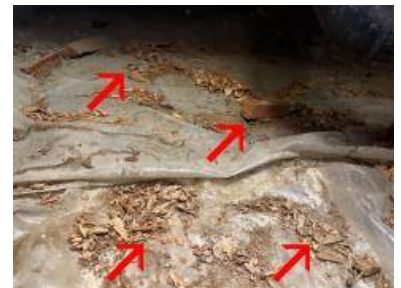
*Comments:* All debris should be cleaned out of crawlspace.

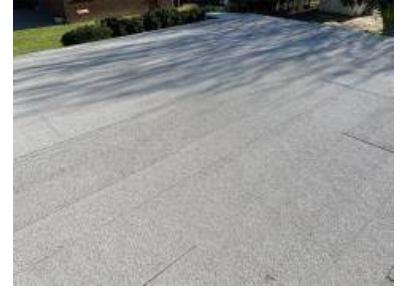
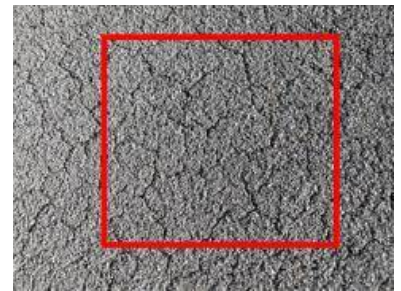
**Attention Needed-** There is cracking throughout the rolled asphalt on the low sloped portions of the roof. Cracks can allow water entry. I recommend contacting a roofer.

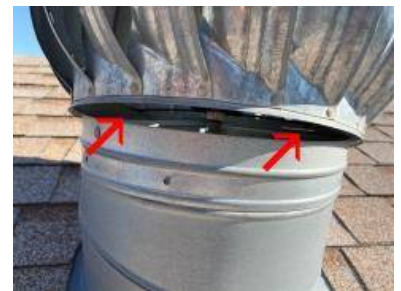
Attention Needed- The turbine vent is loose. Repairs are needed.

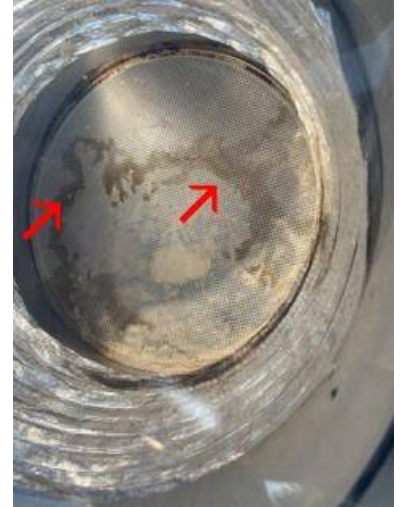
**Attention Needed** - The skylight shows signs of leakage. Some attention is needed either to the window or the installation.

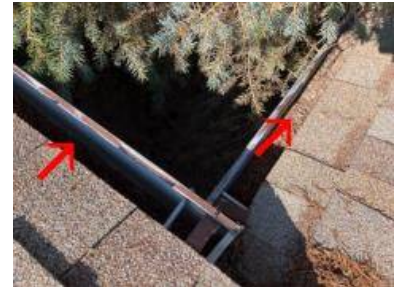
**Attention** - The gutters are in need of being cleaned out so that the debris build up does not clog or hinder the drainage of water.

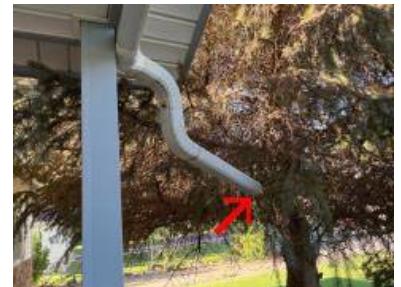
**Attention** - Installation of downspout extensions would help carry the water further away from the foundation.

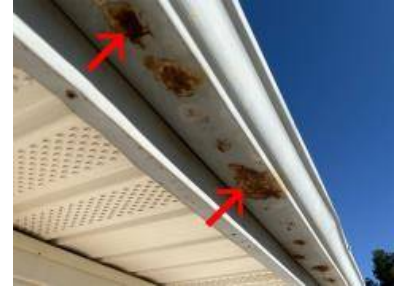
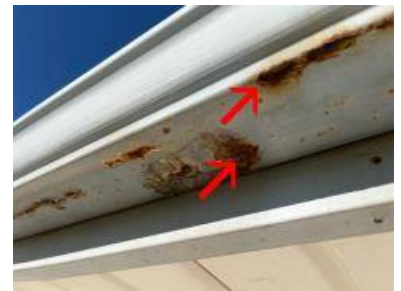
**Attention Needed-** The gutters on the rear of the home appear to have rusted through and need to be replaced.

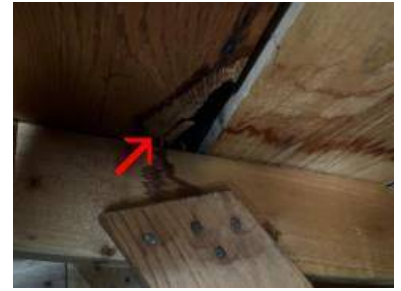
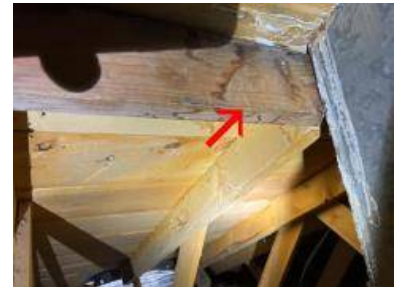
There is water staining on the underside of the roof decking or rafters. The stains are not currently wet nor do they have an elevated moisture content. **Note** - There is staining on the roof decking boards around the evaporative cooler. The area was dry during the inspection. It is recommended this area be monitored.

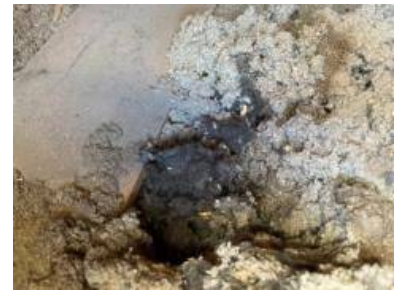
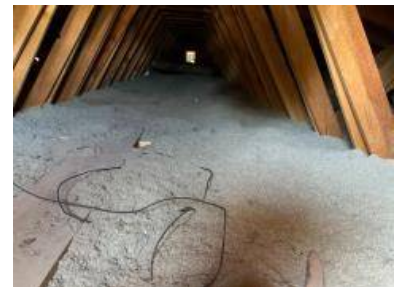
Satisfactory - The attic insulation appears to be adequate and properly installed. The following type of insulation was noted in the attic: Cellulose. Blown in place. Rockwool poured in place. There is an average of at least 8" of insulation installed. **Recommended** - Installation of more insulation would be beneficial.

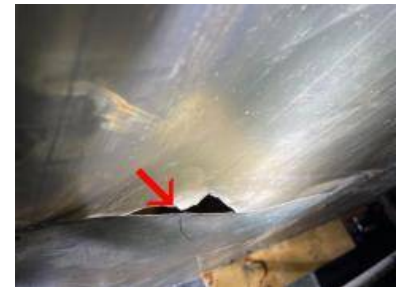
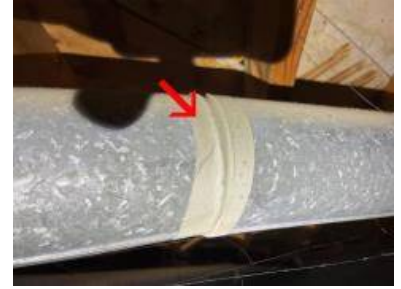
*Blower Condition:* Satisfactory - The blower assembly appears to be performing as expected.  
*Filter Type/Size:* No filter noted.  
*Ducts Condition:* **Attention Needed** - The ducts appear to have an air leak that reduces the effectiveness of the heating system. There is also an older tape. Due to the age of the home, there is potential for this to contain asbestos.

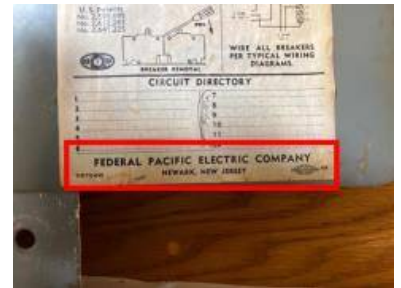
Panel Condition: **Replacement Recommended** - FPE Panel - The condition of the main panel was inspected and no active arcing or burns were found, however due to the type of panel it is we recommend replacement. If not replaced, we recommend close observation for any evidence of arcing, burns, or melting that would indicate overloading of the breakers. FPE main panel boxes from this era have shown a higher than average failure rate of the breakers and the breakers to panel bus connection. The UL listing has since been pulled from these panels due to these dangers. A licensed electrician is recommended for the replacement of the panel box. Search FPE panel or Federal Pacific Electric for more information online.

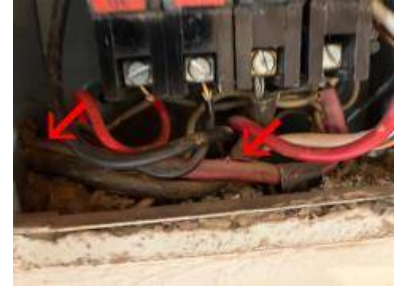
Note- There is old wiring in this panel. The insulation may be brittle.

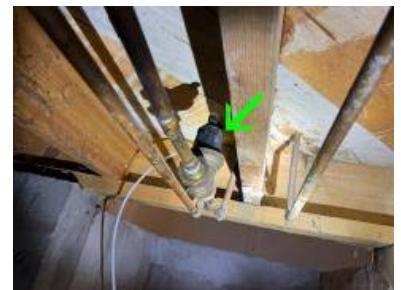
*Interior Supply Piping Size:* The interior water supply piping is 1/2" in diameter.  
*Interior Supply Piping Material:* The interior supply piping in the structure is predominantly copper.  
*Water Pressure:* There is a water pressure regulator valve correctly installed. This allows adjustment of the incoming water pressure. **Note-** The pressure regulator was installed past the exterior hose bib. The hose bib has pressures over 110 PSI.

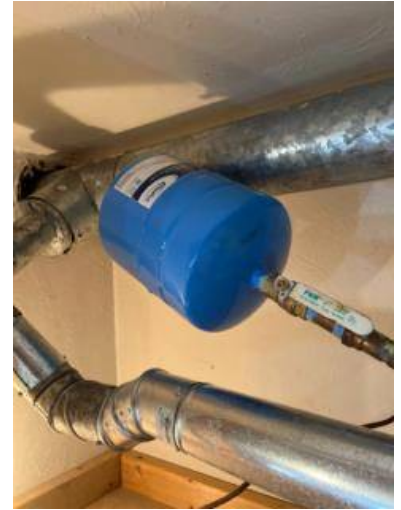
**Attention** - The expansion tank no longer has any air in it. It needs to be repressurized or replaced.

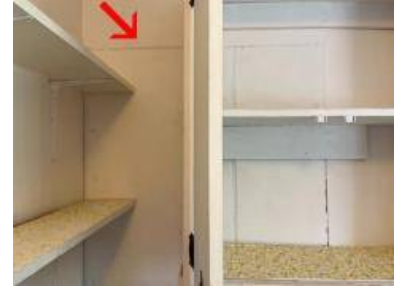
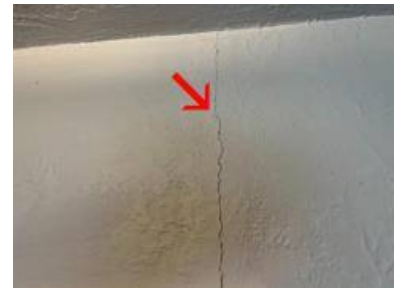
Satisfactory - The walls in the laundry room appear to be satisfactory. There is some minor cracking in the sheetrock. Most likely this is due to slight settlement or shrinkage. **Note-** There is an old patch behind the cabinets.

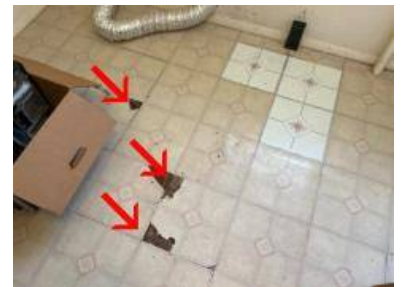
**Action Necessary** - The floor in the laundry room needs some repair or replacement.

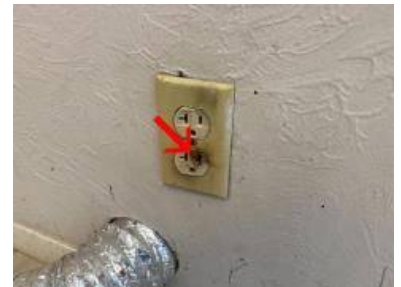
**Action Necessary** - At least one outlet tested in the laundry is incorrectly wired or needs to be replaced. The 3-prong outlets are not grounded. This is an unsafe condition. It has evidence of arcing and should be replaced.

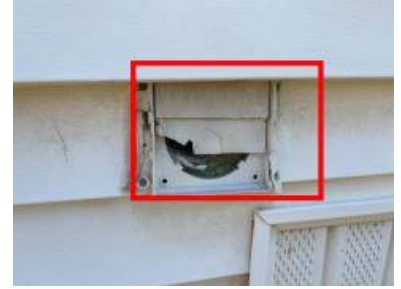
**Attention Needed-** The dryer vent cover requires replacement.

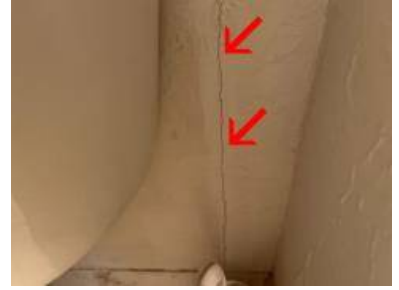
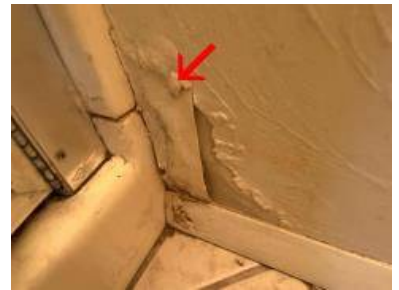
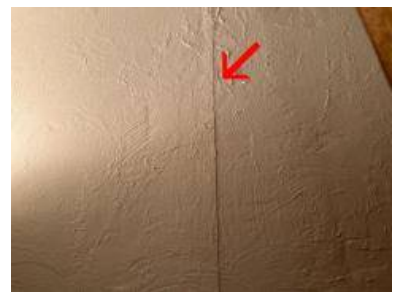
**Attention Needed** - The walls in this bathroom show some minor cracks. They do not appear to be a serious structural concern at this time.

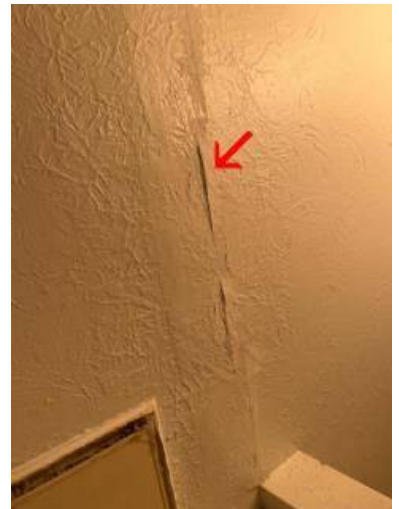
Satisfactory - The ceiling in this bathroom is satisfactory. Moisture Damage - The damage to the ceiling in this bathroom appears to be caused from moisture within the room. There may not be adequate ventilation, or the ventilation is not being used as needed.

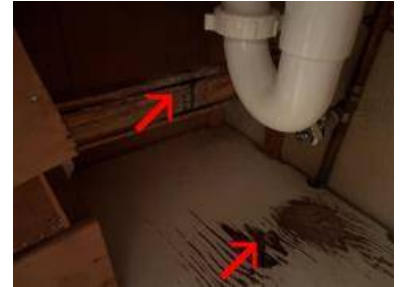
Satisfactory - The basin and drainage fixture appears to be satisfactory. **Note** - There's evidence of the previous leak. No leak was seen during the inspection.

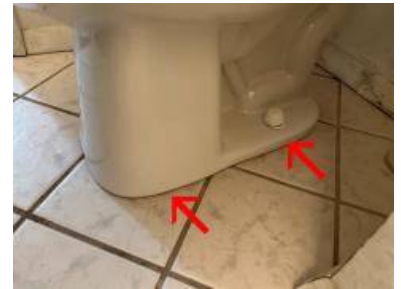
**Action Recommended** - The toilet in the master bathroom needs repair. The toilet is not secure to the floor, allowing it to wobble or twist and possibly leak. Action should be taken to re-secure it to the floor.

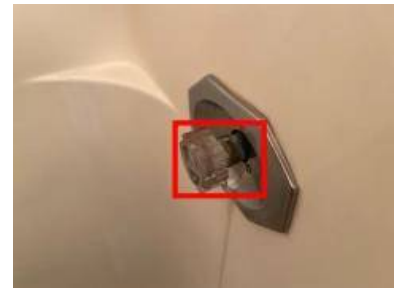
Satisfactory - The shower, shower head, and mixing valves are all performing as required. **Attention** - The handle is very loose and needs to be sealed and anchored to the wall. Damage to the piping can occur.

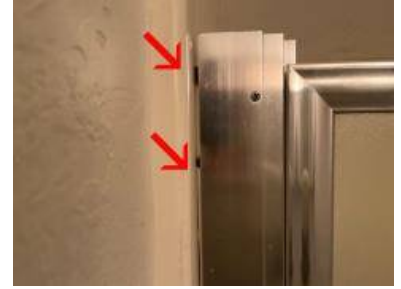
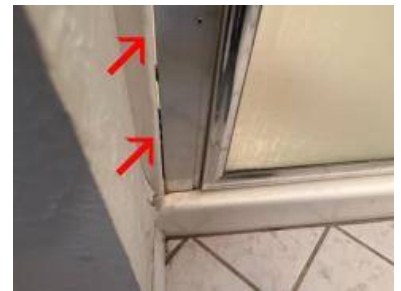
**Attention Needed**- The shower door frame is loose and the door does not shut properly. Repairs are needed.

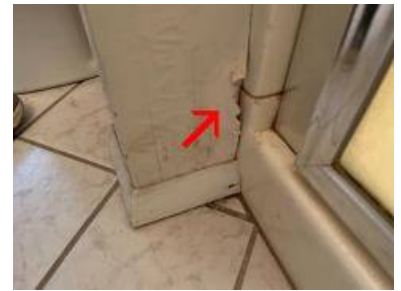
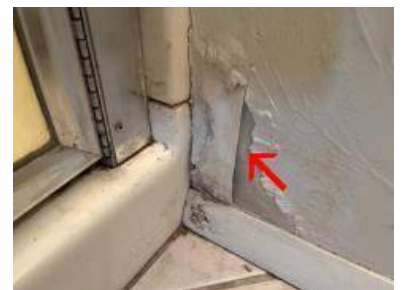
**Action Necessary** - Some caulking in the water contact areas is necessary. There may be current damage. This inspection is of the visible areas only. No invasive action was taken.

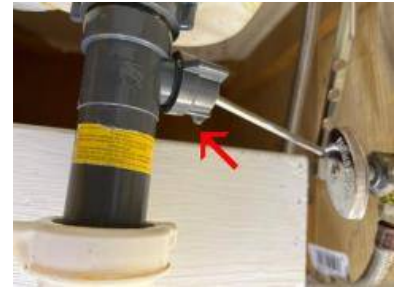
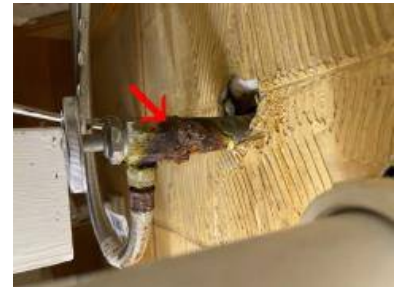
*Faucet and Supply Lines:* Satisfactory - Faucets and supply lines appear satisfactory. **Note-** There is corrosion behind the valve. There may have been a leak.

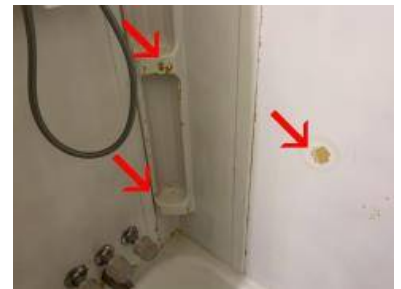
*Tub & Shower Walls:* **Attention Needed** - The walls show some deterioration. Some attention is needed to prevent further deterioration..

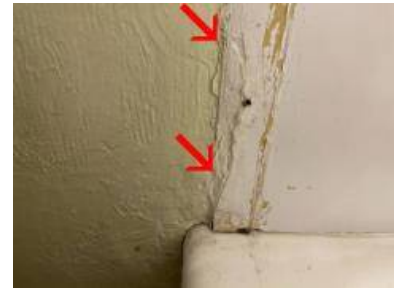
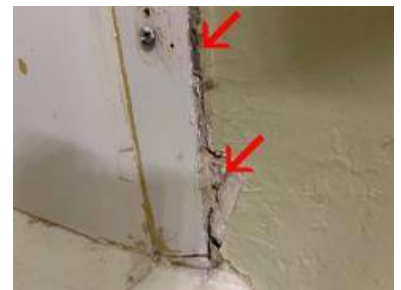
**Attention** - The caulking in the water contact areas appears to need attention. Damage may result if not corrected. The wall - tub or shower seam needs to be caulked to prevent moisture from entering the wallboard.

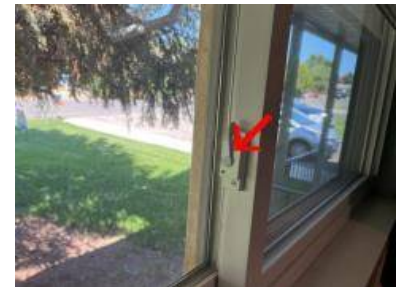
<i>Location:</i>	West side of home.
<i>Entry Door:</i>	Satisfactory - The entry door to this bedroom is as I expected, and it is functional.
<i>Closet:</i>	Satisfactory - The closet is functional and of average size.
<i>Walls:</i>	Satisfactory - The walls in the bedroom appear to be satisfactory.
<i>Ceiling:</i>	Satisfactory - The ceiling is functional and as I expected.
<i>Light and Light Switch.</i>	Satisfactory - The light and light switch were functional at the time of the inspection.
<i>Ceiling Fan:</i>	Satisfactory - There is a ceiling fan installed in this bedroom. It appears to be functional.
<i>Floor:</i>	Satisfactory - The floors are in satisfactory condition.
<i>Windows:</i>	<b>Attention Needed</b> - At least one window or associated hardware in this bedroom needs attention. Locking hardware needs repair or replacement.

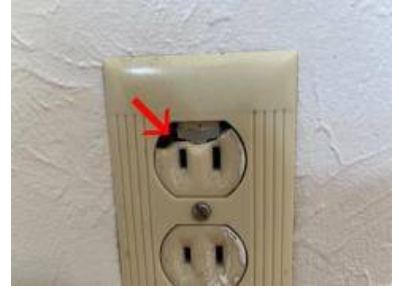
**Action Necessary** - At least one outlet tested in this bedroom is incorrectly wired or needs to be replaced. The 3-prong outlets are not grounded. This is an unsafe condition.

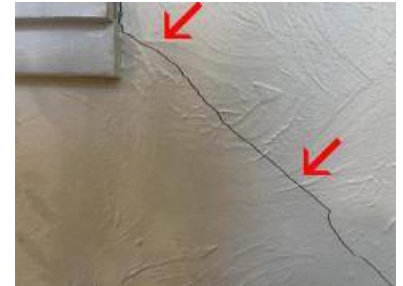
**Attention Needed** - The walls in this room show a condition that needs some attention. Some minor cracks were noted that do not appear to be a serious structural concern at this time. Be sure to take note of any future movement. Most minor cracking is due to shrinkage of the construction materials.

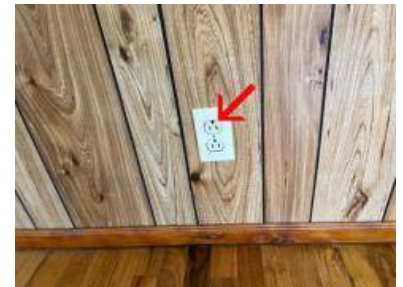
The 3-prong outlets are not grounded. This is an unsafe condition.

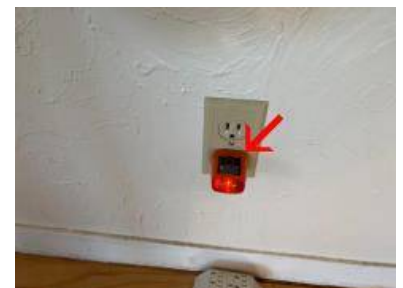
The noted outlet has the hot and neutral wires reversed. Note-Any outlets with cracked ground plugs should be replaced.
