RE: Inspection Site
Inspection Address

Inspection Report

**Inspection Site
Inspection Address**

**Prepared by: Brothers' Inspection Inc.
636 Shadowood Ct.
Grand Junction, CO 81505
970-640-0214**

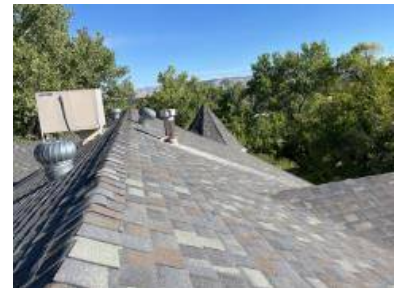
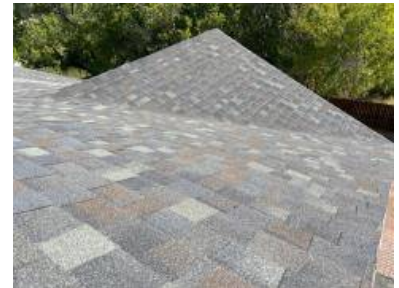
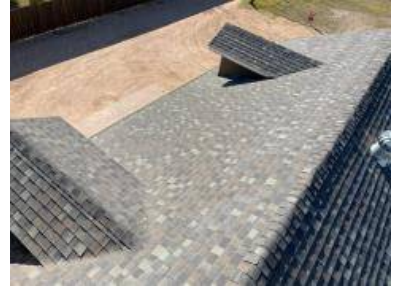
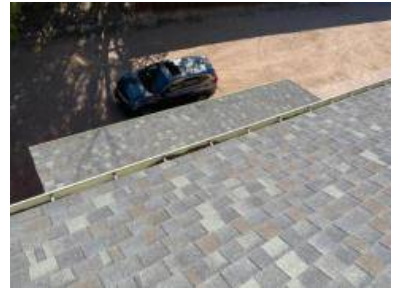
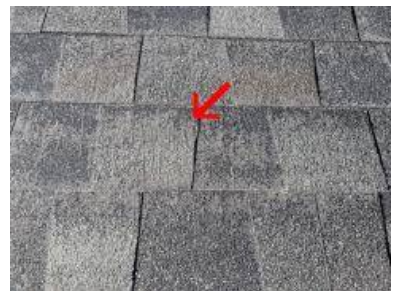
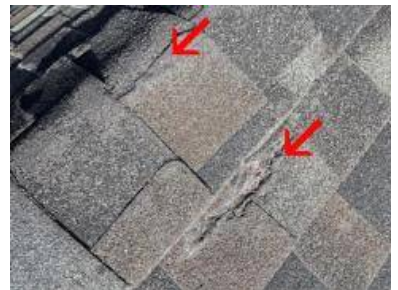
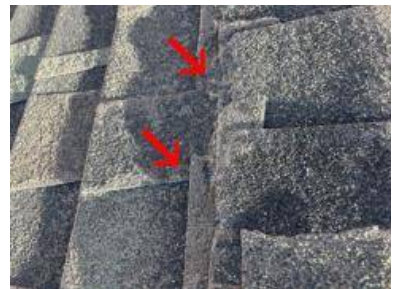
Attention Needed- Although a majority of the shingles are in satisfactory condition, the area above the garage has some damage due to ladder use. Because of this and several other concerns I recommend having a roofer come out to provide quotes for the necessary repairs.

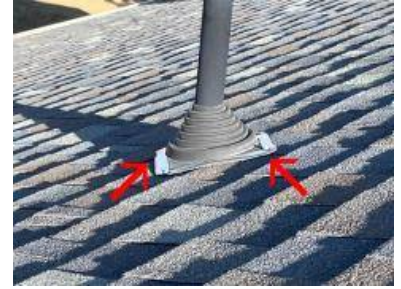
Attention- The rubber gasket around the plumbing vent is not ideal. These need to be sealed periodically to prevent leaks.

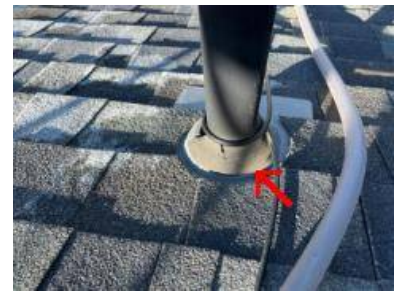
The rubber vent pipe flashing is cracking or in need of repair/replacement at one or more of the plumbing vents.

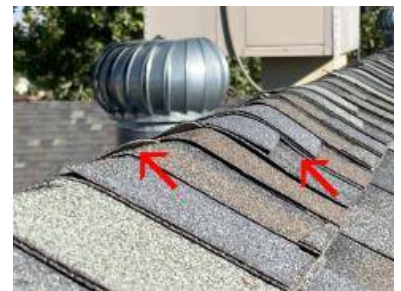
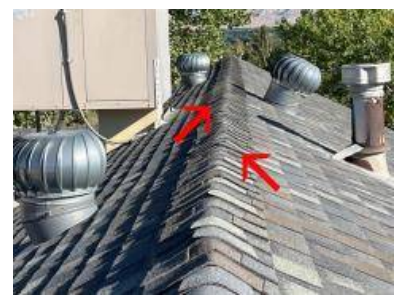
Action Necessary - Some portion of the ridge(s) needs to be repaired or replaced. The type of shingle used is not meant for use on a ridge. A ridge type shingle should be installed.

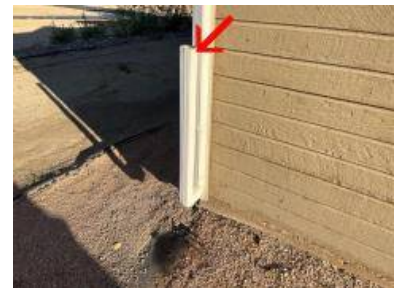
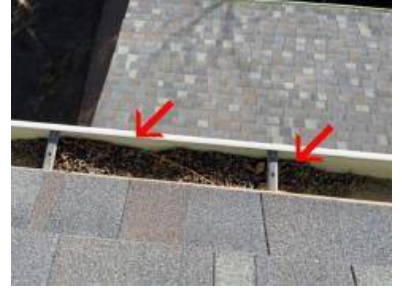
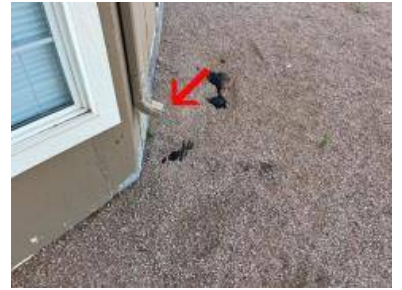
Attention - Installation of downspout extensions would help carry the water further away from the foundation. **Attention** - The gutters are in need of being cleaned out so that the debris build up does not clog or hinder the drainage of water. Note - It is best to leave downspouts in the down position to ensure water is directed away from the foundation.

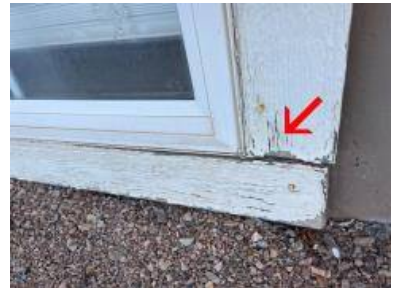
Attention - The trim needs some minor repair to prevent further deterioration. Some portion of the trim boards needs some painting to prevent further deterioration.

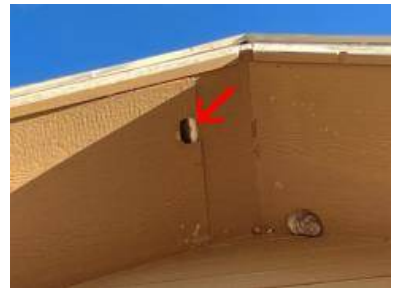
Attention - Soffit/eaves appear to need some minor repair to prevent further deterioration. Hole in the eaves or soffit should be repaired.

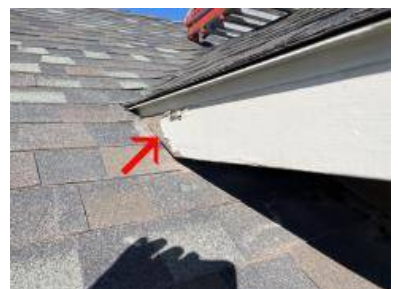
Satisfactory - The fascia and rake boards appear to be in satisfactory condition and show only signs of normal wear. **Note** - The rake board or fascia is in contact with the roof covering materials. Ideally, there is a gap between these two materials to prevent moisture transfer. Moisture being wicked up from the roof surface can cause premature deterioration of the fascia or rake board materials.

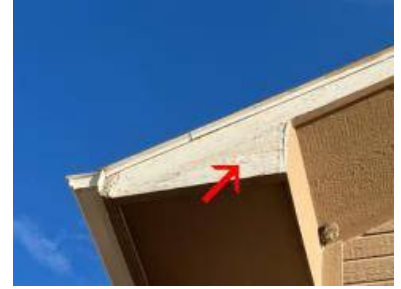
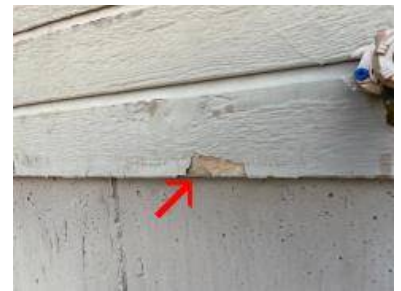
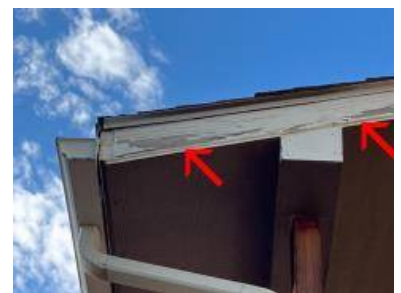
Action Necessary - Portions of the exterior finish or painted surfaces are in a condition that calls for refinishing. Delay will cause further deterioration of the siding material.

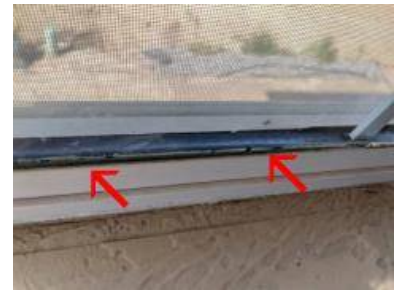
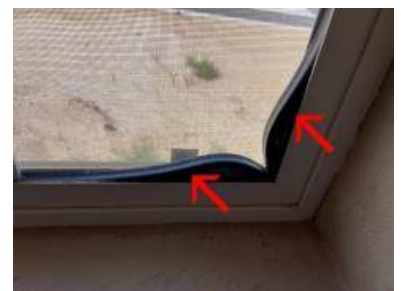
Attention Needed - Some of the window screens installed need to be replaced.

Attention Needed - There is at least one window that needs attention given to the glazing, framing, or caulking. **Attention** - Several of the window sills and around the frames through the house are in need of having the caulking re-done. Window condensation can cause moisture damage over time in these areas if not sealed as well as loss of efficiency. These are old vinyl windows. There is some warping and damage to the frame and seals on many of the windows.

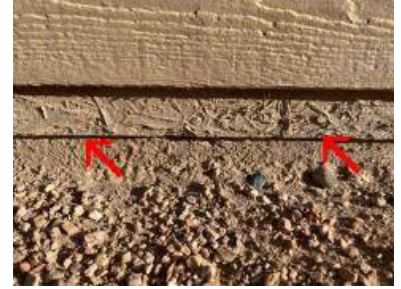
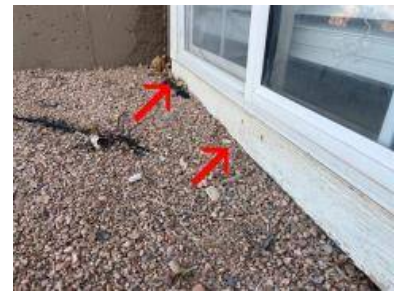
Attention - There does not appear to be adequate clearance between the earth and the wood siding or framing members of the structure. It is suggested that there should be a minimum of a 4" clearance between the earth and any wood siding or framing materials. The OSB sheathing is visible on the south side of the home.

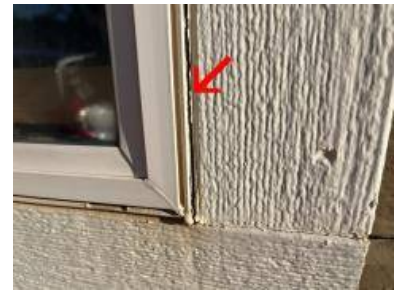
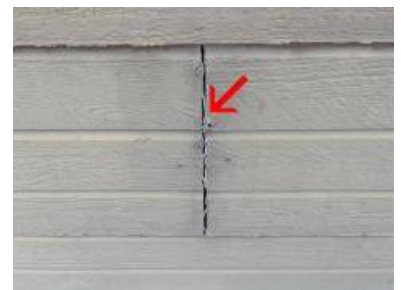
Attention - Several spots around the structure were noted that need to be caulked. Caulk should be applied to areas where brick and wood siding meet, trim around window frames or doors, and piping and service penetrations. Also, any cracks that allow moisture or wind entry should be caulked to prevent deterioration.

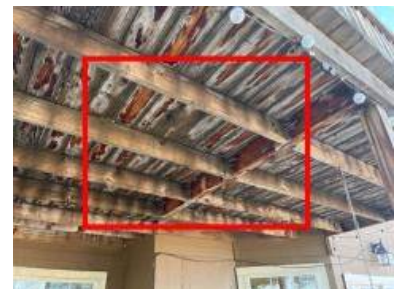
Attention Needed - The wood materials used in the deck need some repair or replacement. **Note** - Paint or stain updates will help to preserve the wood materials.

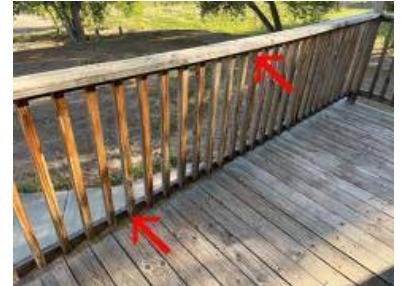
Deck or Porch Railings: **Attention Needed** - The railings are in place; however, some repair is needed. The center of the long railing could use more support.

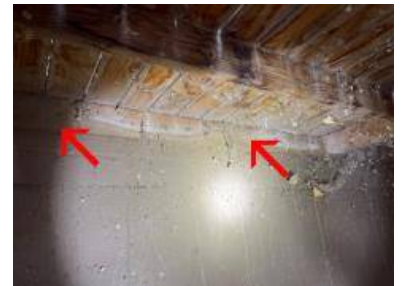
Framing of Deck/Porch: **Action Necessary** - Some portion of the framing in the deck or porch is in a condition that warrants immediate repair. The deck framing is not bolted to the rim joist of the structure. This can allow the deck to pull away from the structure resulting in collapse and possible serious injury to anyone on the deck.

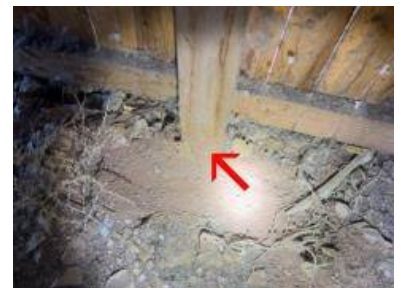
The Foundation Materials: The deck support posts are set in soil. The inspector was unable to determine the depth to which the posts are set and if the posts are set below the frost line.

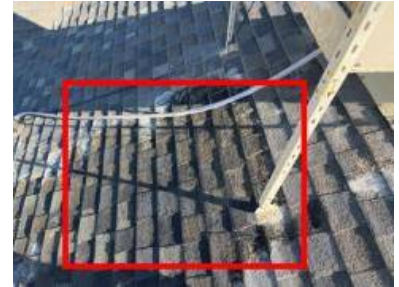
Model/ Serial Number/ Size: Mastercool. Manufactured 2009.
Type: Evaporative Cooler. Electricity-powered.
Unit/Condenser Location: Roof top.
Unit Tested: Yes, this unit works well by the settings of the control switch.
Unit Condition: **Attention Needed-** There is water dripping out of the cooler. Adjustments are needed.

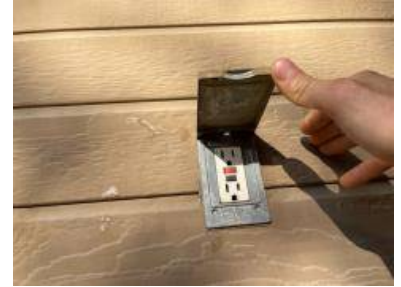
Attention Needed- The GFCI protecting the external outlets was not functional at the time of the inspection and should be replaced.

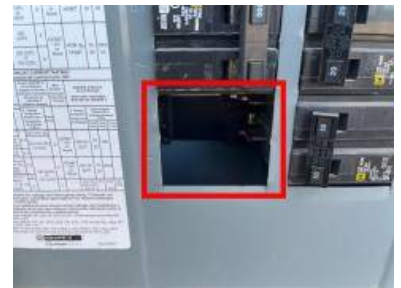
Satisfactory - The power panel, as a container for safely covering electrical circuitry and components, is functioning as intended, minimizing the risk of electrical shock. **Attention-** The opening in the panel should be covered.

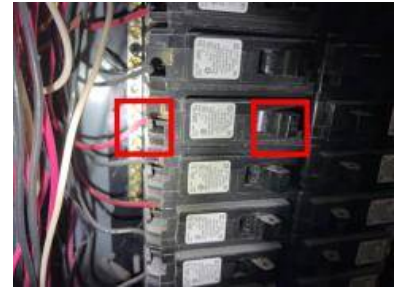
Attention Needed- There was at least one instance of a 14 gauge wire being fed into a 20 amp breaker. This is under sized and an unsafe electrical condition. A licensed electrician should correct this.

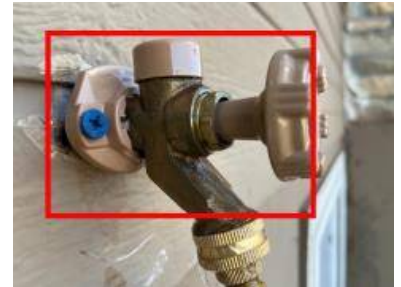
Attention Needed- The west facing hose bib is leaking from the anti siphon valve. Repairs are needed.

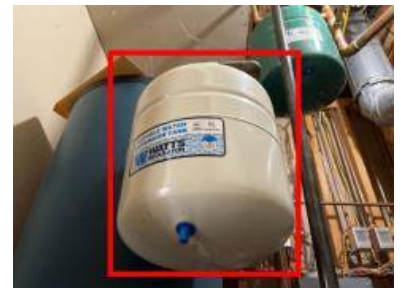
Comments: **Attention** - The expansion tank needs replaced. It has failed.

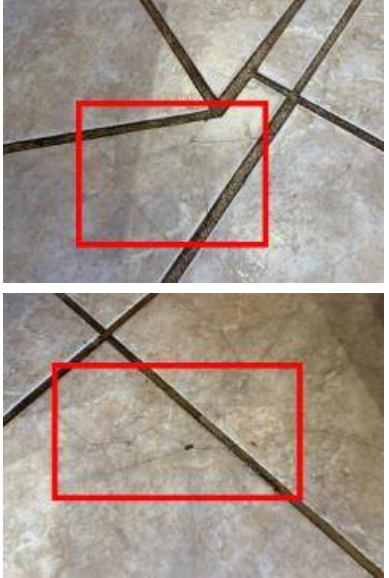
<i>Location:</i>	Main level rear of house.	
<i>Pantry:</i>	Satisfactory - The pantry is functional, and it has shelving installed.	
<i>Windows:</i>	Satisfactory - The windows and associated hardware in the kitchen are satisfactory.	
<i>Walls:</i>	Satisfactory - The walls in the kitchen appear to be satisfactory.	
<i>Ceiling:</i>	Satisfactory - The ceiling is functional and as expected.	
<i>Floor:</i>	Attention Needed - The flooring in the kitchen is in need of attention to prevent further deterioration. There are several cracked tiles.

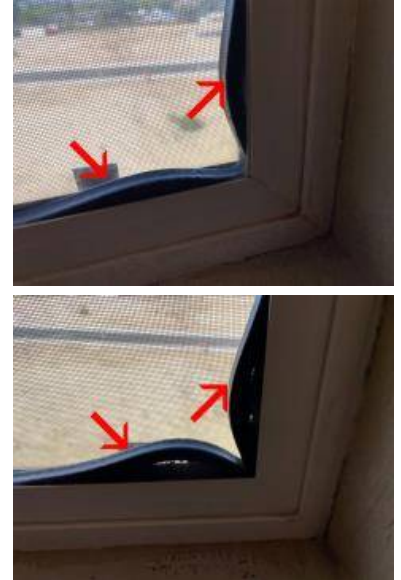
Location: Off the hallway to the guest bedrooms, Upstairs.
Entry Door: Satisfactory - The entry door to the bathroom is functional.
Walls: Satisfactory - The walls in this bathroom are satisfactory.
Windows: **Attention Needed-** The seals are warping. These windows will need to be replaced.

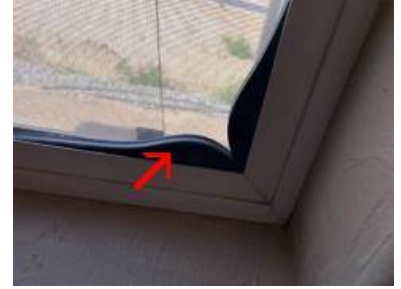
Attention Needed- The seals are warping. This window will need to be replaced although it is keeping the elements out.

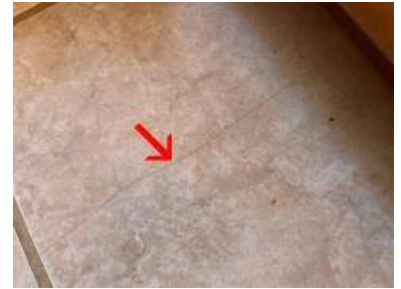
Attention Needed - The flooring in this bathroom is in need of attention to prevent further deterioration.

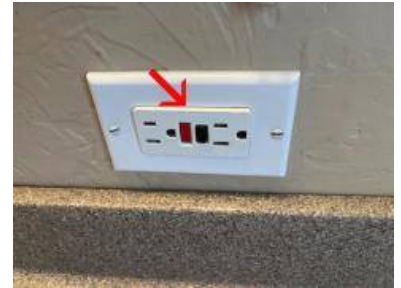
Satisfactory - There is a functional Ground Fault Circuit Interrupt outlet installed in the area of the bathroom vanity. *Attention Needed-*The GFCI in this bathroom is on the same circuit as the other bathroom outlets. It appears to be original. It is best practice to replace GFCI outlets every 20 years. This one should be replaced.

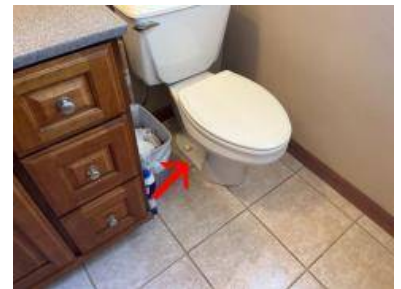
Action Recommended - The toilet in this bathroom needs repair. The toilet is not secure to the floor, allowing it to wobble or twist and possibly leak. Action should be taken to re-secure it to the floor.

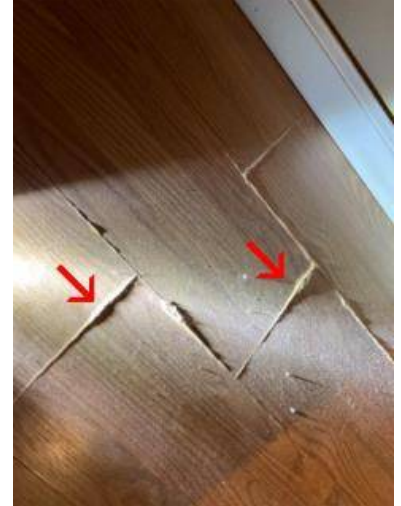
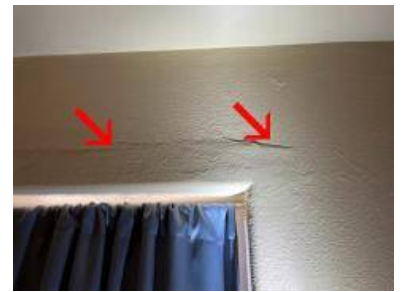
Note- There is evidence of drywall repairs around the closet window.

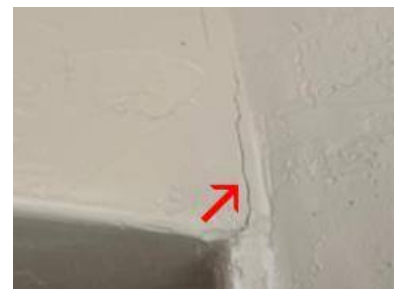
Satisfactory - The ceiling is functional and as I expected. **Note-** Minor cracking was noted. This is not a concern.

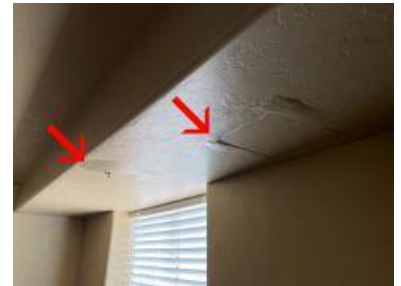
Location: Basement Northeast.
Entry Door: Satisfactory - The entry door to this bedroom is as I expected, and it is functional.
Closet: Satisfactory - The closet is functional and of average size.
Walls: Satisfactory - The walls in the bedroom appear to be satisfactory.
Ceiling: **Action Necessary** - There is deterioration in the ceiling of this bedroom that needs to be repaired. There is a leak from the hose bib piping.

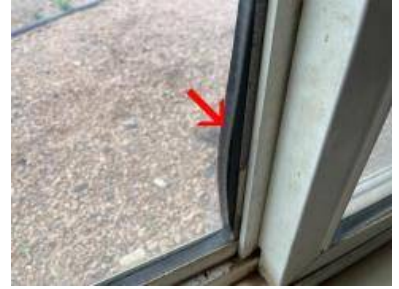
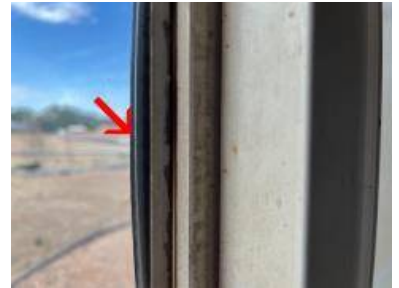
Action Recommended - At least one window or associated hardware in this bedroom needs repair. The seals around the vinyl and on the interior have failed.

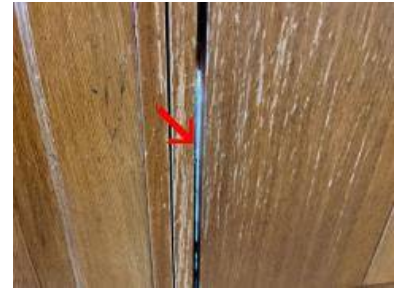
Attention - The main entry door or its associated hardware needs adjustment or repair. The weather strip around the door needs some repair. There is a deadbolt installed on the main entry door, and it is operational. This is a recommended safety feature. The guest at the front door is visible by either a window in the door or next to it, or by a viewing lens. This is a safety feature.

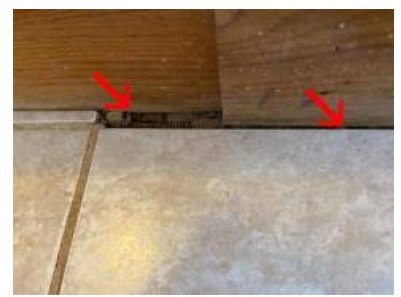
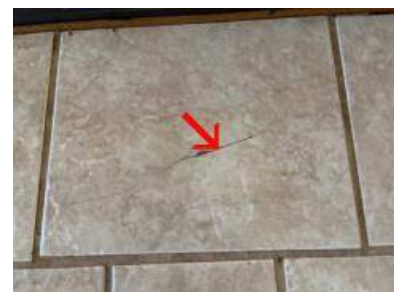
Attention Needed - The entry flooring is in need of repair or refinishing.

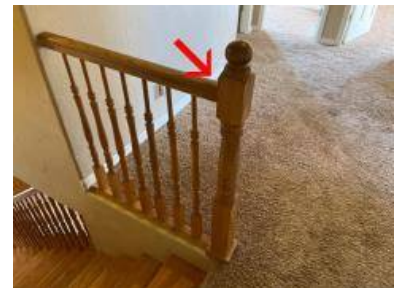
Action Necessary - Some portion of the main stairway needs Immediate Action. Newel post needs tightening. It is excessively loose.

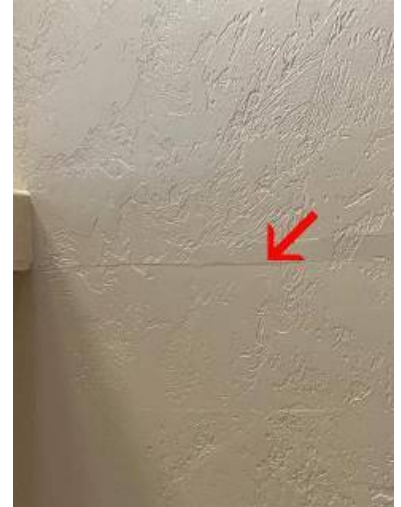
Satisfactory - The ceiling is functional and as expected. **Note-** There is minor drywall cracking along the threshold to the dining room.

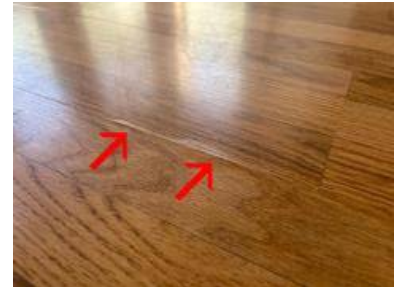
Satisfactory - The floor in this room is in satisfactory condition. **Note-**There is swelling along the seams in several areas. This is typically due to excess moisture when cleaning or incorrect chemicals.

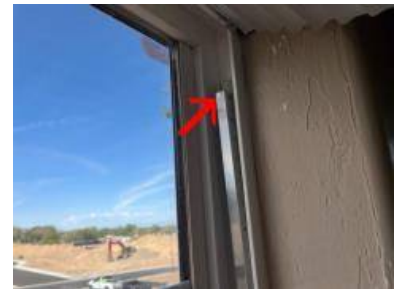
Action Recommended - At least one window or associated hardware in this room needs repair. The spring or slide that holds the window in the up position is not functional. It needs to be replaced.

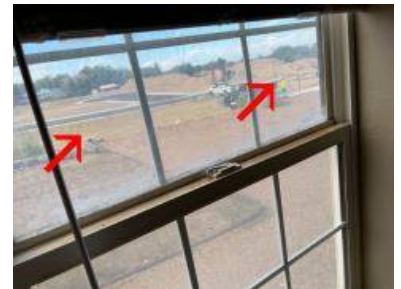
Location: Basement North side.
Outside Entry Door: Satisfactory - The outside entry door to this room is satisfactory. **Action Necessary** - The screen door is missing. Replacement is needed.
Closet: Satisfactory - The closet is functional and of average size.
Walls: Satisfactory - The walls in this room appear to be satisfactory.
Ceiling: Satisfactory - The ceiling is functional and as expected.
Floor: Satisfactory - The floor in this room is in satisfactory condition. The floor covering material is carpet.
Windows: **Action Recommended** - At least one window or associated hardware in this room needs repair. The thermal seal in at least one window is noted as deficient. The window still keeps the rain out, but the staining between the panes of glass will continue to cloud the glass. At some time, if left in place, the window will turn opaque.

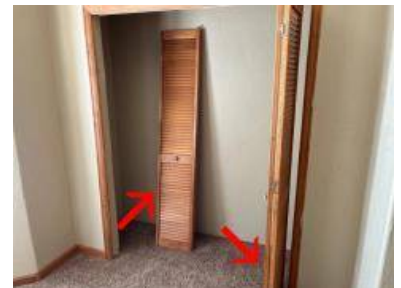
Location: In from main entry.
Entry Door: **Attention** - The entry door or hardware to this room needs some adjustment or repair to function properly. The lock is broken and the latch plate needs to be adjusted on the south door.
Closet: **Attention Needed-** One door has fallen off the tracks and the other needs adjustment to not rub on the carpet.

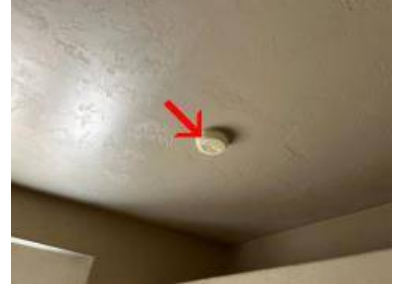
Attention Needed- The smoke detector is over 10 years old and should be replaced.

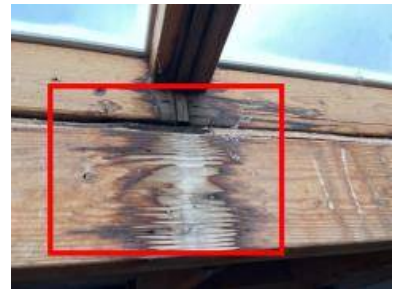
Attention Needed- There is evidence of leaking around the skylight. Some repairs are needed at the roof level.
