RE: Inspection Site  
Inspection Address

# Inspection Report

**Inspection Site  
Inspection Address**

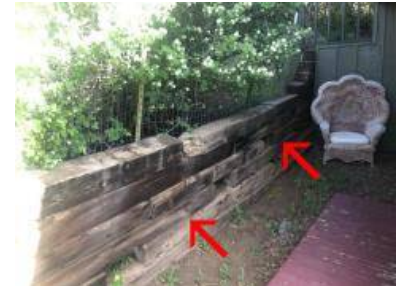
<i>Location of Retaining Wall:</i>	West side of property.
<i>Materials Used:</i>	The retaining wall is made of stacked railroad ties.
<i>Condition of Wall and Materials Used:</i>	<b>Attention Needed</b> - The retaining wall is in need of some repair in order to function properly. The wall is beginning to lean and it appears to need some re-anchoring or restructuring.

<i>Water Drainage:</i>	Satisfactory - The water above the retaining wall is correctly directed away from the wall.
<i>Retaining Wall Anchoring:</i>	Not adequate - The railroad ties appear to be screwed together to prevent movement. No other anchoring was noted.

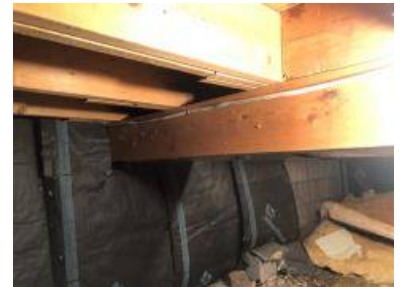
*Crawlspace Ventilation:* Vents to the crawlspace are sealed. This prevents the normal air movement needed. Open the vents to allow normal function.

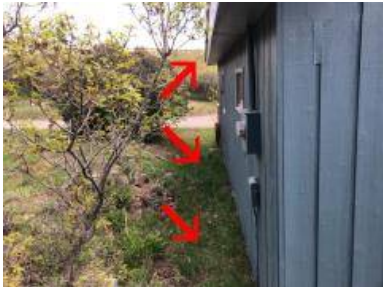
Attention Needed-The north side of the roof should have gutters installed. Water can pool near the foundation and has nowhere to drain too.

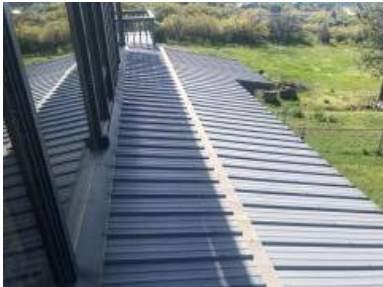
**Attention Needed** - There is minor damage above the garage that needs to be resealed to prevent moisture entry.

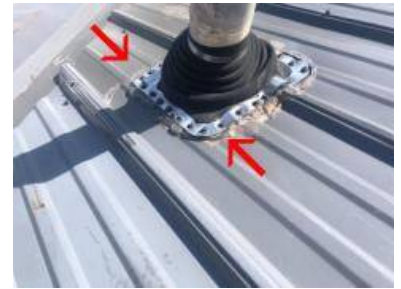
**Attention** - The roof penetrations will need to be resealed periodically.

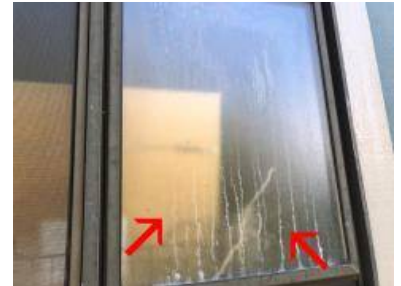
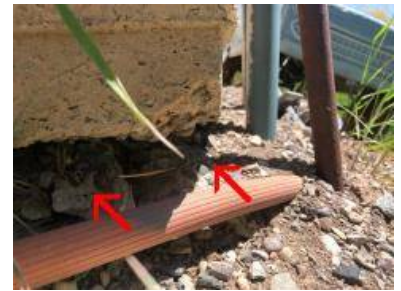
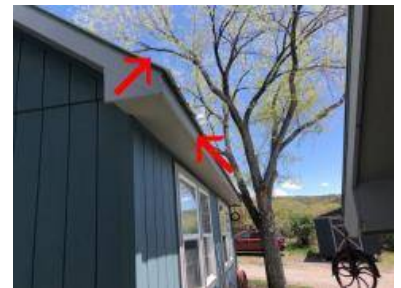
<i>Window Condition:</i>	<b>Attention</b> - Insulation Seal - One or more insulated glass windows have lost their vacuum seal. As a result of losing this seal, condensation between the two panes creates a clouded or streaked appearance. The window still performs the task of keeping the weather out, but it has lost some efficiency.
<i>Window Flashing:</i>	Satisfactory - The installed window flashing above the windows appears to be adequate.
<i>Wall Covering Material:</i>	Sheetrock.
<i>Ceiling Covering Material:</i>	Sheetrock.
<i>Gutters</i>	<b>Attention Needed</b> - Installing gutters around the strict would help prevent further soil removal from around the structure. Eventually, damage may be caused to the slab. Ideally, some repairs would be made to prevent further washout from under the slab.

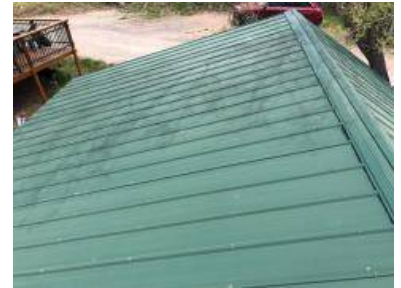
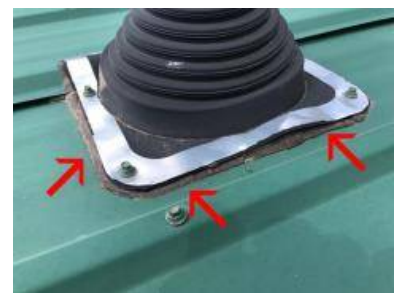
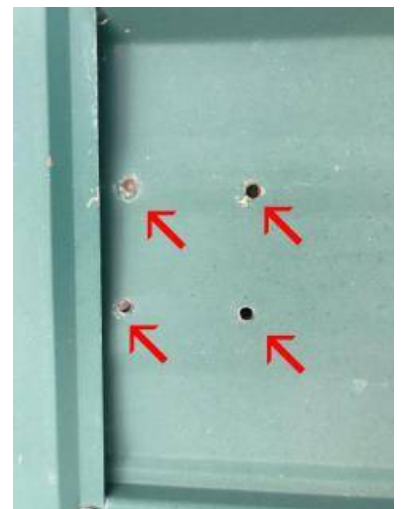
Satisfactory- The roof covering is in a condition that matches its age. Some holes and a plumbing vent will need to be resealed around.

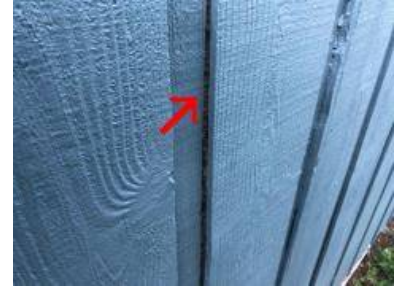
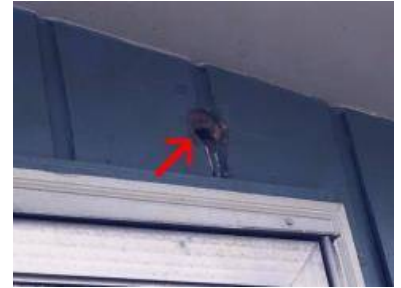
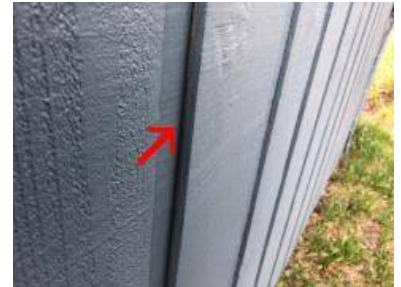
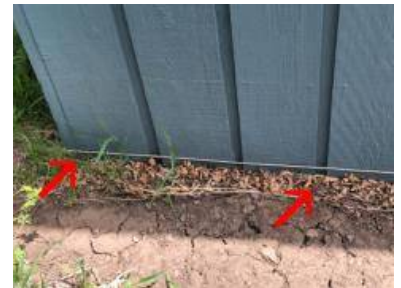
**Attention Needed** - There are several areas that should be sealed to prevent water entry.

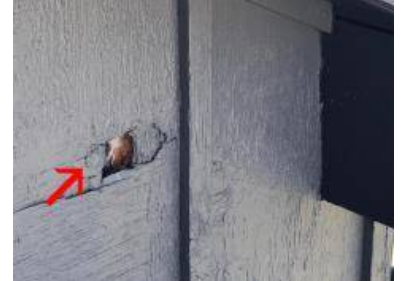
*Siding Conditions.* **Attention-** There is some minor damage to the siding on the upper roof that could allow for water or pest entry.

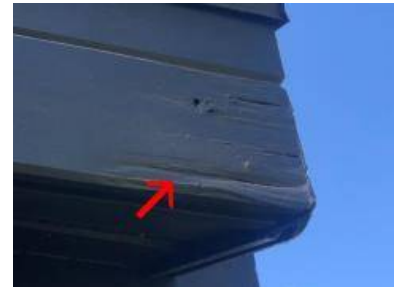
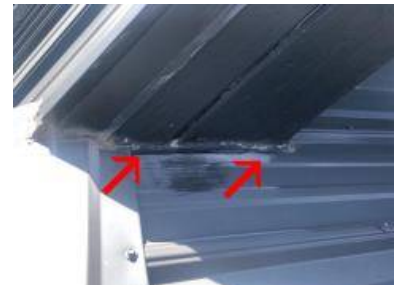
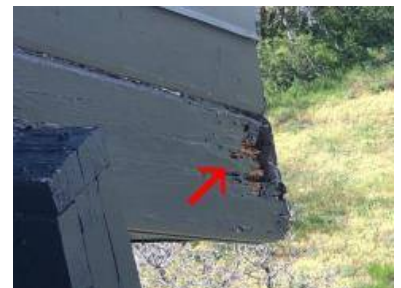
*Fascia & Rake Boards:* **Attention** - The fascia and/or rake boards appear to need some minor repair to prevent further deterioration. **Note-** The rake board or fascia is in contact with the roof covering materials. Ideally, there is a gap between these two materials to prevent moisture transfer. Moisture being wicked up from the roof surface can cause premature deterioration of the fascia or rake board materials. There are several areas where the fascia appears to have deteriorated slightly but has been painted over.

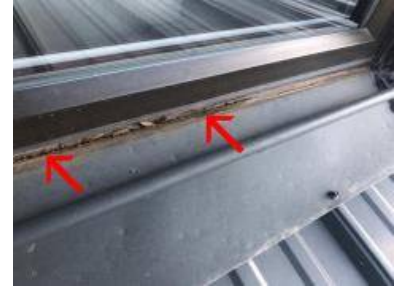
**Attention Needed-** Many of the windows have wood framing with sealant around them. Several of the windows require new sealant to prevent leakage. This should be done as needed on all windows for the home.

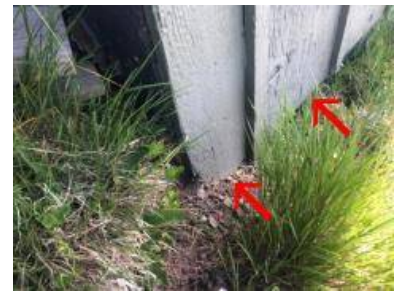
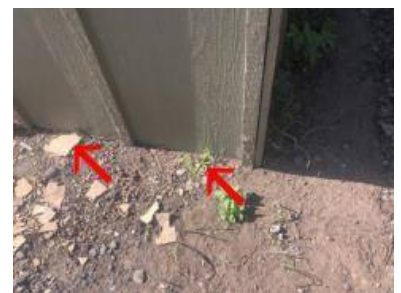
**Attention** - There does not appear to be adequate clearance between the earth and the wood siding or framing members of the structure. It is suggested that there should be a minimum of a 4" clearance between the earth and any wood siding or framing materials.

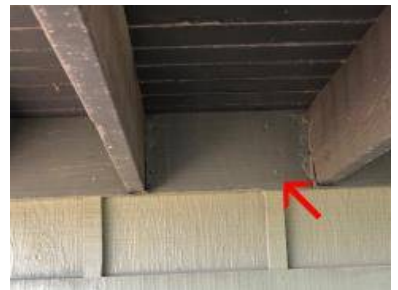
Satisfactory - The framing of the deck or porch was done in an acceptable manner. **Attention**-This portion of the deck does not appear to have been bolted to the structure. Only nails were seen.

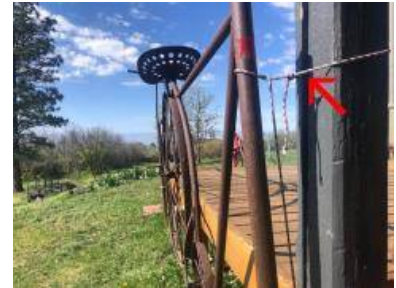
*Deck or Porch Railings:* **Attention Needed-** Metal railing on the lower deck is not attached/anchored except by rope.

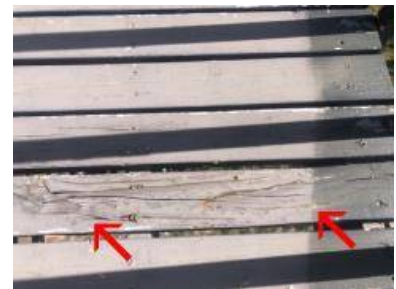
*Condition of Wood Materials:* **Attention** - Although the majority of the wood is in satisfactory condition, there are several boards that are rotting or deteriorated to the point that replacement is needed.

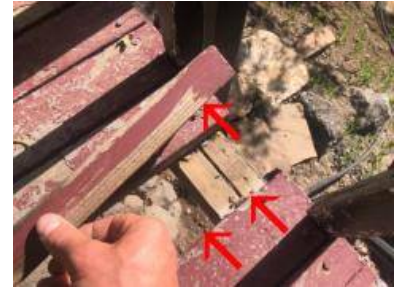
**Attention Needed** - The wood materials used in the deck need some repair or replacement. **Note** - Paint or stain updates will help to preserve the wood materials.

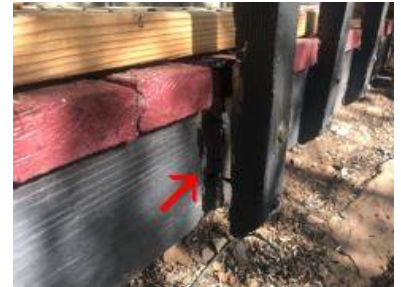
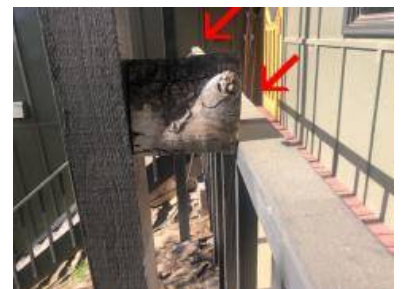
**Attention Needed** - The railings are in place; however, some repair is needed.

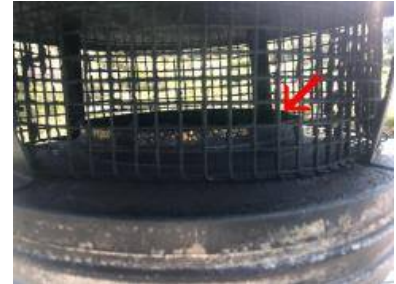
*Flue Condition From Roof:* **Attention Needed** - The visible portions of the fireplace chimney show evidence of creosote build-up. Cleaning and further evaluation by a professional chimney sweep are recommended.

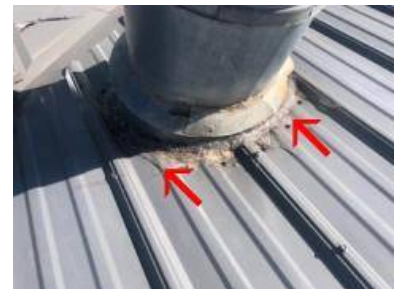
*Flashing:* The stack flashing will need to be resealed periodically.

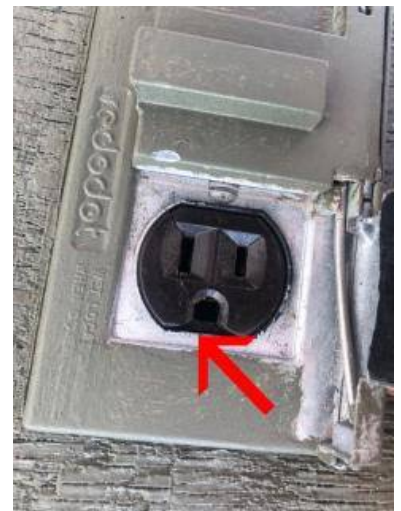
Comments: **Attention Needed-** Exterior outlet on the east mid level deck is cracked and should be replaced.

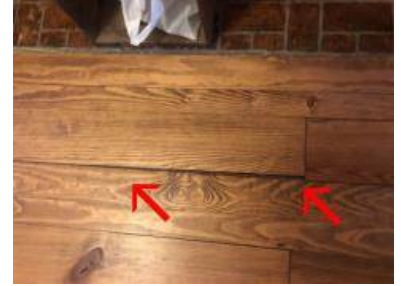
Some movement in the flooring was noted in this area.

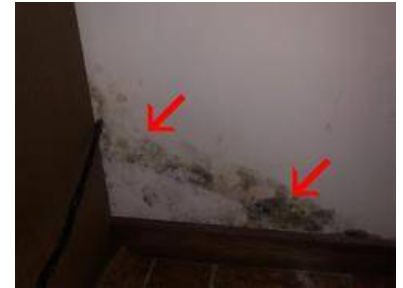
**Attention-** There is evidence of a leak in the back wall. There may be a leak behind the drywall but it is difficult to tell. This area should be monitored closely.

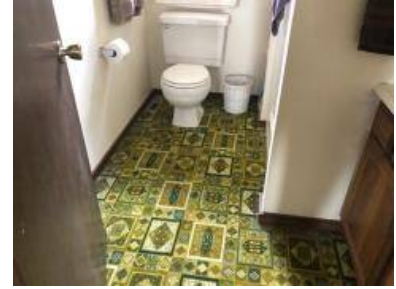
*Floor:* **Note** - Carpet in a bathroom is not a good idea. It holds moisture and conceals damage.
