BROTHERS' INSPECTION INC

## RESIDENTIAL REPORT

1234 Main Street  
Grand Junction, CO 81505

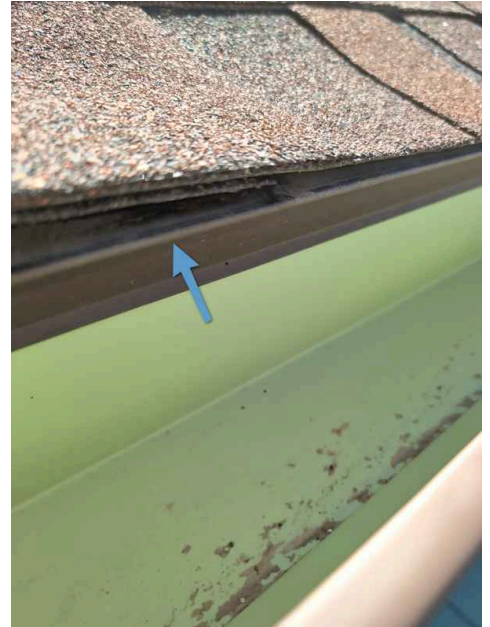
## 3.4.1 Flashings

**DRIP EDGE OVER UNDERLAYMENT**

The drip edge was installed on top of the underlayment. This is a common error by roofers. It is not ideal, however, once installed it is difficult to change. The main concern is that water could enter underneath the drip edge and affect the fascia and soffits. For this to happen there would have to be an issue with the roof above as well. At this time this should be monitored. If water staining is ever observed on the fascia and soffits, it may be necessary to contact a roofer.

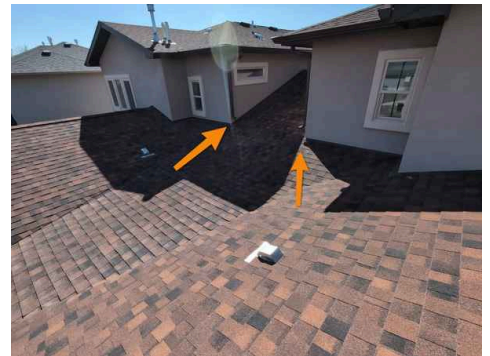
## 3.6.1 Gutters and Drainage Systems

**DOWNSPOUTS DEPOSITING ONTO ROOFING**

It is not recommended to have an upper gutter deposit onto a lower roof. This will cause increased granular loss and wear in these areas and is not recommended. Ideally, all upper gutter extensions are routed directly into a lower gutter.

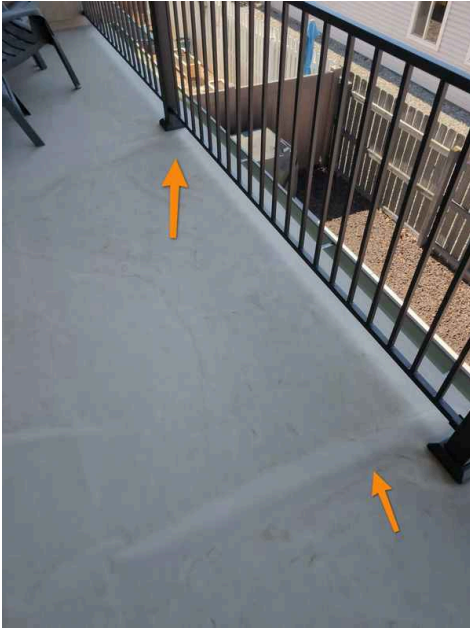
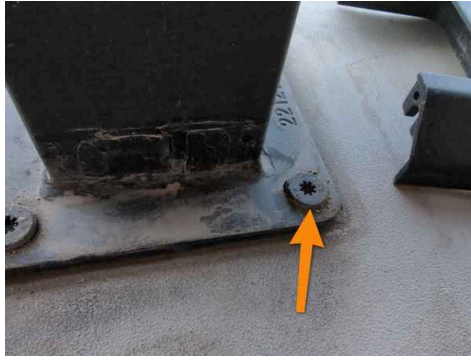
**BUBBLES IN MEMBRANE**

There are bubbles in the membrane deck covering. These both stem from posts installed for the railing. It's possible the posts caused the membrane to wrinkle which is less concerning. It is also possible the anchoring of the posts are allowing moisture to enter underneath the membrane. It is recommended a roofing professional be contacted for further assessment.

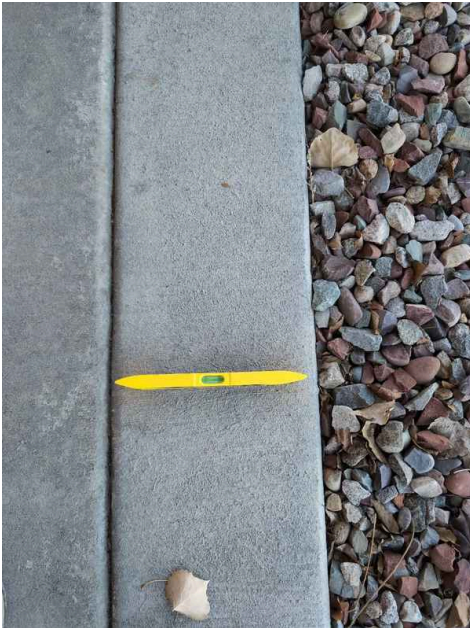
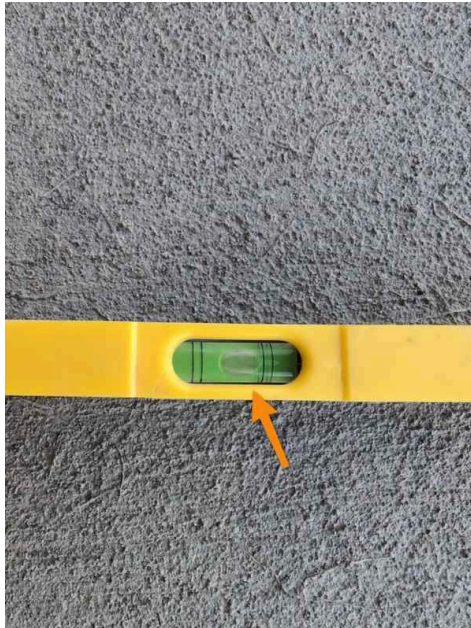
### 5.5.1 Walkways

#### **SLOPE**

The outside edge of the walkway, on the north side of the home, appears to have a slope down towards them. Ideally, all surfaces would slope down and away from the foundation.

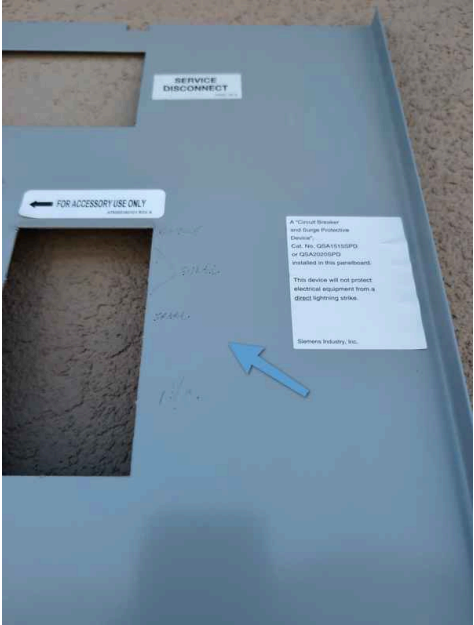
The legend is fading. It is recommended that the legend be retraced if possible.

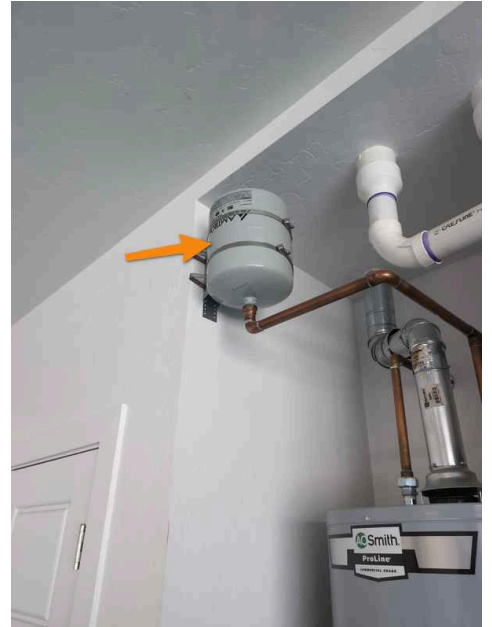
**DIAPHRAGM FAILED**

The expansion tank needs replaced. The diaphragm has failed and the tank is full of water.

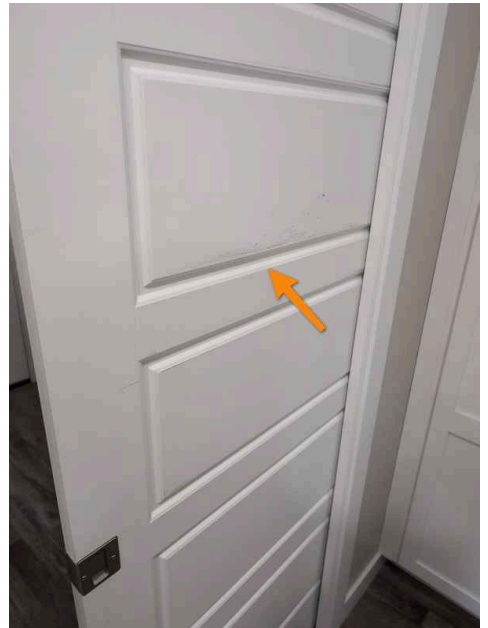
### 13.2.1 Interior Entry Door

#### **RUBS**

The pocket door rubs on the door jamb. Adjustments may be needed to prevent this.

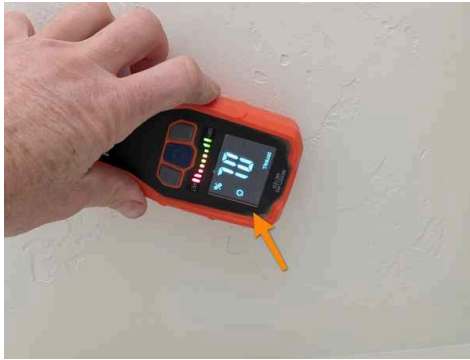
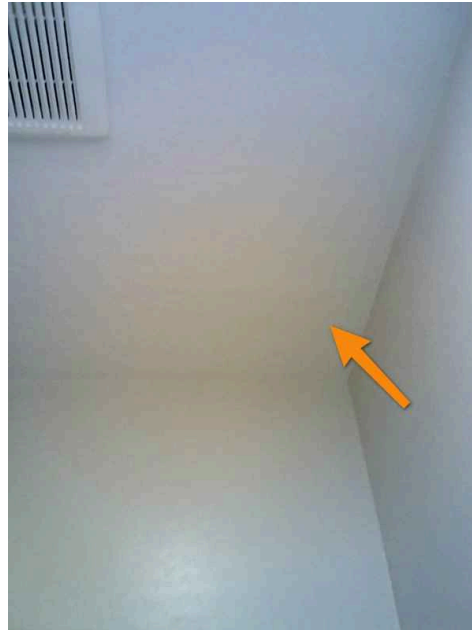
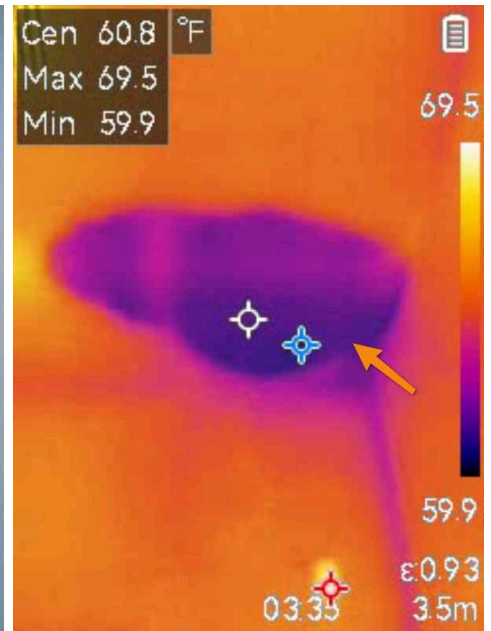
15.3.1 Ceiling  
**LEAK**

There is evidence of a leak. This was found using an IR camera and cross referencing with a moisture meter. To determine the source of the leak further testing or invasive measures may be necessary. This was above the toilet.

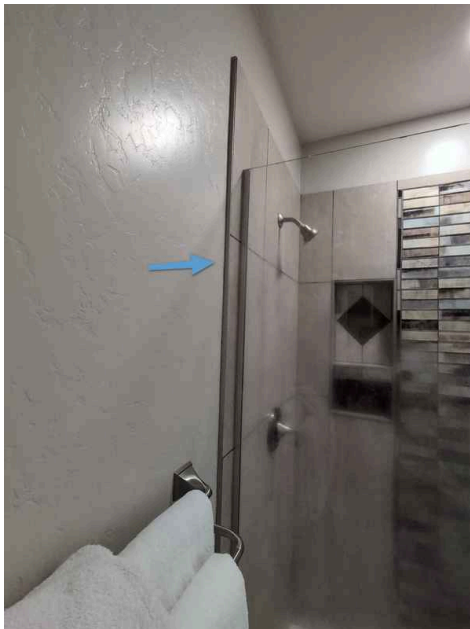
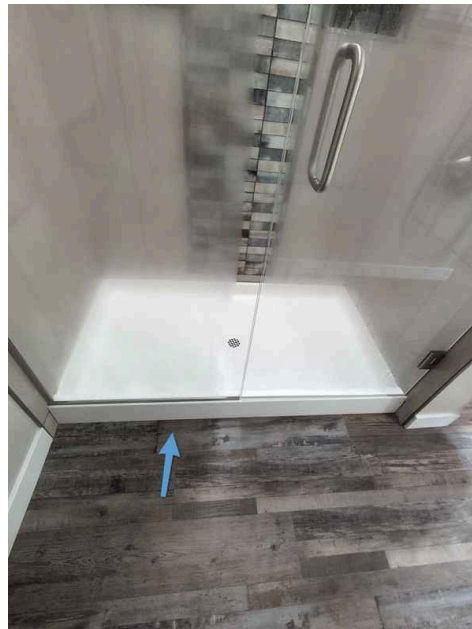
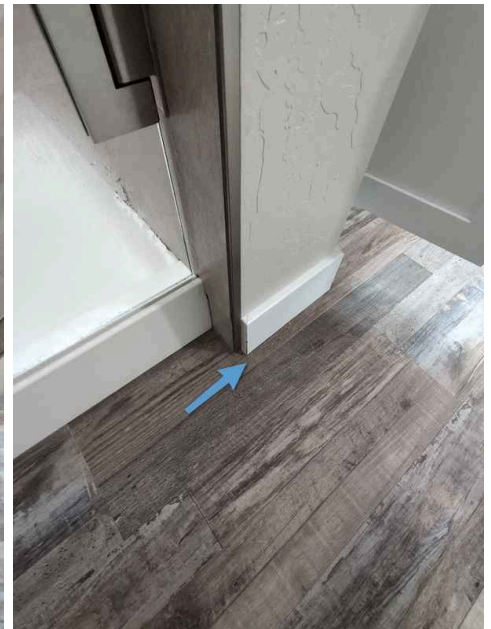
#### 15.17.1 Tub and Shower Walls

##### **CAULK PERIMETER**

Caulking updates are recommended around the perimeter of the shower walls.

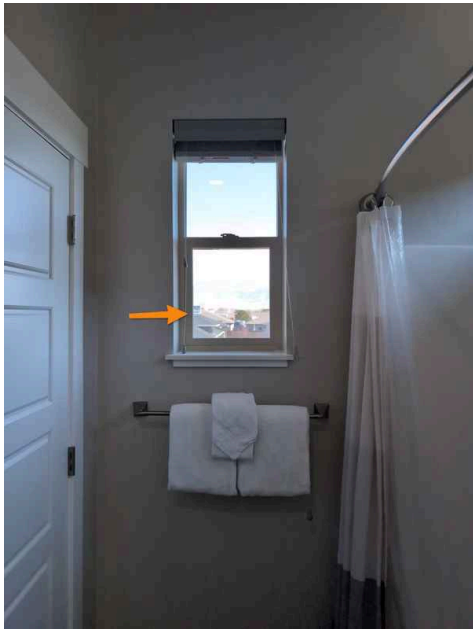
16.6.1 Window  
**MISSING SCREEN**  
One or more of the window screens are missing

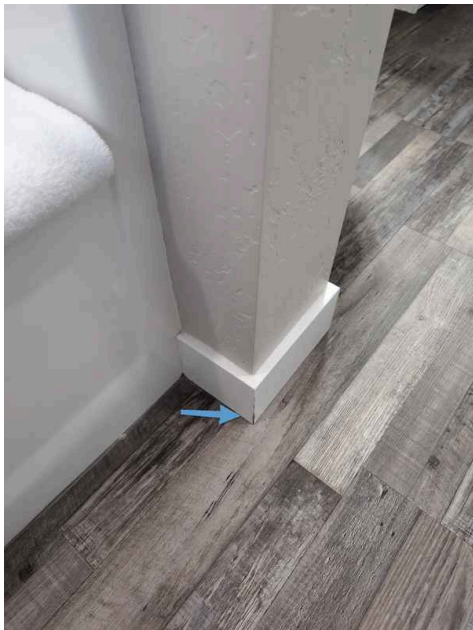
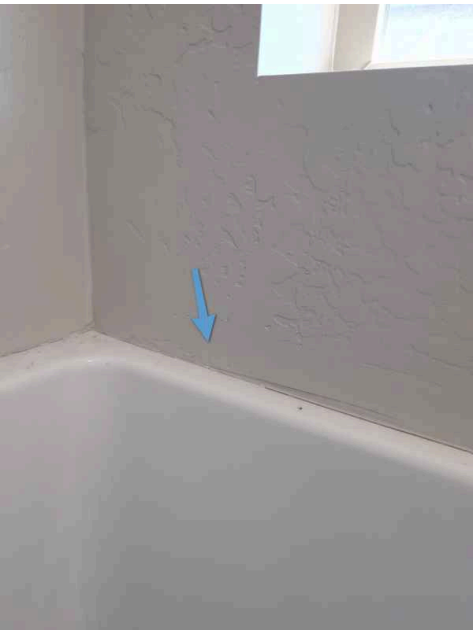
16.17.1 Tub and Shower Walls

**CAULK PERIMETER**

Caulking updates are recommended around the perimeter of the shower walls.

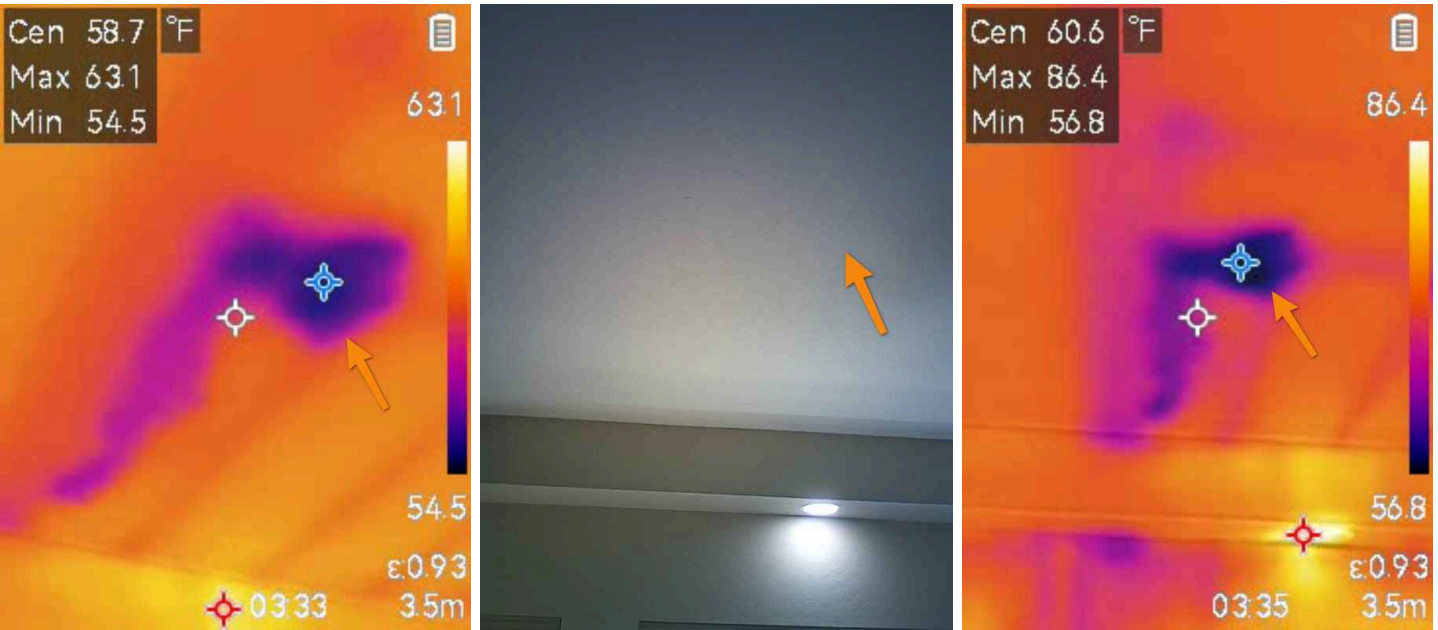
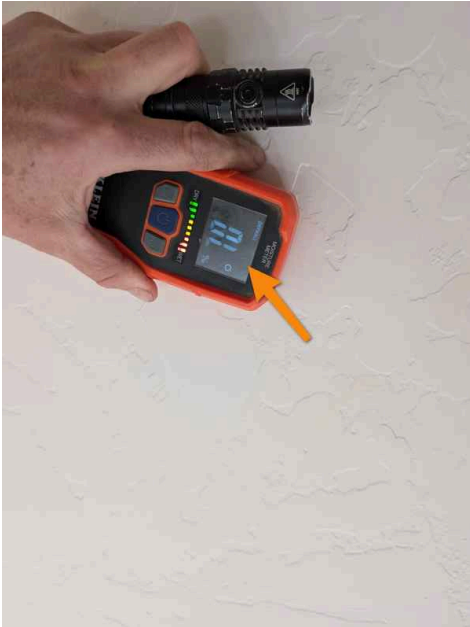
ACTIVE LEAK

There is evidence of an active leak. This was found using an IR camera and cross referencing with a moisture meter. To determine the source of the leak further testing or invasive measures may be necessary.

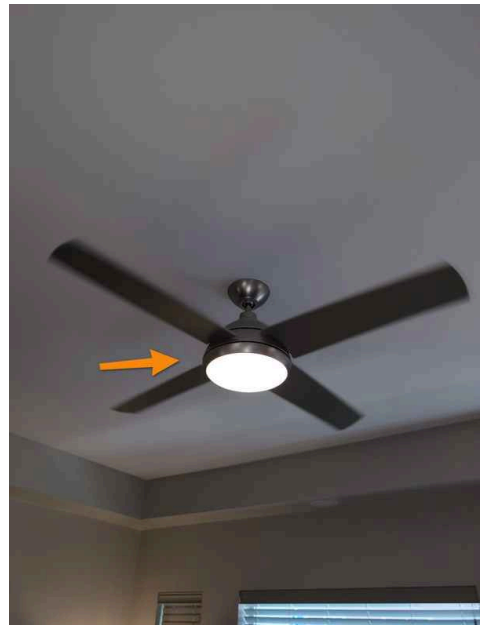
## 18.9.1 Ceiling Fan

**SLIGHT WOBBLE**

The ceiling fan installed in this bedroom appears to need some adjustment. The fan blades wobble slightly. The blades may need to be cleaned, balanced, or the hardware tightened. Sometimes the blades or brackets have bent over time and the only way to remedy the wobble is replacement

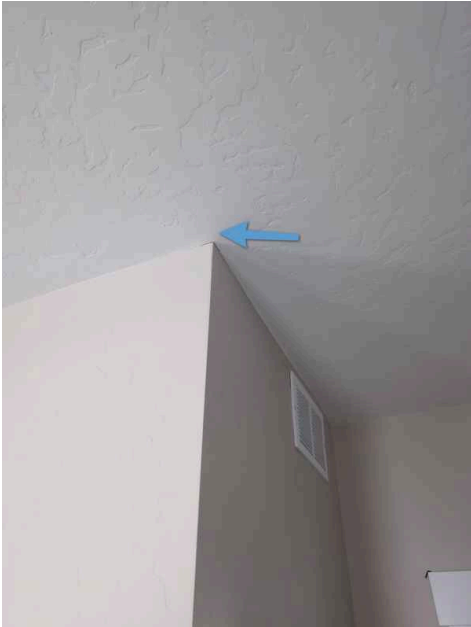
21.3.2 Main Hallway

### HAIRLINE CRACKS

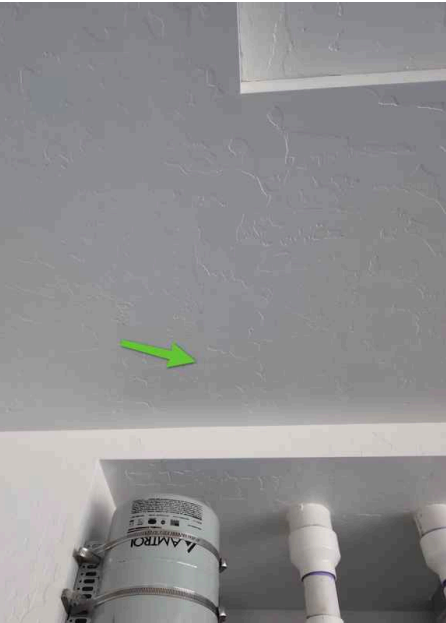
**Garage Ceiling: Minor Cracking**  
There is some minor cracking in the sheetrock. Most likely this is due to slight settlement or shrinkage. It does not appear to be a concern.
