BROTHERS' INSPECTION INC

## RESIDENTIAL REPORT

1234 Main Street  
Grand Junction, CO 81505

08/26/2026 9:00AM

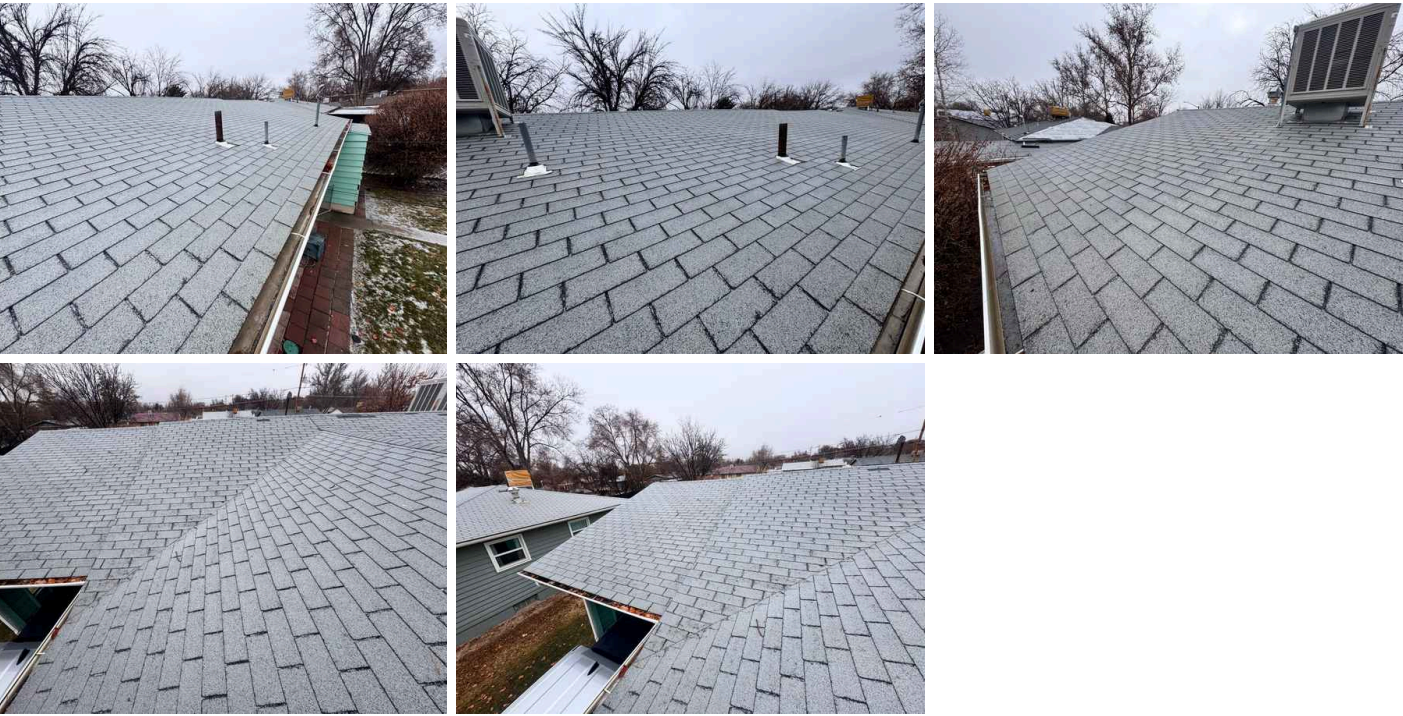
Coverings: Overall Condition

The shingle covering appears to have a 15 to 20 year life expectancy. It may be approaching this age as there are several missing/wind blown shingles, the tack strip is failing, and there is moderate granular loss, particularly on the south facing side and around the evaporative cooler. Minimally, the missing shingles should be replaced. A licensed professional roofer may be able to give a better recommendation for remaining life.

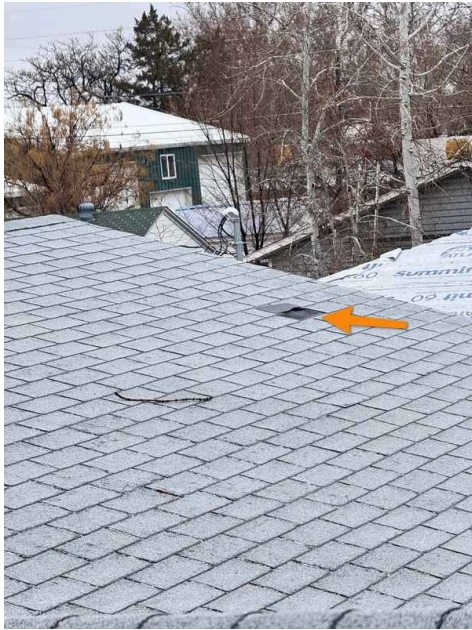
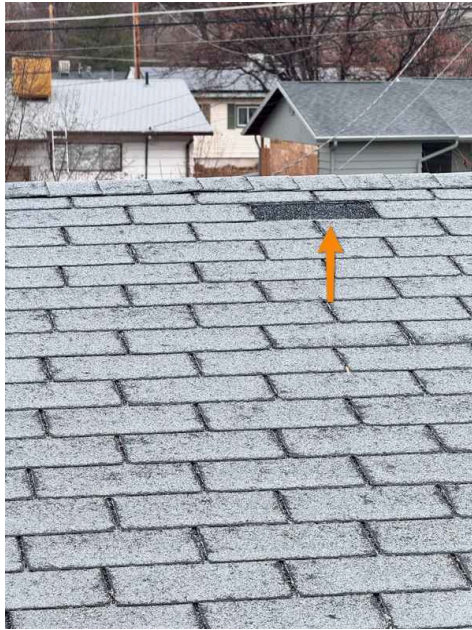
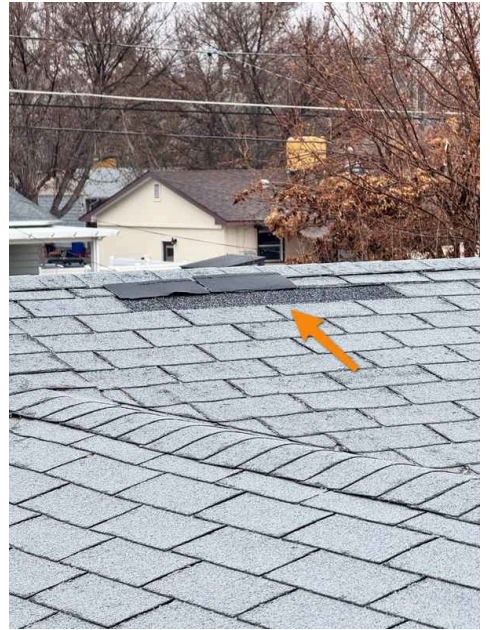
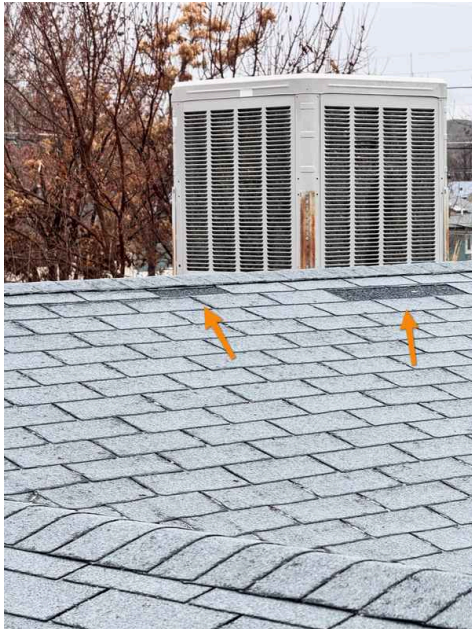
There are multiple windblown shingles. It is showing signs that repair/replacement is needed. A roofer should be contacted for assessment.

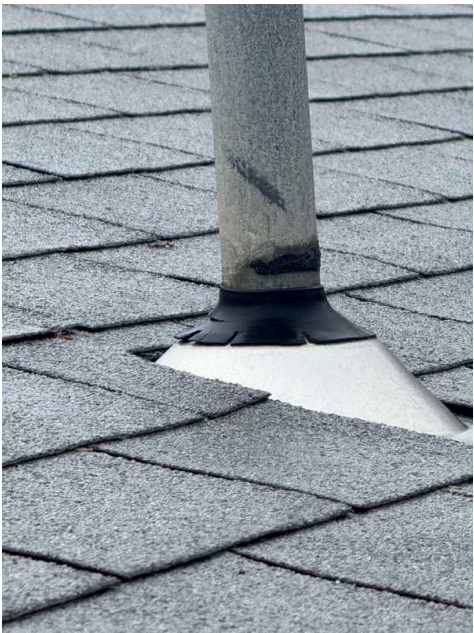
The boots or sealant around the plumbing vent(s) are in need of updating or replacement.

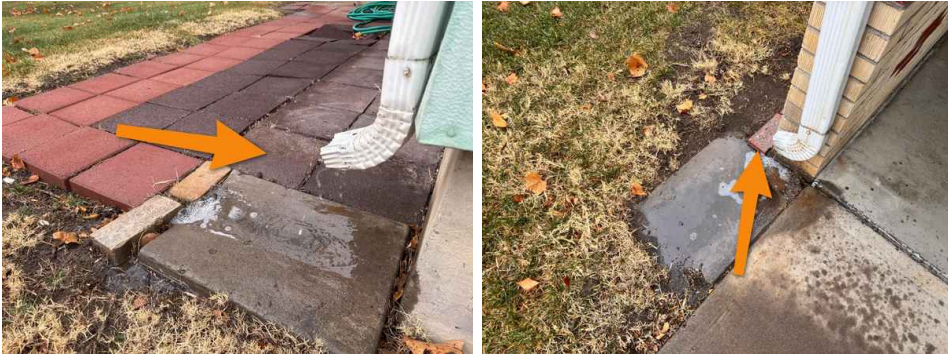
3.6.1 Gutters and Drainage Systems

**DOWNSPOUT EXTENSIONS**

One or more downspouts drain too close to the home's foundation. This can result in excessive moisture in the soil at the foundation, which can lead to foundation/structural movement and other issues. Installation of downspout extensions would help carry the water further away from the foundation.

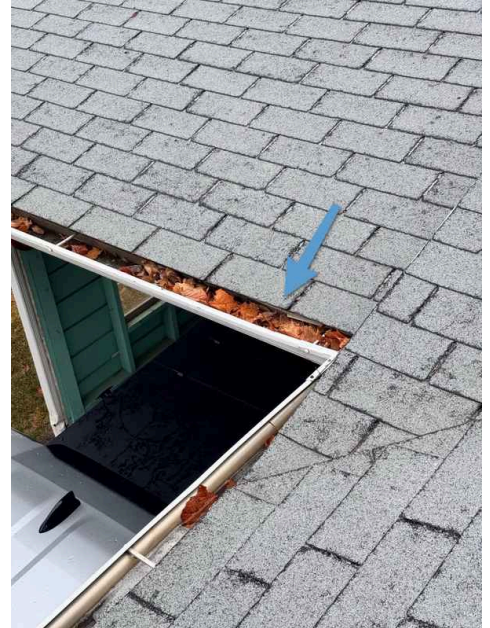
#### DEBRIS

Debris has accumulated in the gutters. Recommend cleaning to facilitate water flow.

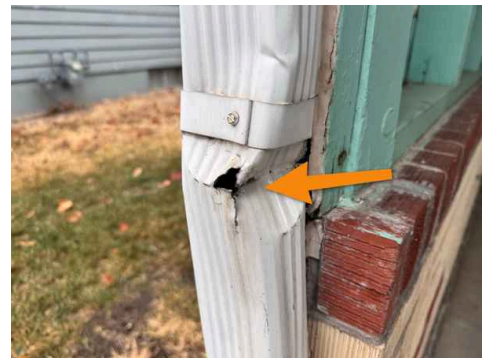
### 3.6.3 Gutters and Drainage Systems

#### GUTTER DAMAGED

Gutters were damaged. This can result in excessive moisture in the soil at the foundation, which can lead to foundation/structural movement. Recommend a qualified contractor evaluate and repair.

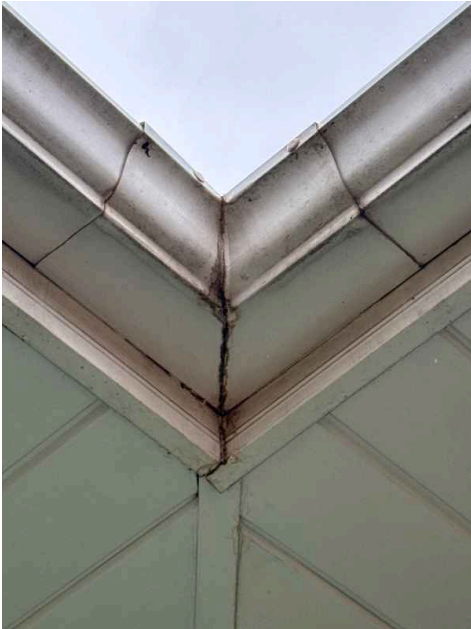
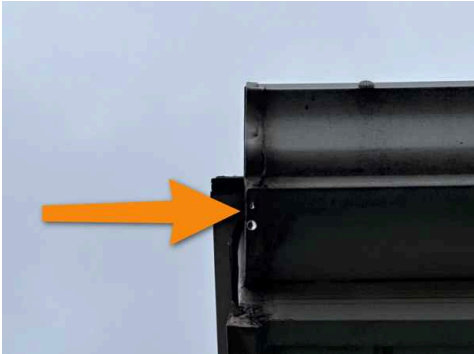
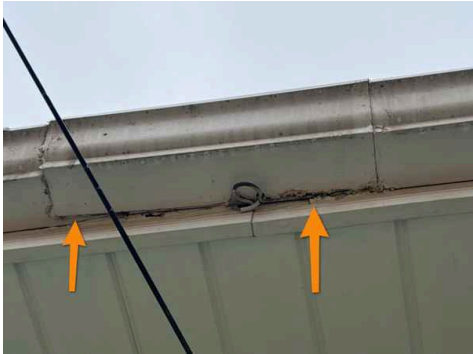
### 3.6.4 Gutters and Drainage Systems

#### GUTTER LEAKAGE

Gutters were observed to be leaking in one or more areas. This can result in excessive moisture in the soil at the foundation. It is recommended a qualified contractor evaluate and repair gutters.

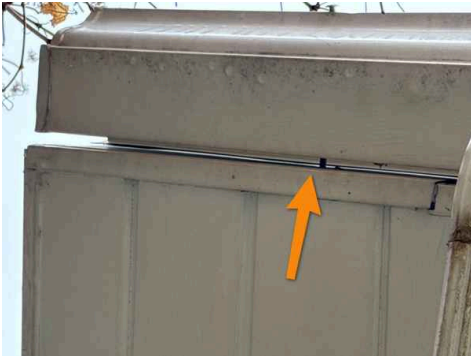
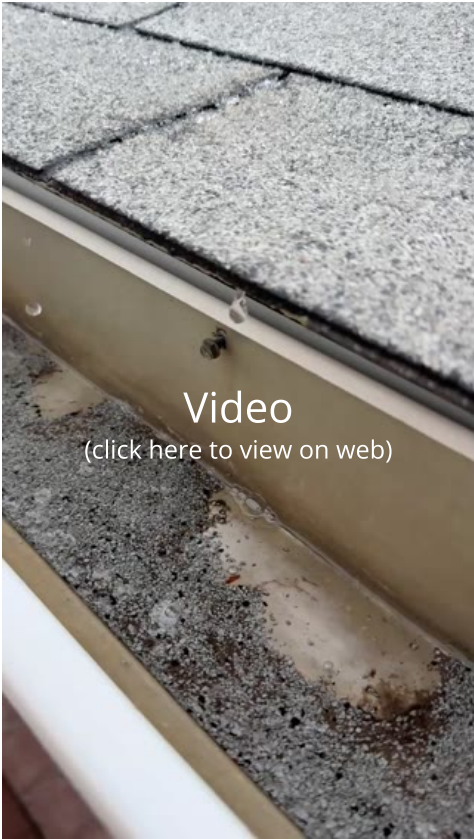
3.6.5 Gutters and Drainage Systems

**GUTTER LOOSE**

The gutter(s) is loose and needs to be re-fastened to fascia.

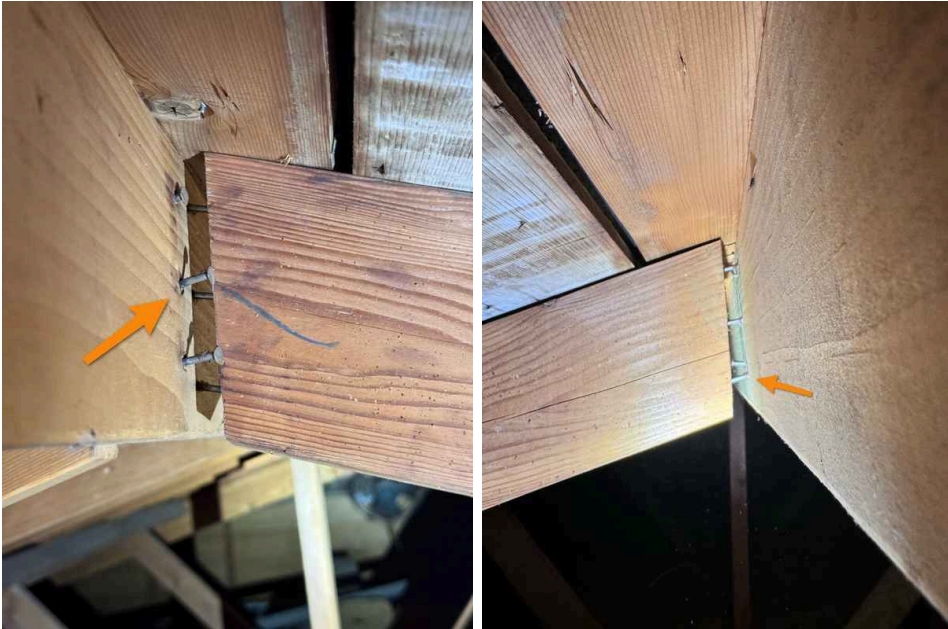
At some point, the top connections of the rafters have pulled apart, leaving gaps and loose nails. While the roof still appears to have adequate support in these areas, it may be beneficial to re-anchor these and install collar ties to prevent any further movement. Consult a licensed contractor.

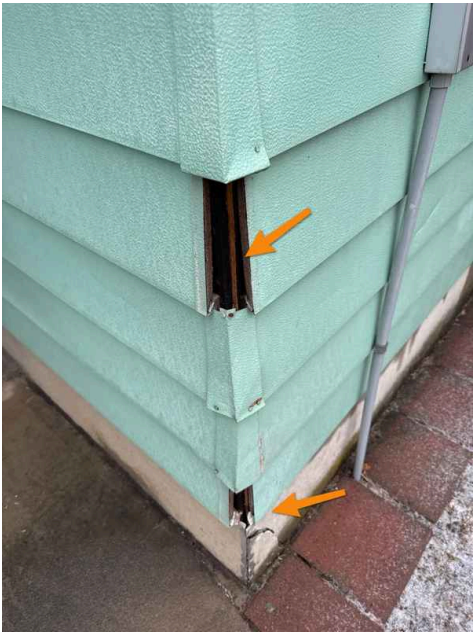
CORNER TRIM- MISSING

Some of the corner trim is missing and needs to be replaced to prevent water entry.

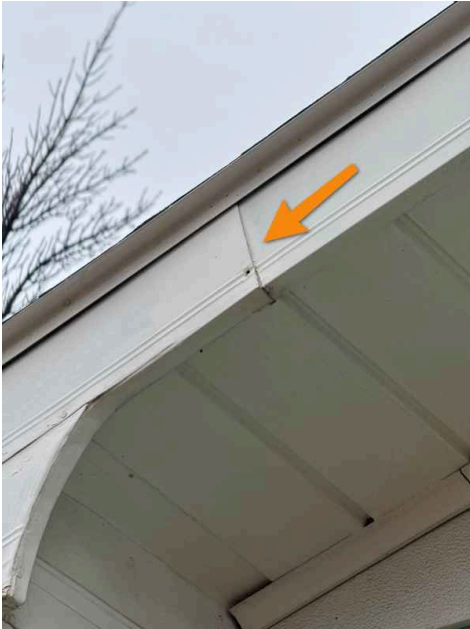
5.2.1 Eaves, Soffits & Fascia

FASCIA FLASHING- NOT OVERLAPPED CORRECTLY

In one or more locations the fascia flashing is installed improperly. The above flashing should be overlapped on top of the lower flashing to help prevent water entry. In the current orientation, water may be able to enter and cause damage to the materials behind.

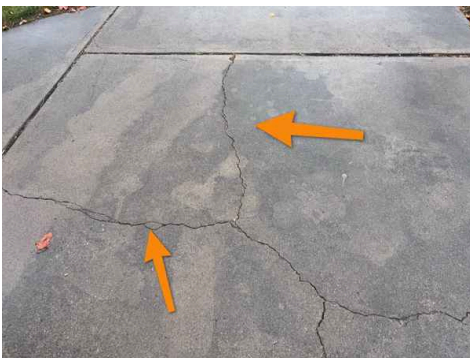
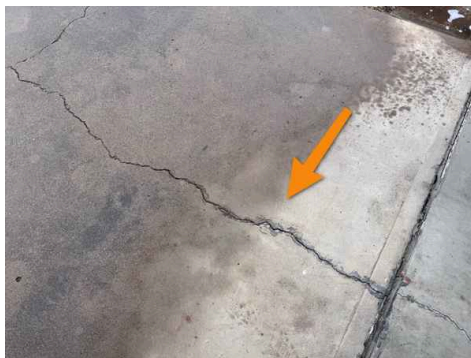
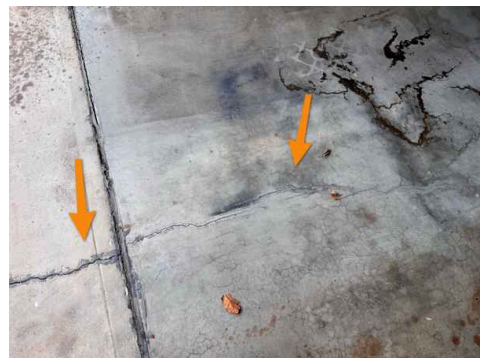
##### **DRIVEWAY CRACKING**

Minor cosmetic cracks observed, which may indicate movement in the soil. Recommend monitor and/or have driveway contractor patch/seal.

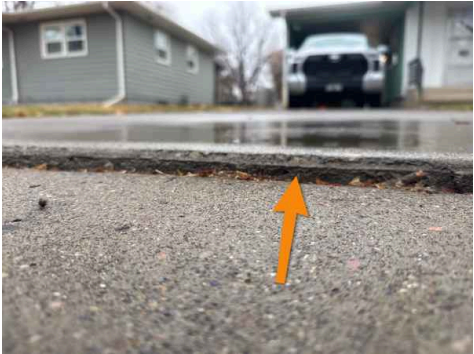
5.4.2 Driveways

**DRIVEWAY TRIP HAZARD**

Trip hazards observed. Patch or repair recommended.

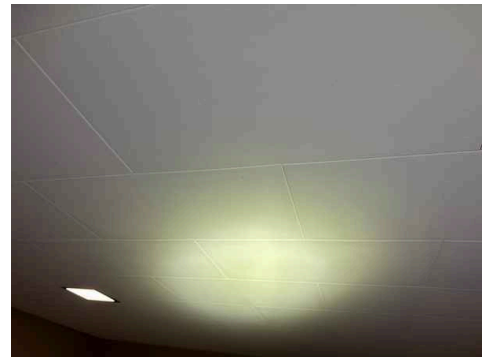
#### 6.2.1 Potential Hazardous Materials

##### CEILING TILES

The ceiling tiles are of a size and shape that may contain asbestos. The only way to know for certain is to test the material. An abatement company can be contacted for testing if desired. Generally, sealing asbestos materials with paint and not disturbing them can prevent health concerns

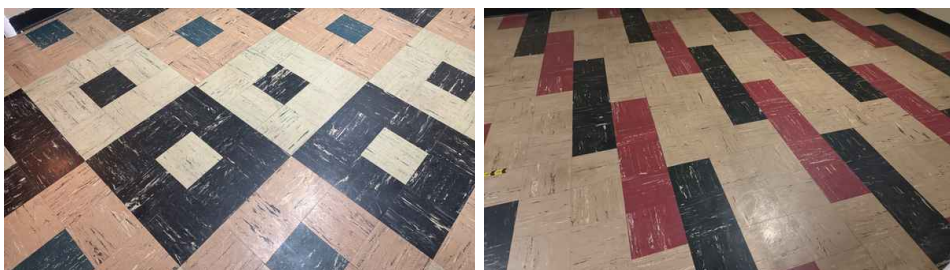
#### 6.2.3 Potential Hazardous Materials

##### FLOORING

In some areas of the home, the flooring is of a type which may contain asbestos. In general if the flooring is not disturbed, it is not a health concern. If the flooring becomes friable, it is considered a health hazard. If this is a concern, an environmental company can be contacted for testing.

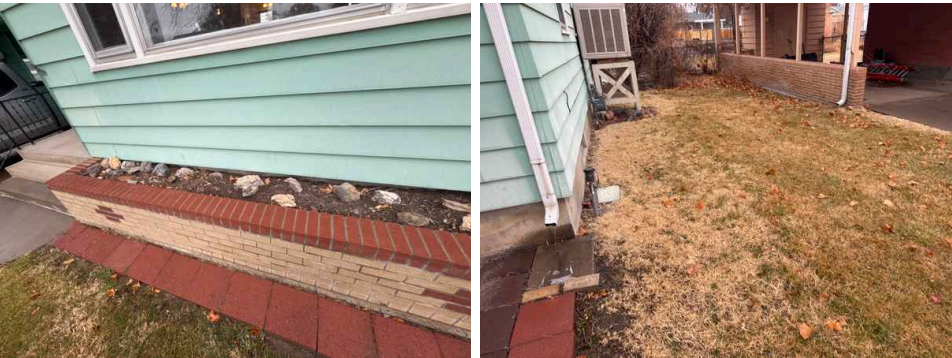
7.1.2 Foundation

Portions of the landscaping do not establish a proper dry zone around the home. This may allow water to pool near the foundation which is not recommended and can cause damage or movement.

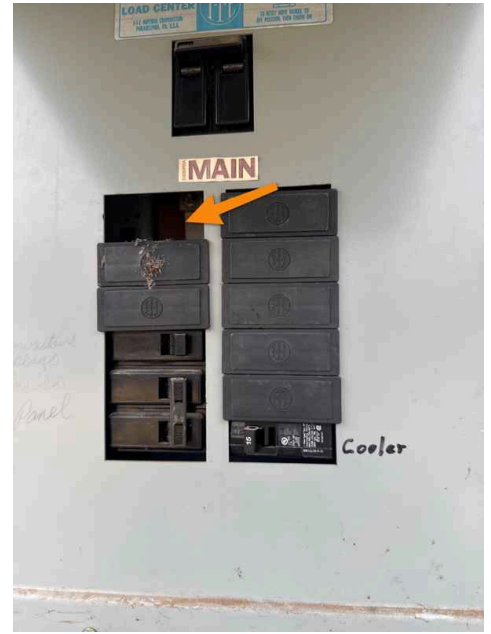
There are open slots in the panel breaker cover where a breaker is missing or a snap in cover is needed.

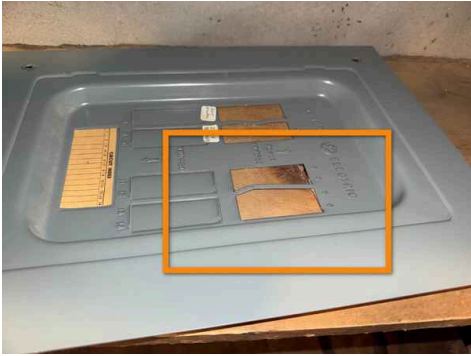
##### MISSING LEGEND

The breakers are not marked as to the rooms, areas, or appliances controlled. It is recommended that they be noted as soon as possible.

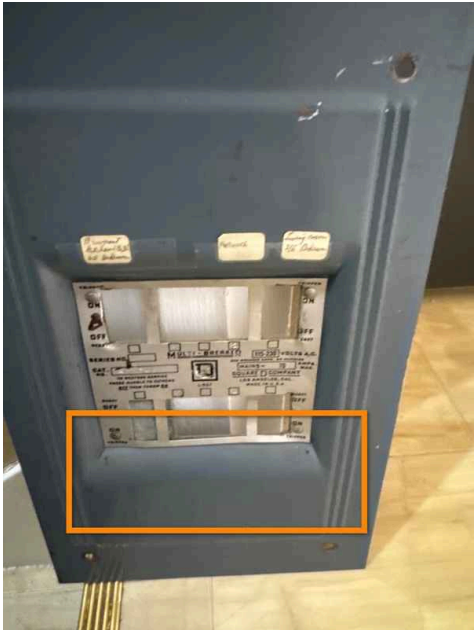
8.4.1 Sub Panel

**MISSING LEGEND**

The breakers are not marked as to the rooms, areas, or appliances controlled. It is recommended that they be noted as soon as possible.

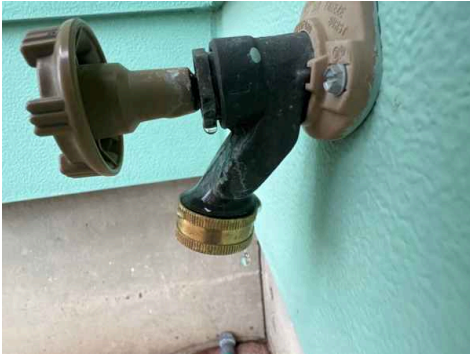
#### VALVE SEAL LEAK

At least one of the exterior hose bibs leaked at the valve seal during the inspection when the water was on and the bib was capped to pressurize it. The packing probably just needs rebuilt or even tightened.

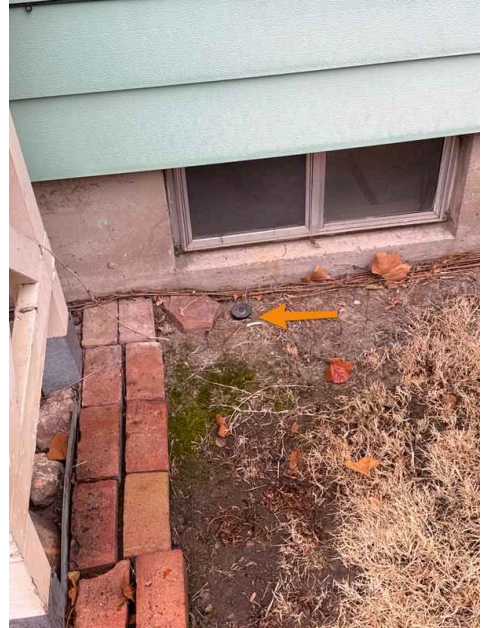
#### 9.12.1 Lawn Irrigation System

### TOO CLOSE

There's irrigation installed right next to the foundation of the home. This is not ideal as it prevents a moisture source close to the foundation and siding and could potentially cause damage or water entry. 3 to 4 feet of clearance is recommended between any irrigation and the foundation.

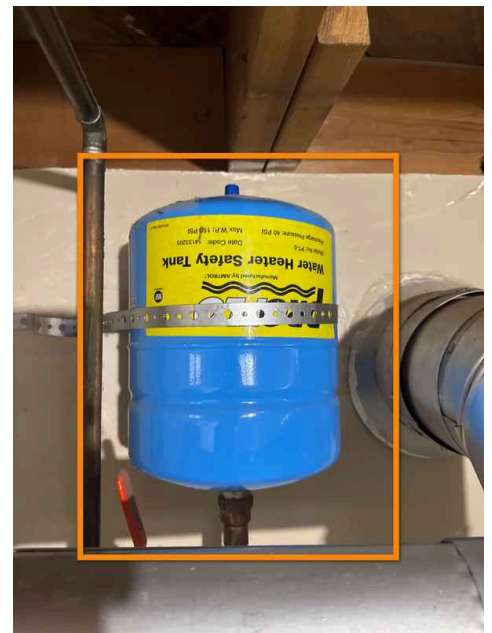
#### **DIAPHRAGM FAILED**

The expansion tank needs replaced. The diaphragm has failed and the tank is full of water.

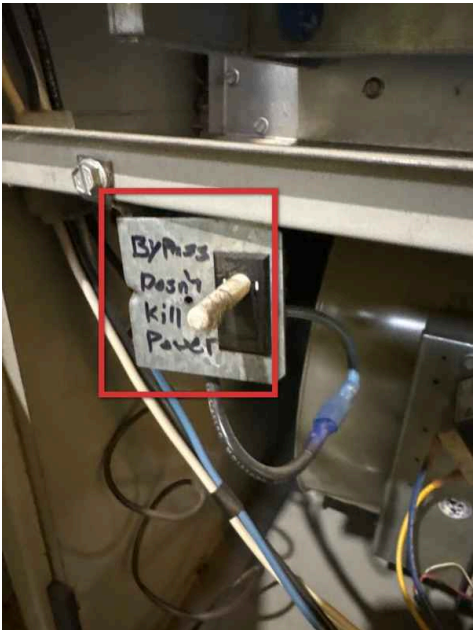
11.6.2 Blower Condition

The kill switch to the blower has been bypassed. This is not recommended as this is a safety feature.

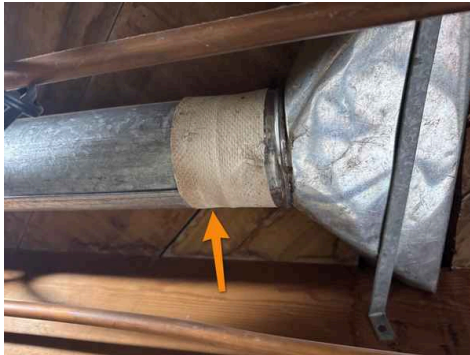
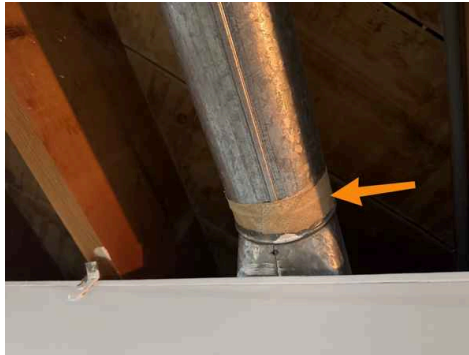
#### 11.8.2 Ducts Condition

The seams of the ducts are sealed with what appears to be a mineral fiber. It is possible that it is an asbestos-containing material. Asbestos is considered a health concern if it is in a friable state and can dust into the air. If asbestos is not disturbed and sealed, it is not considered an immediate concern.

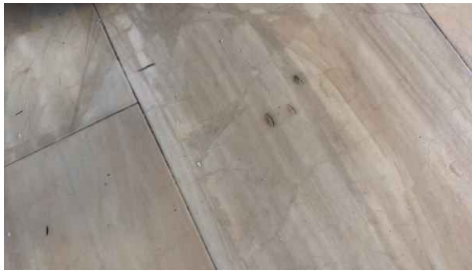
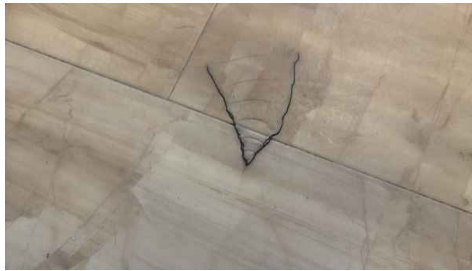
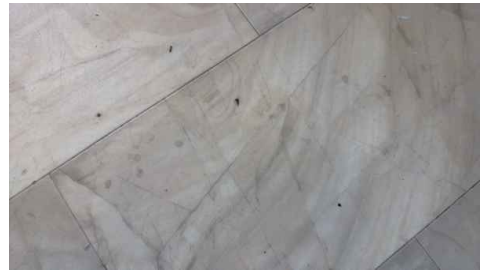
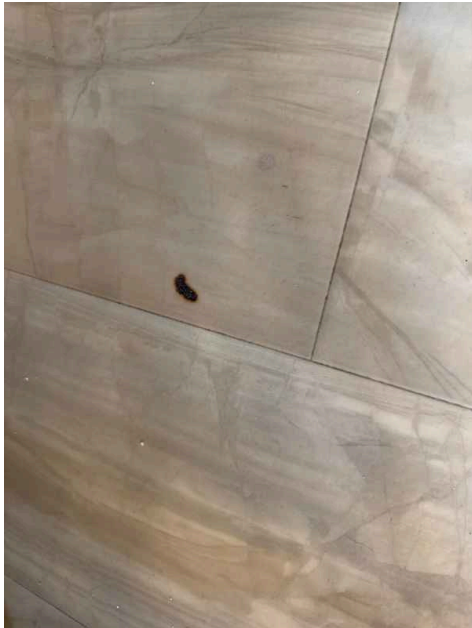
**TEARS/CUTS**

There are tears and cuts in the flooring. Kitchen flooring should ideally be waterproof to help prevent leaks below. It may be beneficial to replace the flooring at some point.

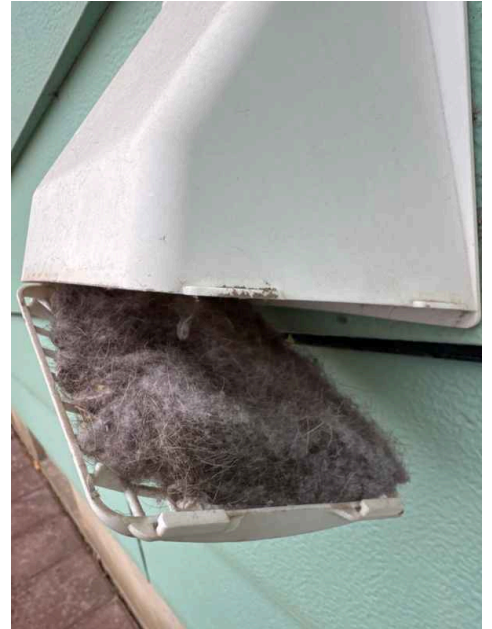
There is a mesh or grate installed on the vent hood. This can inhibit air flow and increase lint buildup. It is recommended the grate be removed.

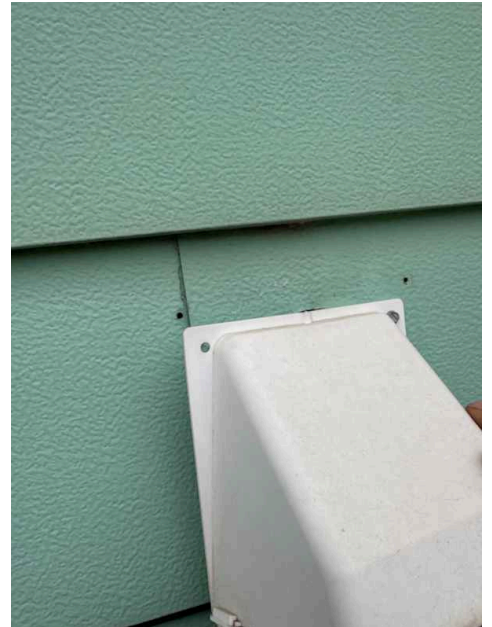
14.11.3 Dryer Vent  
**HOOD- NOT ANCHORED**

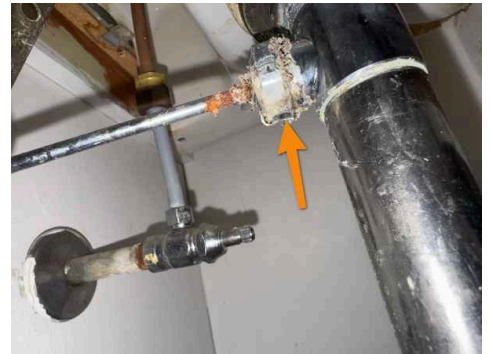
### STOPPER LEVER

There is a leak where the stopper lever fitting connects to the drain line. It is recommended this be adjusted or replaced to prevent this leak.

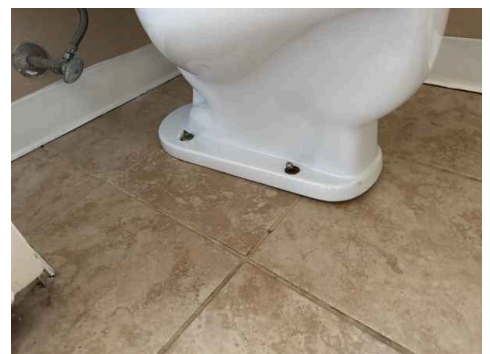
### NOT SECURE

The toilet is not secure to the floor, allowing it to wobble or twist and possibly leak. Action should be taken to re-secure it to the floor. Replacement of the wax seal is recommended as well.

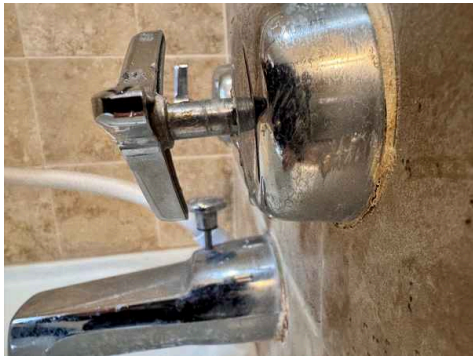
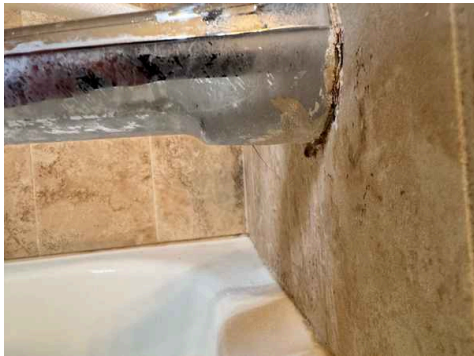
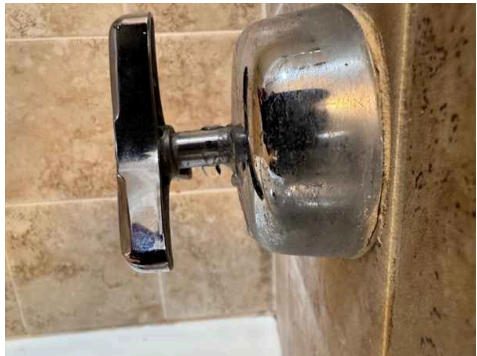
15.15.1 Tub Plumbing  
**VALVE LEAKS**

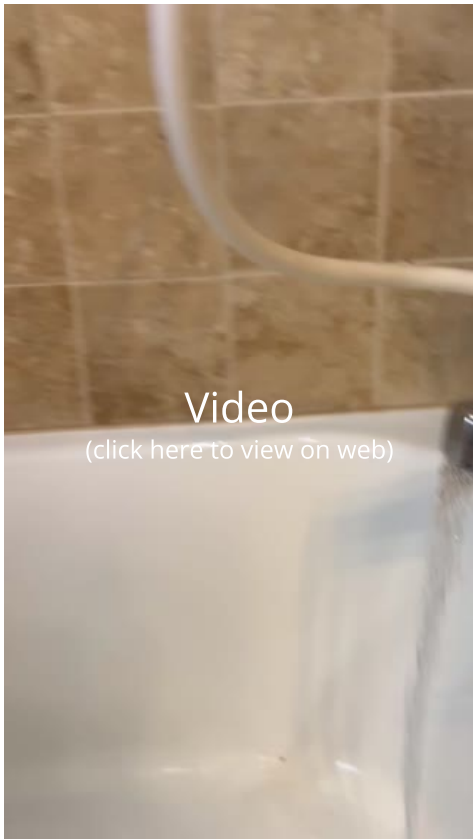
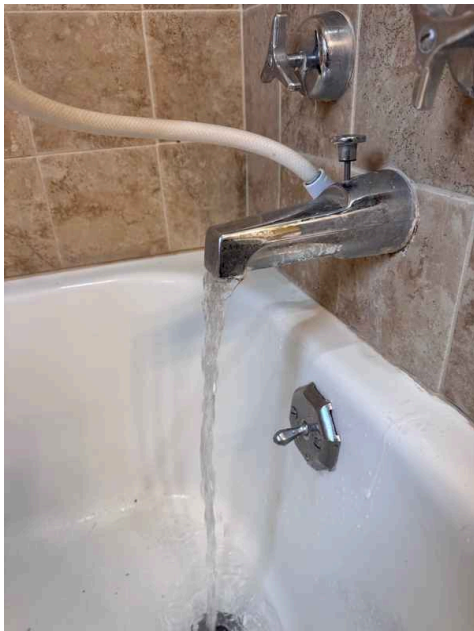
15.16.1 Shower Plumbing  
**DIVERTER VALVE**

The diverter valve did not adequately direct water to the shower head. for the shower to function properly, it should be repaired or replaced.

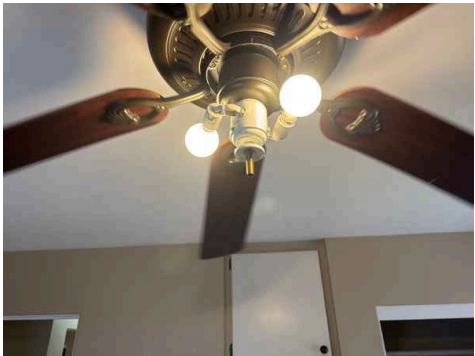
17.9.1 Ceiling Fan  
**LIGHT COVER MISSING**

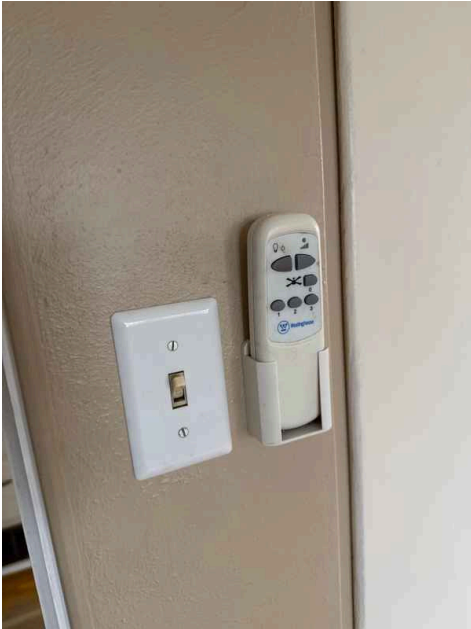
18.8.1 Lighting

**BATTERIES**

The remote did not turn on the fan or light. It may need new batteries.

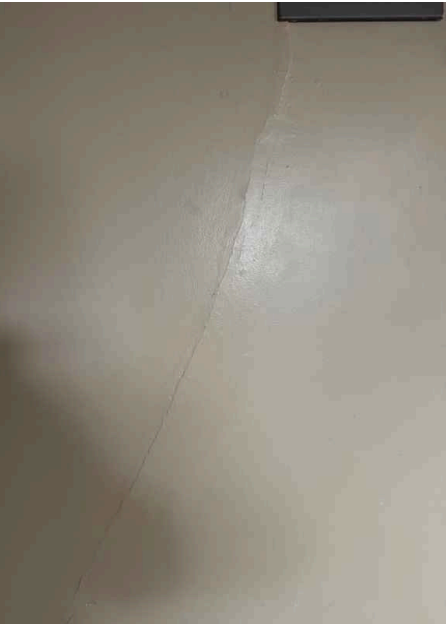
**Walls: Prior Cracking**

There is some minor cracking noted. Be sure to take note of any future movement. Most minor cracking is due to shrinkage of the construction materials, normal vibrations, or initial settling. If the aesthetic of the crack is a concern, a drywall professional can be contacted to make changes.

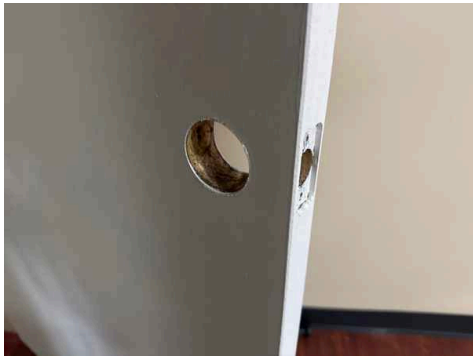
19.2.1 Interior Entry Door  
**NO KNOB**

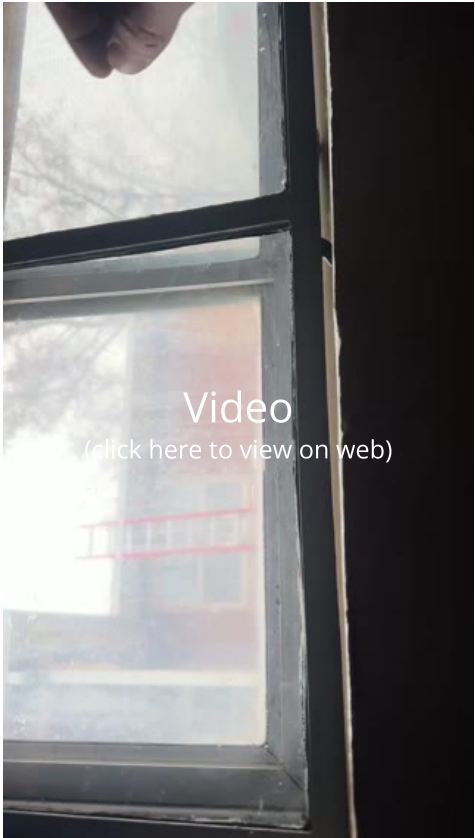
19.5.1 Windows

**REPAIR- REPLACE**

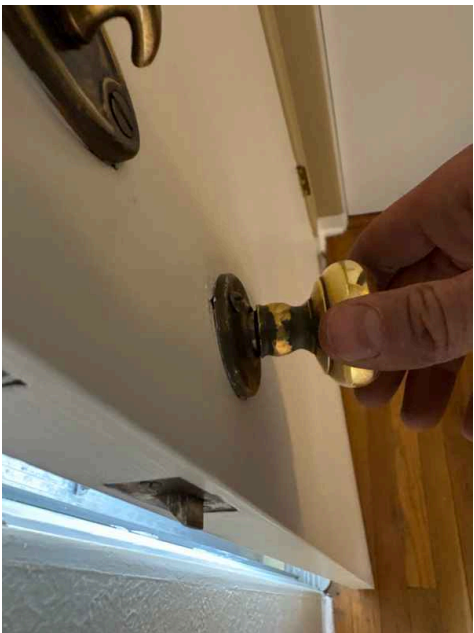
20.2.3 Front Entry Door  
**KNOB**

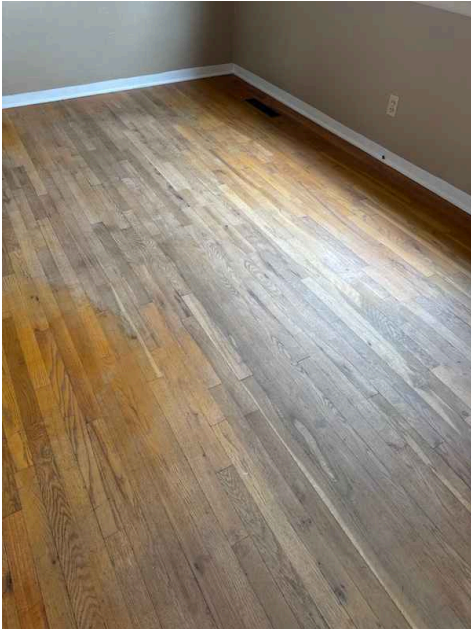
21.7.1 Floor  
**REFINISH**

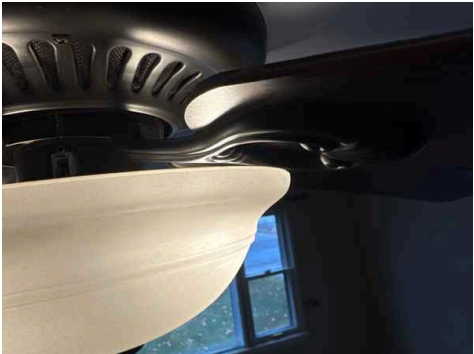
21.9.1 Ceiling Fan  
**RUNNING**

The fan blades are rubbing on the glass cover. Repair is needed.
