BROTHERS' INSPECTION INC

## RESIDENTIAL REPORT

1234 Main Street  
Grand Junction, CO 81505

08/26/2026 9:00AM

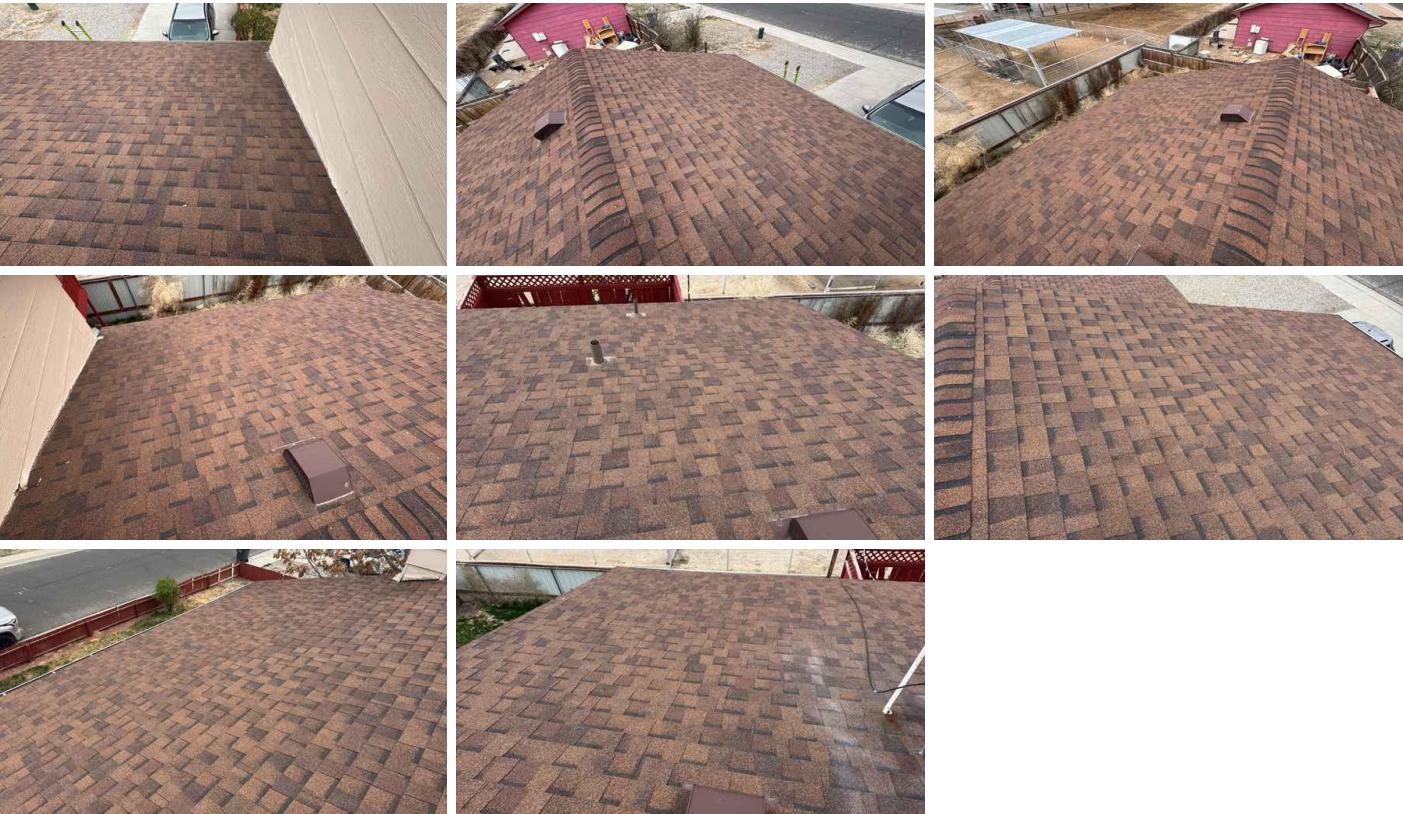
Coverings: Normal Granular Loss

The roof covering material is in a condition that is consistent with its age and method of installation, showing no deficiency or cause for immediate concern.

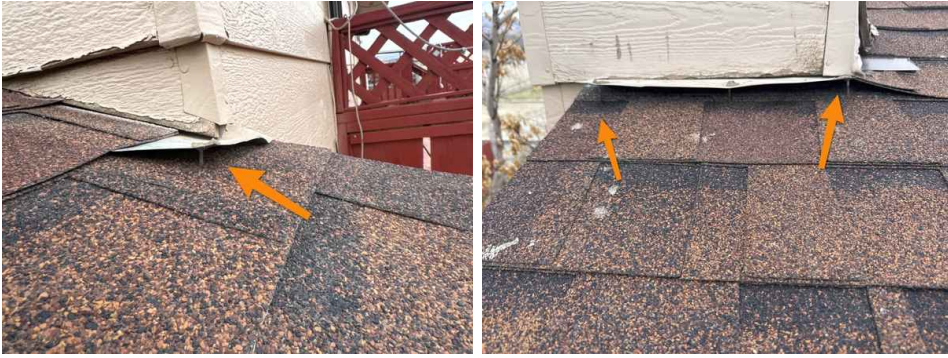
3.4.1 Flashings

The bottom edge of some of the flashings are lifting up. It would be best to secure these down so as to prevent wind damage.

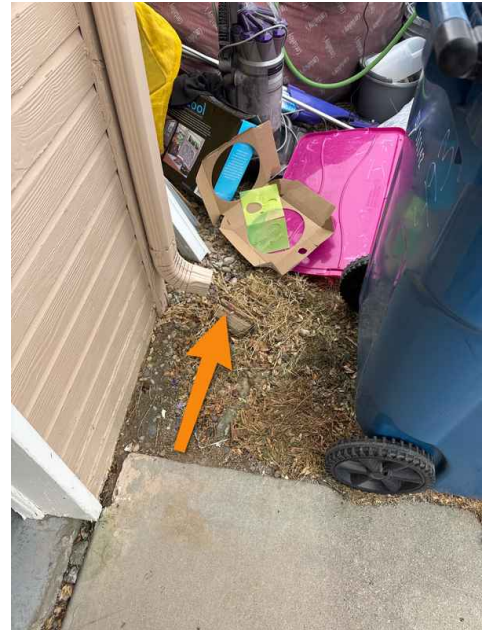
### 3.6.1 Gutters and Drainage Systems

#### **DOWNSPOUT EXTENSIONS**

One or more downspouts drain too close to the home's foundation. This can result in excessive moisture in the soil at the foundation, which can lead to foundation/structural movement and other issues. Installation of downspout extensions would help carry the water further away from the foundation.

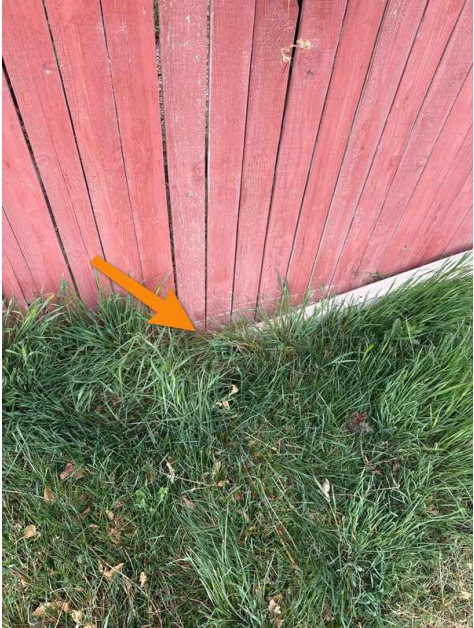
Down about extension on the south east corner of the home is buried. This is not ideal. It should be uncovered and cleaned for proper drainage.

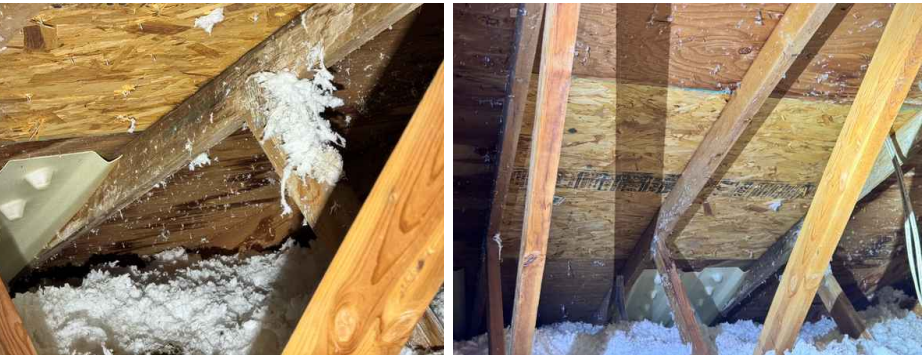
**Evidence of Leaks : Evaporative Cooler Stains**

There is staining on the roof decking boards around the evaporative cooler. The area was dry during the inspection. It is recommended this area be monitored. The current owners can be asked if they are aware of any previous or ongoing issues.

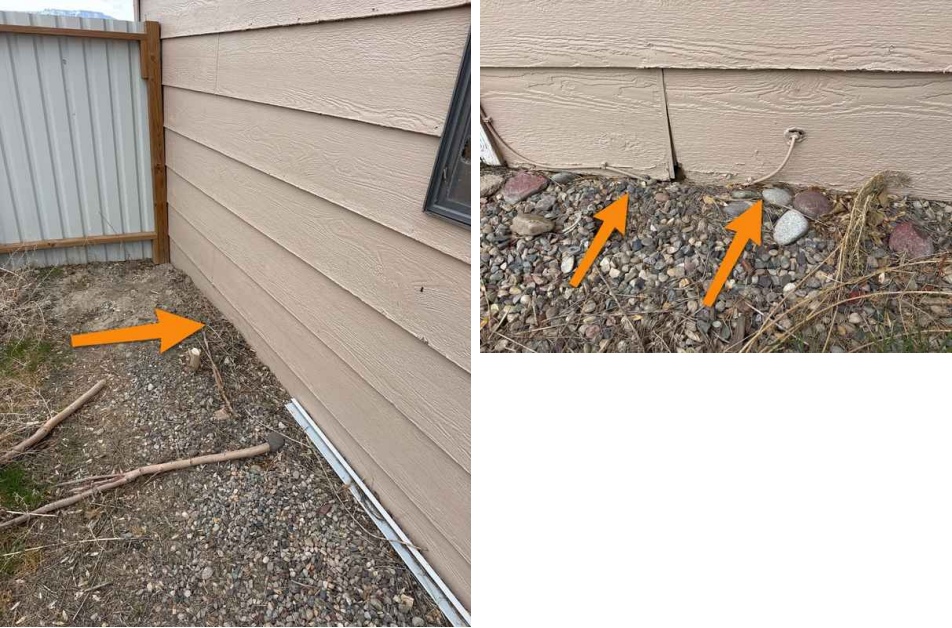
**EARTH TO SIDING CLEARANCE**  
There does not appear to be adequate clearance between the earth and the siding or framing members of the structure. This can cause damage or create a path for insects.

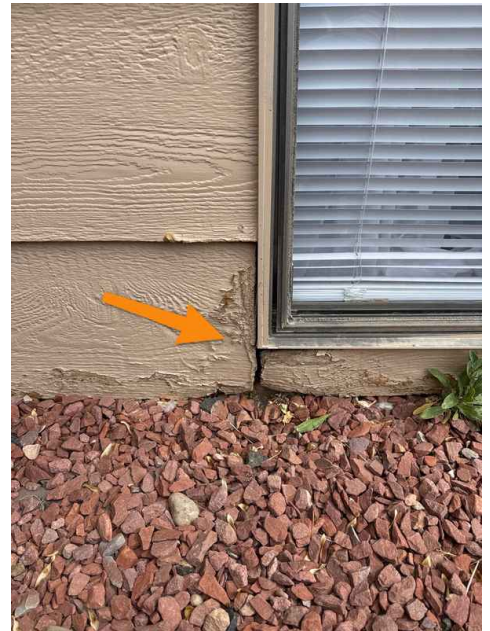
5.1.2 Siding, Flashing & Trim

**EVIDENCE OF WATER INTRUSION**

Siding showed signs of water intrusion. This could lead to further siding deterioration and/or mold. Recommend a qualified siding contractor evaluate and repair.

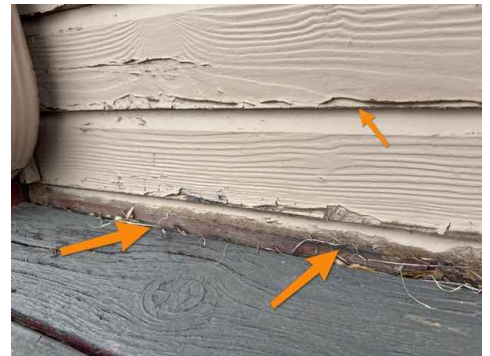
#### 5.1.3 Siding, Flashing & Trim

##### **PAINT NEEDED**

Areas of siding or trim were worn and would benefit from paint updates. This can be a qualified painter or siding specialist.

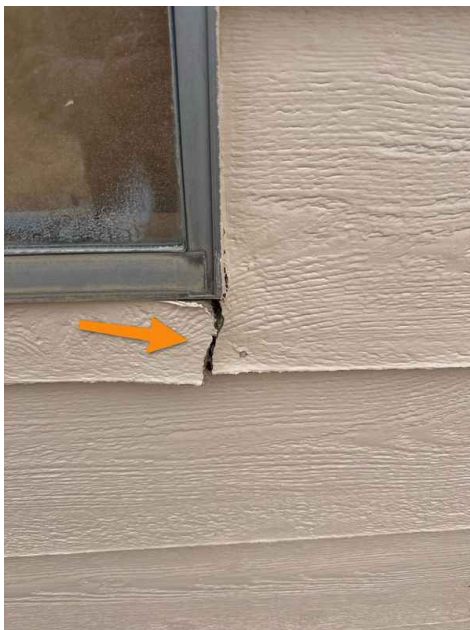
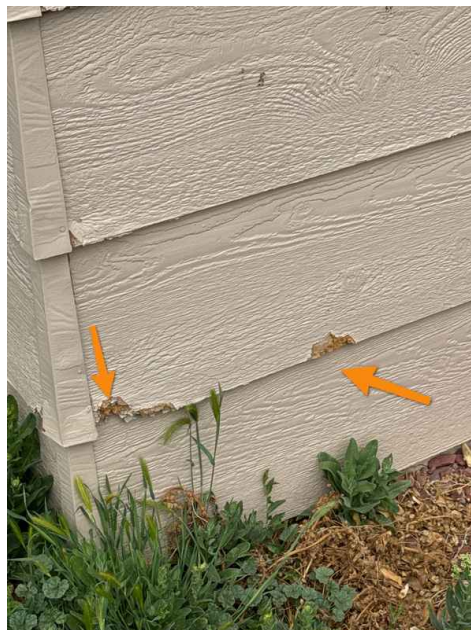
#### 5.1.4 Siding, Flashing & Trim

##### **MINOR DAMAGE**

There is minor damage to the siding. At some point it would be best to replace damaged boards.

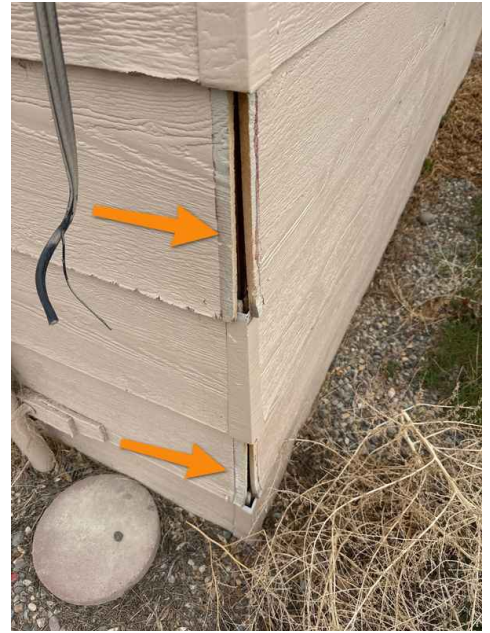
## 5.1.5 Siding, Flashing &amp; Trim

**CORNER FLASHING MISSING**

Some of the metal corner flashing is missing. It should be replaced to prevent water and pest entry.

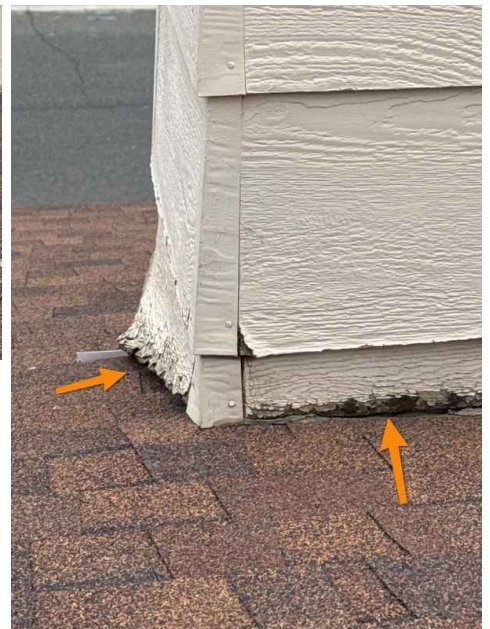
## 5.1.6 Siding, Flashing &amp; Trim

**ROOF TO SIDING CLEARANCE**

It would be beneficial to increase the clearance between the roof covering and the siding. It is inadequate and it is causing moisture damage and swelling

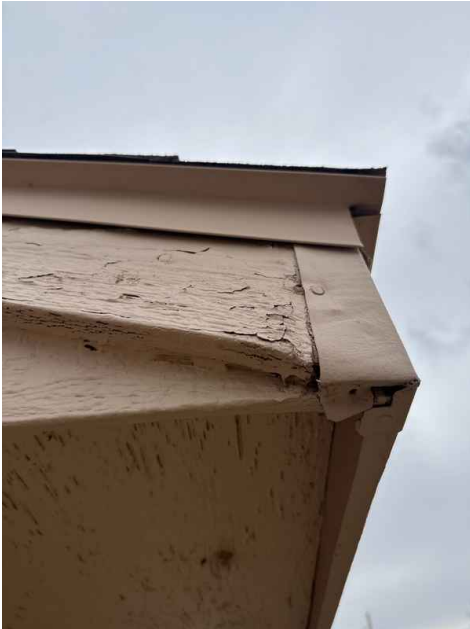
## 5.2.1 Eaves, Soffits &amp; Fascia

**FASCIA - LOOSE**

One or more sections of the fascia are loose. Recommend qualified roofer evaluate & repair.

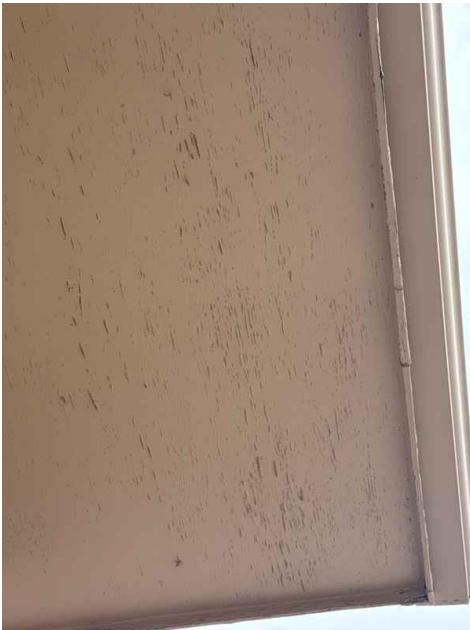
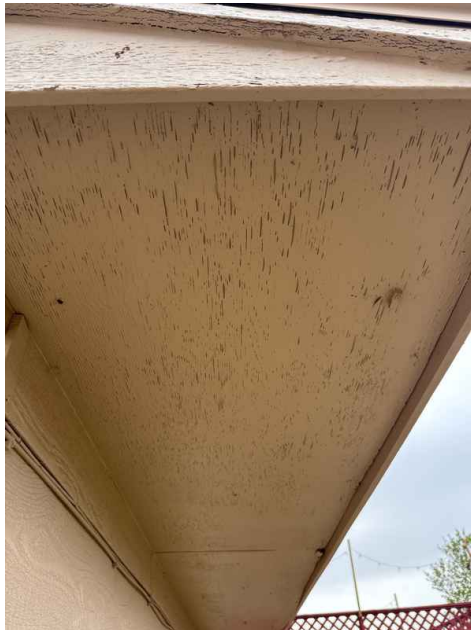
#### 5.2.2 Eaves, Soffits & Fascia

##### **SOFFITS AFFECTED BY WATER**

The soffits show signs of being affected by water. This is evidenced by cracking and wrinkling. This can be common in older homes. It should be monitored to ensure that the roof flashing is preventing water from affecting the soffit boards.

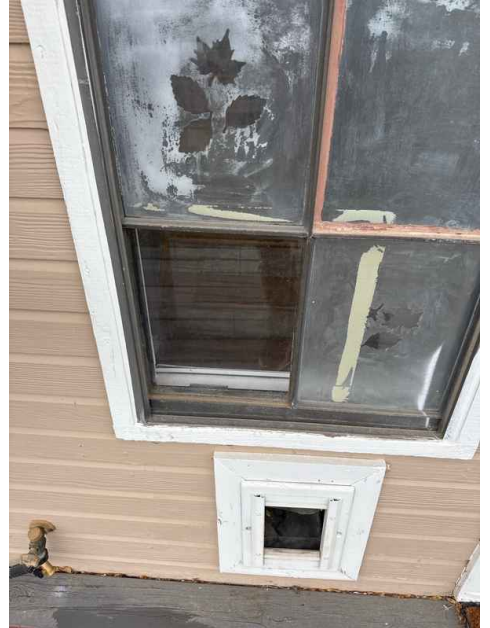
One of the panes of glass at the front entry have been replaced with plexiglass. This is not ideal.

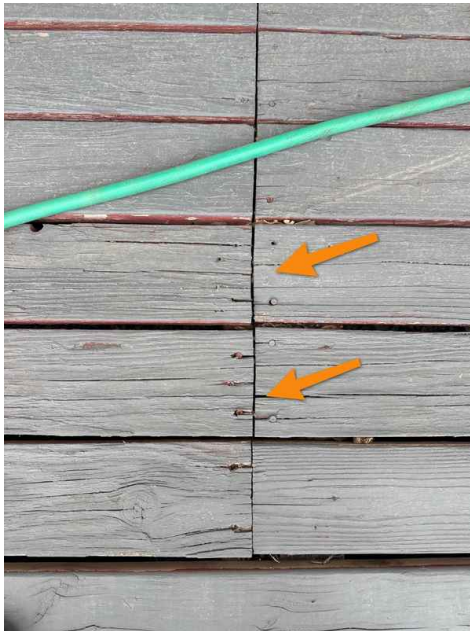
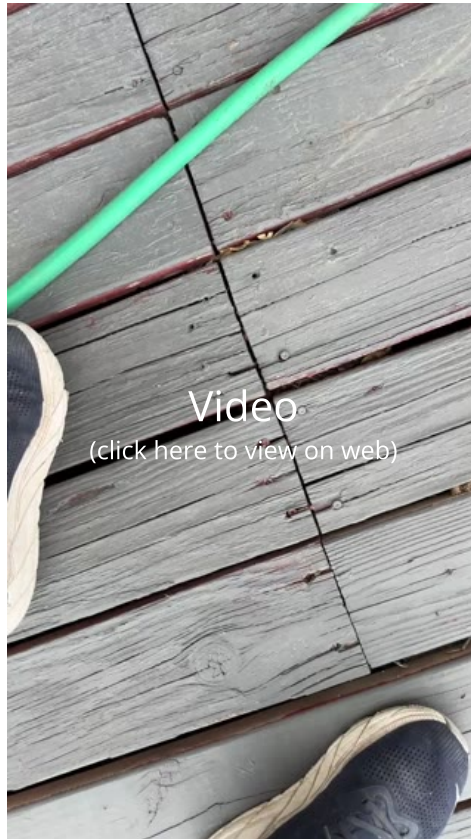
One or more deck boards are showing signs of rot. Recommend a qualified deck contractor replace.

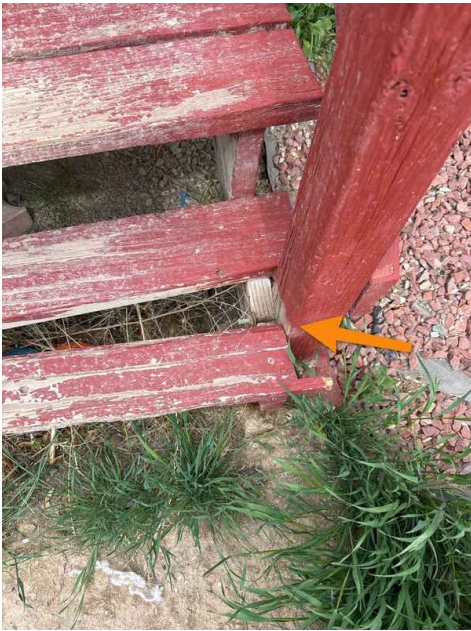
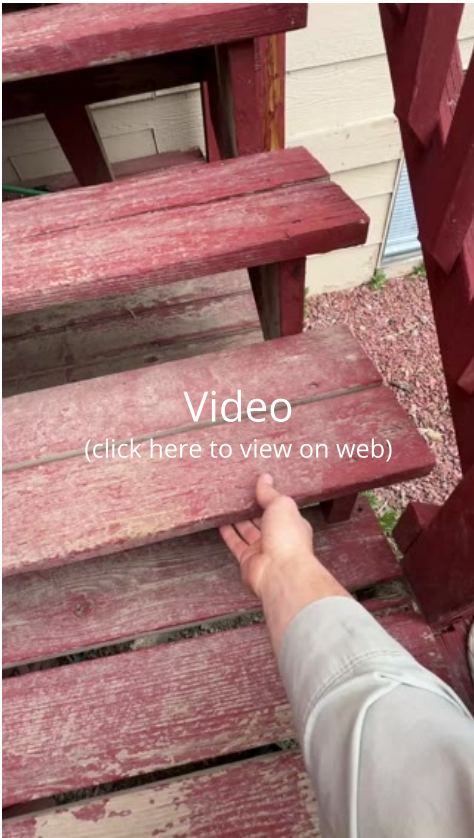
**STAIRS- REPLACE**

The stair stringers are damaged in one or more areas. Replacement is needed.

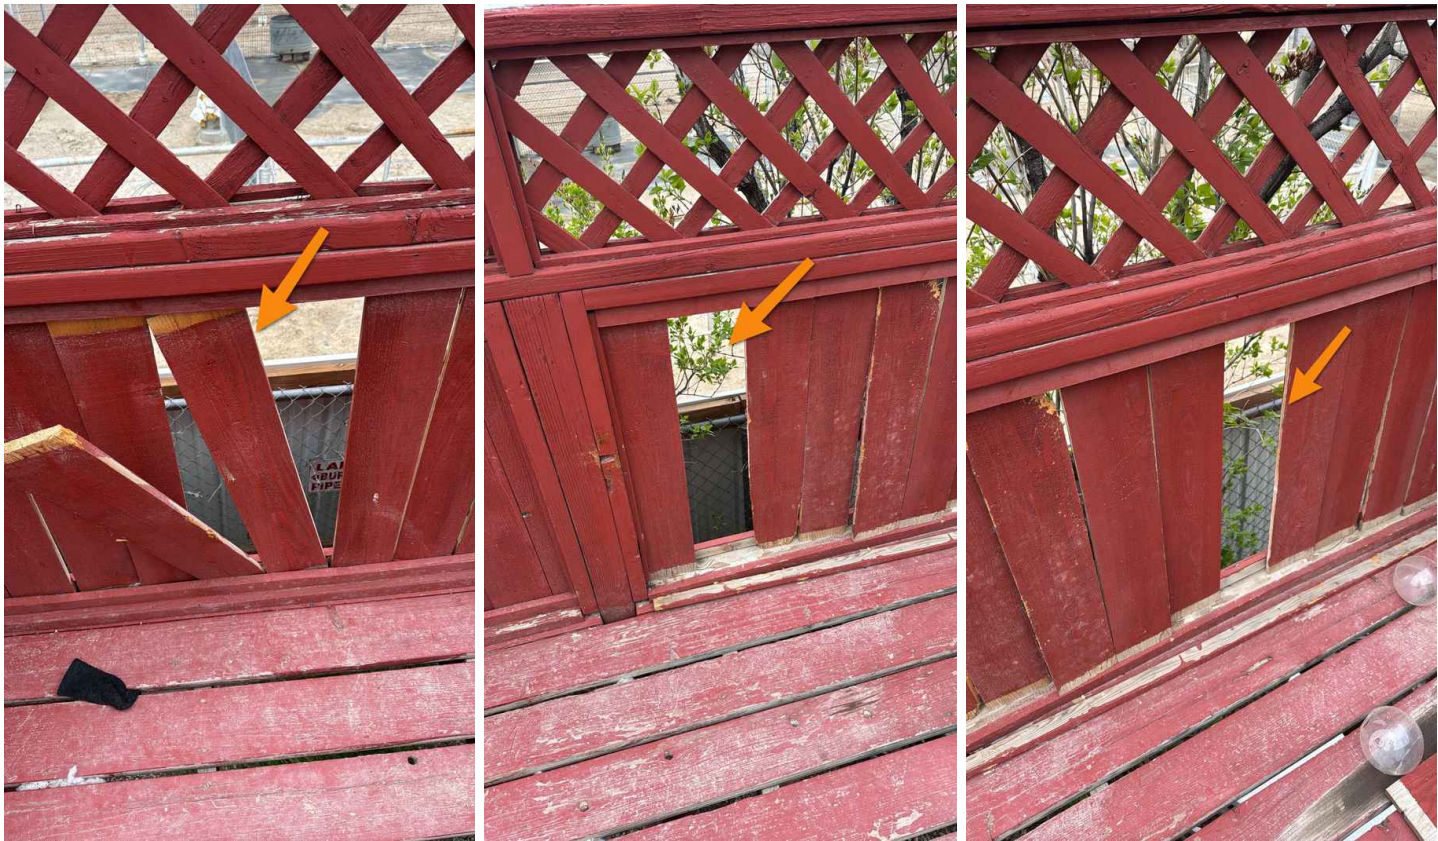
5.6.4 Decks, Balconies, Porches & Steps 2

**RAILING UNSAFE**

The railing is in need of updates. Several of the boards are falling out, which could allow children or animals to fall through.

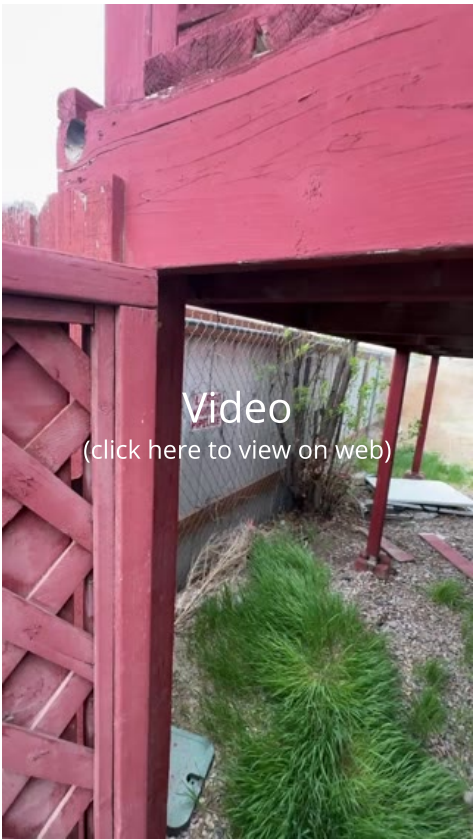
5.6.5 Decks, Balconies, Porches & Steps 2

**SWAY- LACK OF LATERAL SUPPORT**

By pulling lightly on the railing I was able to make the whole deck sway back-and-forth. This indicates a lack of proper lateral support below. This can be accomplished in several ways, including anchoring of the support posts.

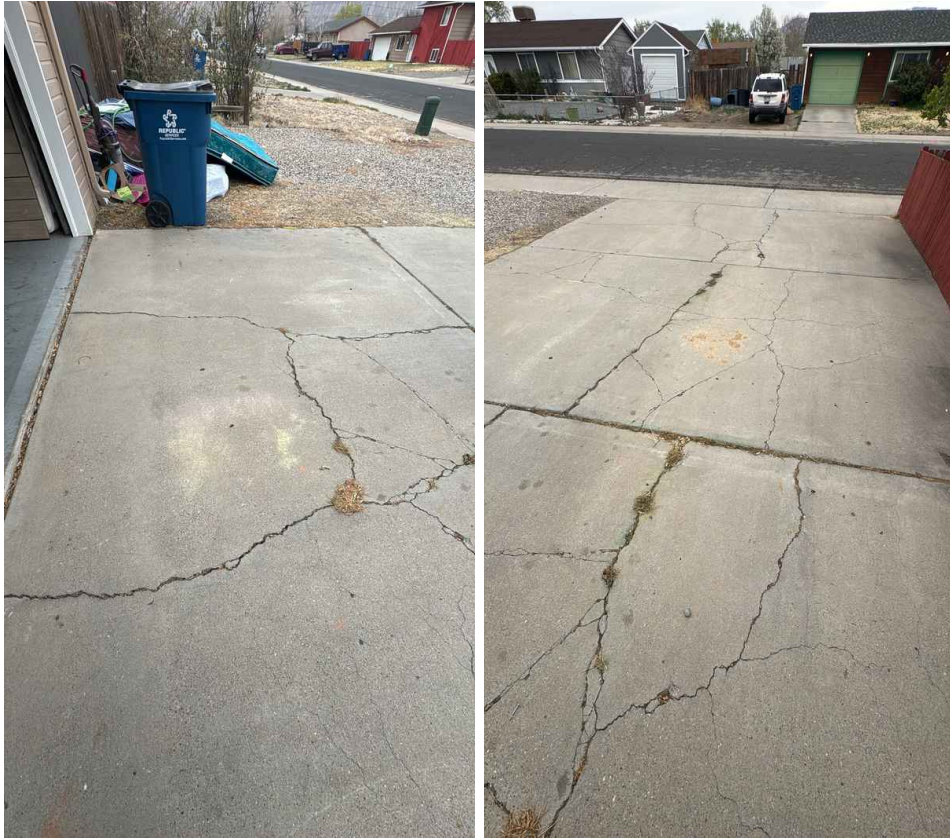
## 5.7.1 Driveways

**DRIVEWAY CRACKING - MAJOR**

The driveway cracks can be sealed to prevent water entry in further deterioration.

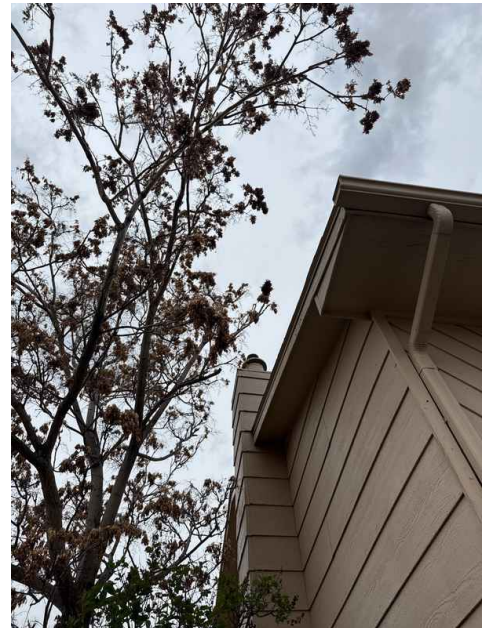
## 5.10.1 Vegetation

**TREE OVERHANG**

Trees observed overhanging the roof. This can cause damage to the roof and prevent proper drainage. Recommend a qualified tree service trim to allow for proper drainage.

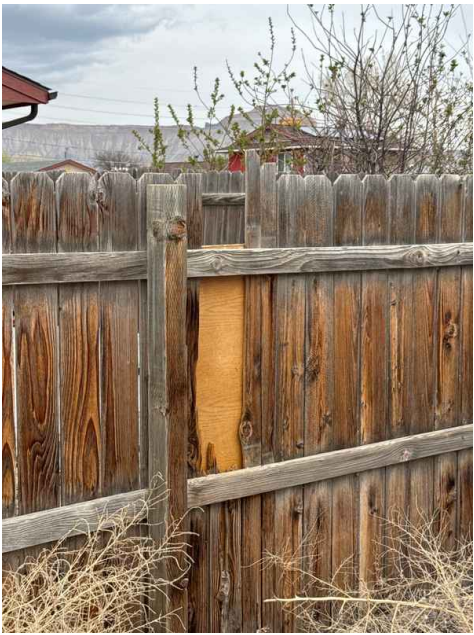
DAMAGED PICKETS

There are various pickets that are damaged.

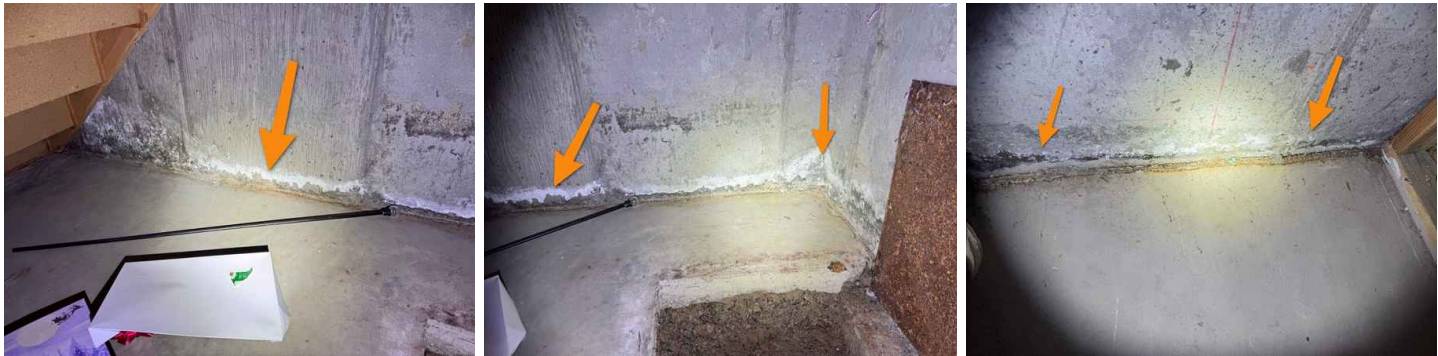
Efflorescence was noted in the visible portions of the foundation wall. This indicates a high level of moisture in the concrete, which is causing some mineral buildup and staining. Exterior landscaping and gutter updates may be beneficial to help divert moisture away from the home. These areas should be monitored as high levels of moisture may eventually cause damage.

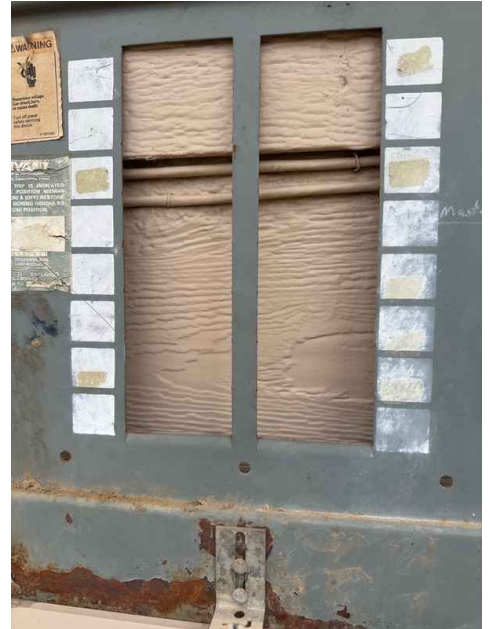
**MISSING LEGEND**

The breakers are not marked as to the rooms, areas, or appliances controlled. It is recommended that they be noted as soon as possible.

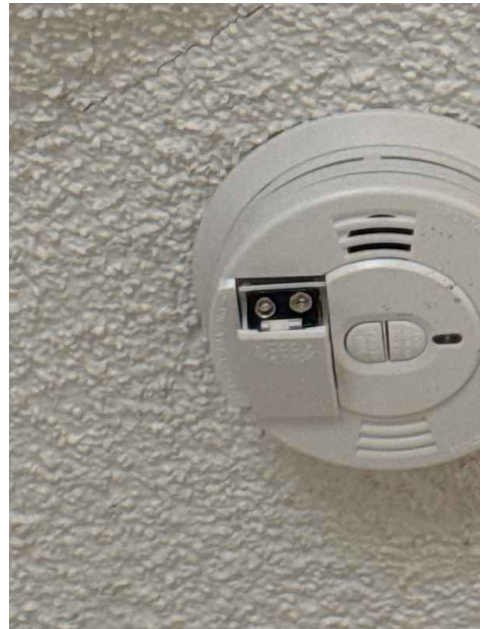
**BATTERIES**

One or more smoke alarms were found with batteries pulled out. These batteries should be replaced. In addition, any smoke alarms over 10 years old should be replaced.

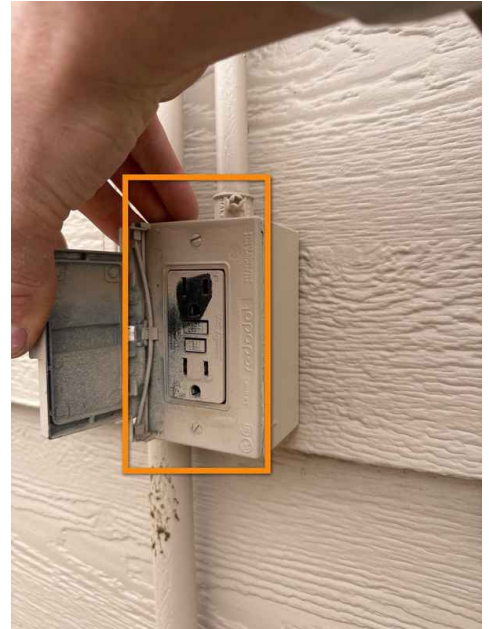
The GFCI protecting the external outlet near the panel was not functional at the time of the inspection and should be replaced.

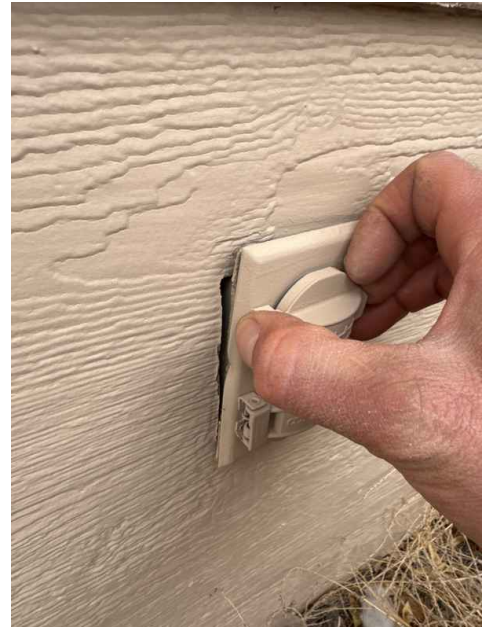
### 7.6.3 Exterior Outlets

#### **LOOSE OUTLETS**

One or more loose outlets were found. Loose outlets can lead to loose wiring. The outlet should be tightened.

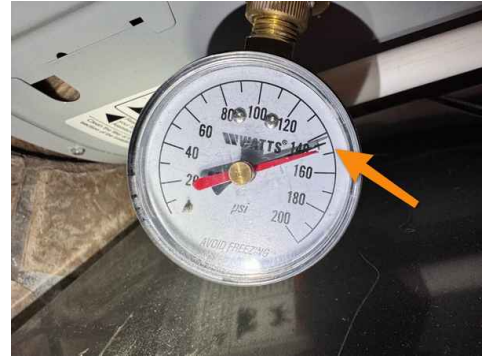
The water pressure is over 100 psi. Water pressure this high can cause damage to fill valves in toilets, dishwasher, and clothes washer. A water pressure regulator valve should be installed to regulate the pressure to an acceptable 40 to 80 psi range.

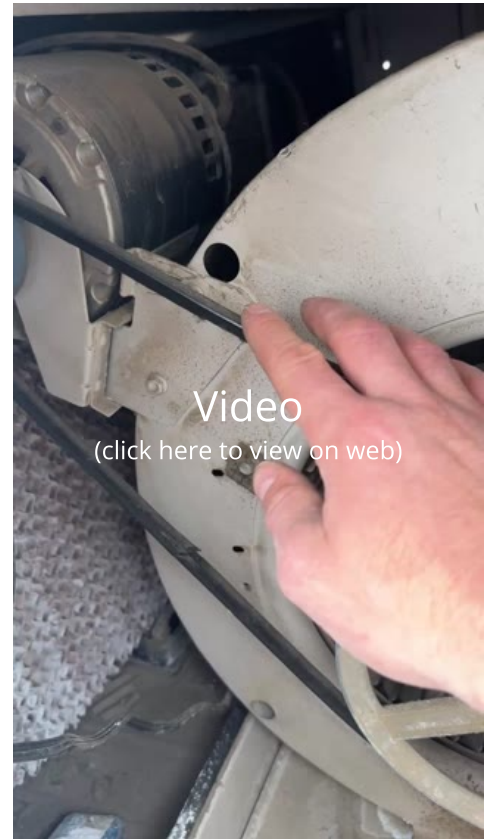
**BELT TENSION**

The belt was looser than recommended and may eventually begin to slip. Consult a professional for maintenance.

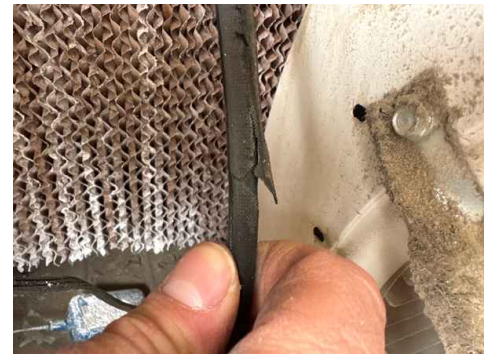
#### 11.2.3 Evaporative Cooler 2

##### **CRACKED BELT**

The belt is cracked. It is recommended for replacement.

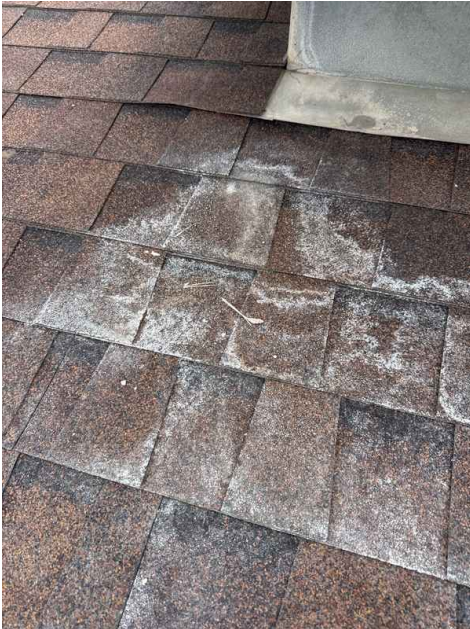
#### 11.2.4 Evaporative Cooler 2

##### **STAINING BELOW**

There is staining on the shingles below the cooler. This can indicate the cooler leaked in the past. The leak come from a bad hose connection or overflow water. This should be monitored. Water flowing across the shingles can shorten the life of the shingles.

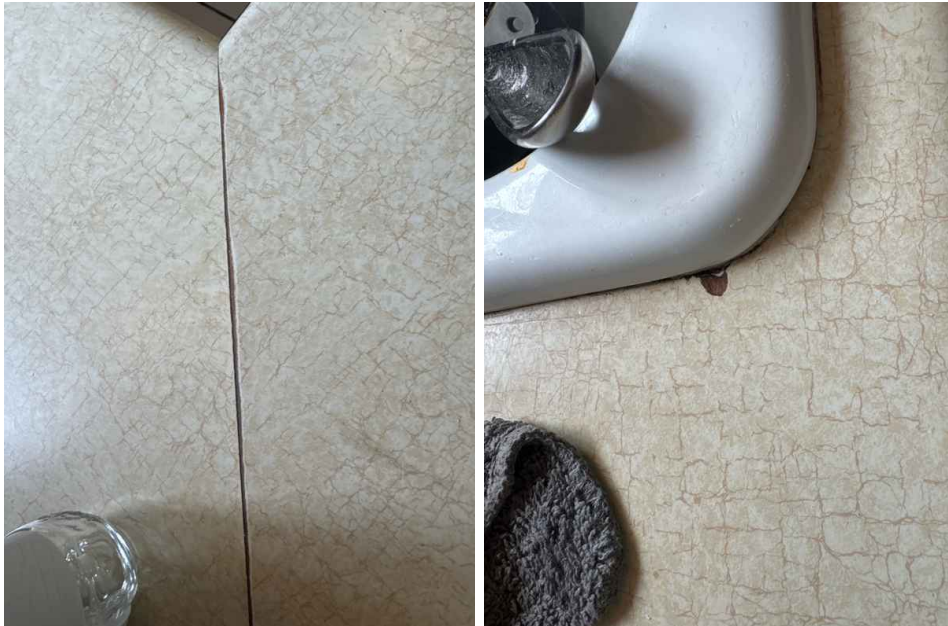
Normal Maintenance

There is some normal deterioration for the age. Normal signs of age include chipped surfaces, expanding corner seams and the front edge de-laminating a bit.

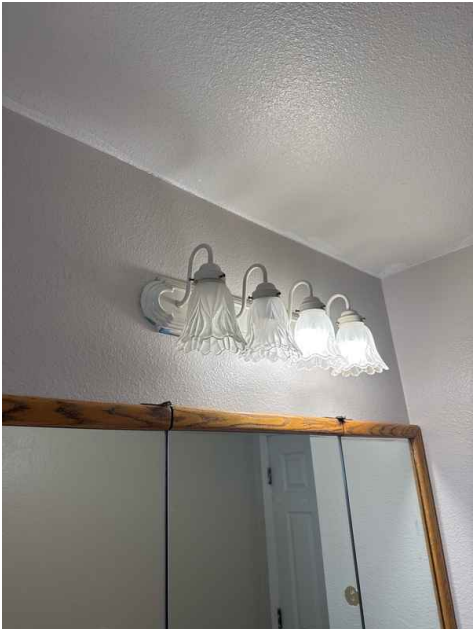
14.8.1 Lighting

**BULBS**

One or more bulbs are in need of replacement.

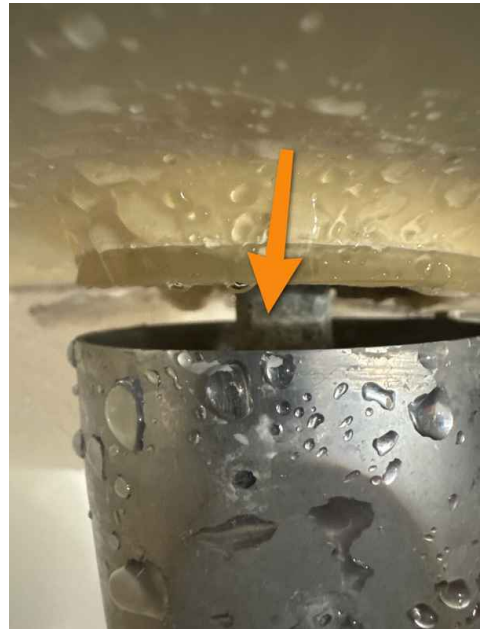
**LOOSE**

The faucet and mixing valve is loose and not anchored properly in the wall. This can cause damage to plumbing components or allow moisture behind the wall. Repairs are needed.

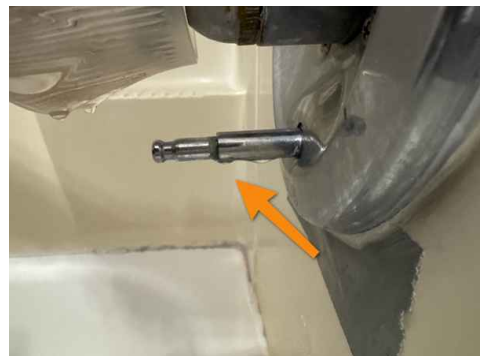
**DIVERTER VALVE DRIPPING**

The diverter valve drips water while the tub faucet is running. It may need a new gasket or replacement.

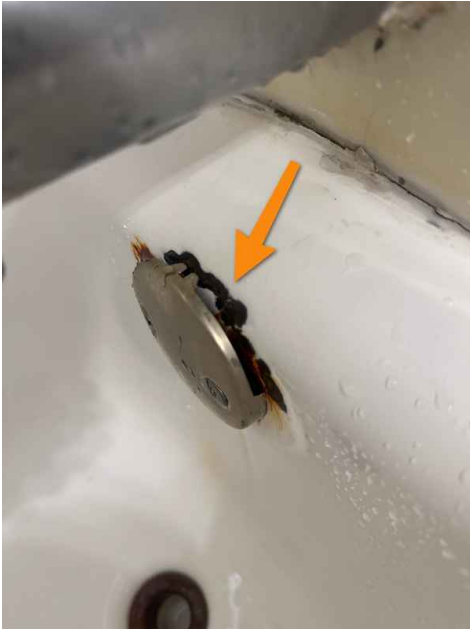
**ENAMEL CHIPPED**

The enamel of the tub is chipped.

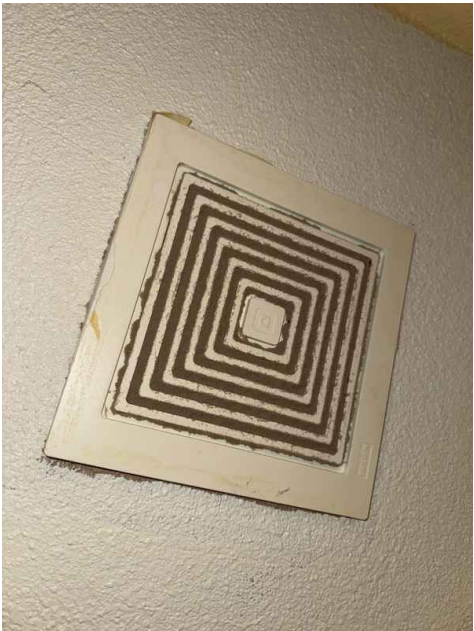
The fan cover and/or motor are dirty. Regular cleaning can lengthen the lifespan of the fan.

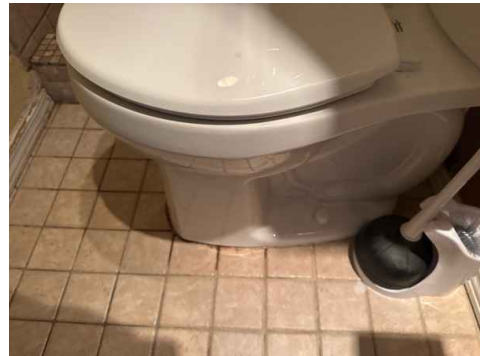
The toilet is not secure to the floor, allowing it to wobble or twist and possibly leak. Action should be taken to re-secure it to the floor.

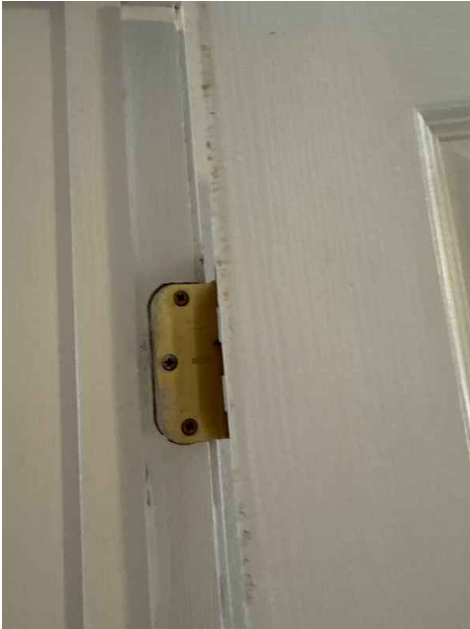
17.2.2 Interior Entry Door  
**LOOSE**  
The upper hinge bracket is loose and needs to be tightened to allow the door to shut properly.

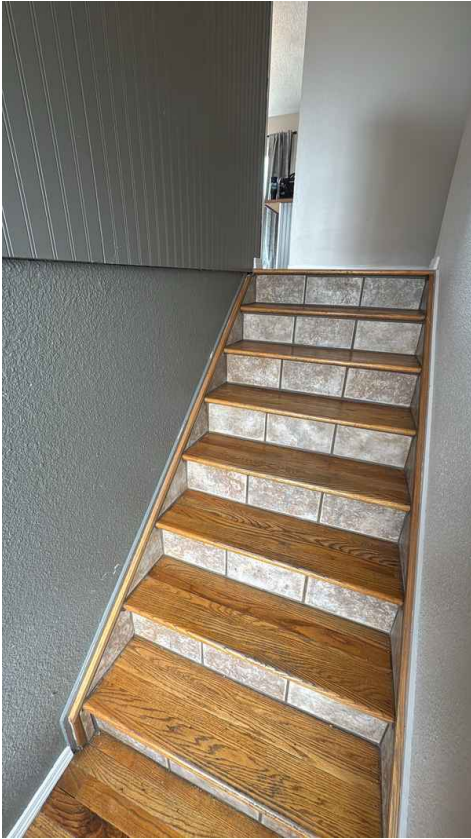
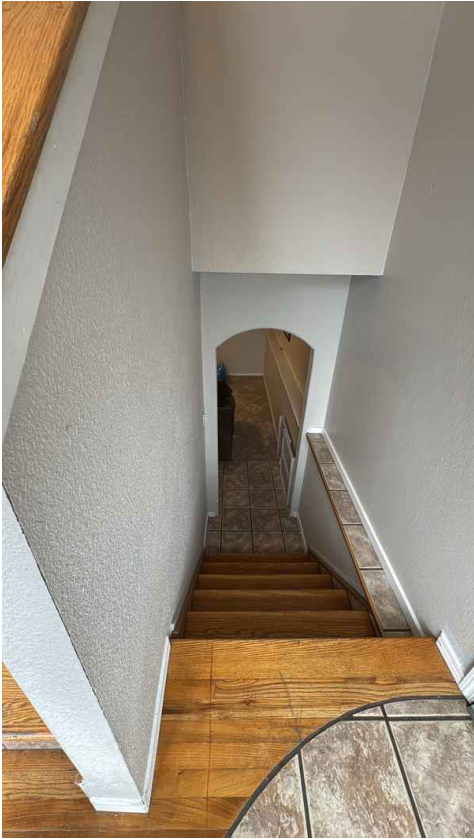
19.4.1 Steps, Stairways & Railings  
**NO HANDRAIL**

Staircase had no graspable handrails. This is a safety hazard. Recommend a qualified contractor install a handrail.

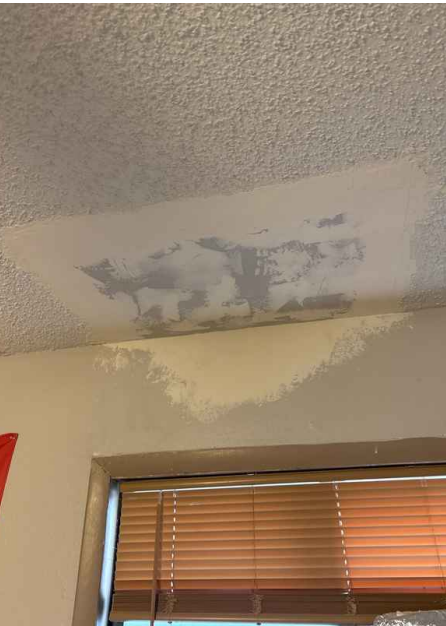
### Ceiling: Prior Staining

There is evidence of a previous leak on the ceiling. The area was dry during the inspection and verified using a moisture meter. Be sure to monitor this area. The current owner may have information on any past issues.

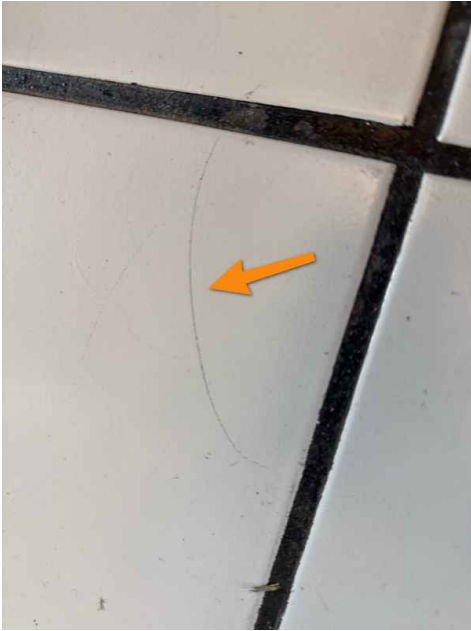
22.5.1 Floor  
**CRACKED TILES**

There are several cracked tiles in the dining room room. This may indicate that the mortar bed is failing and eventually the tiles may need to be replaced.

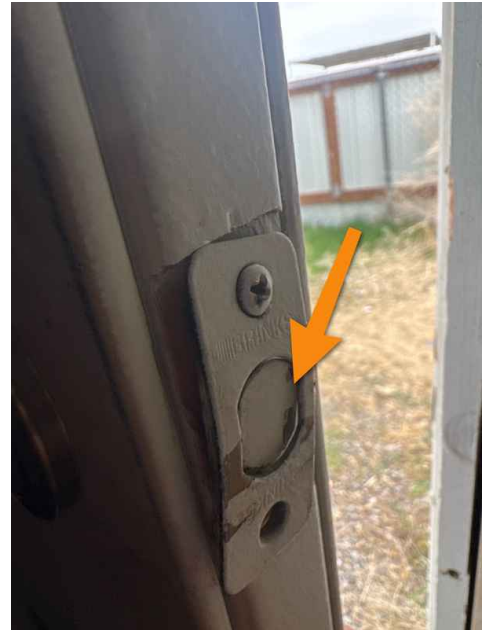
**LOCK BROKE**

The lock on this door is not operational. It should be replaced.

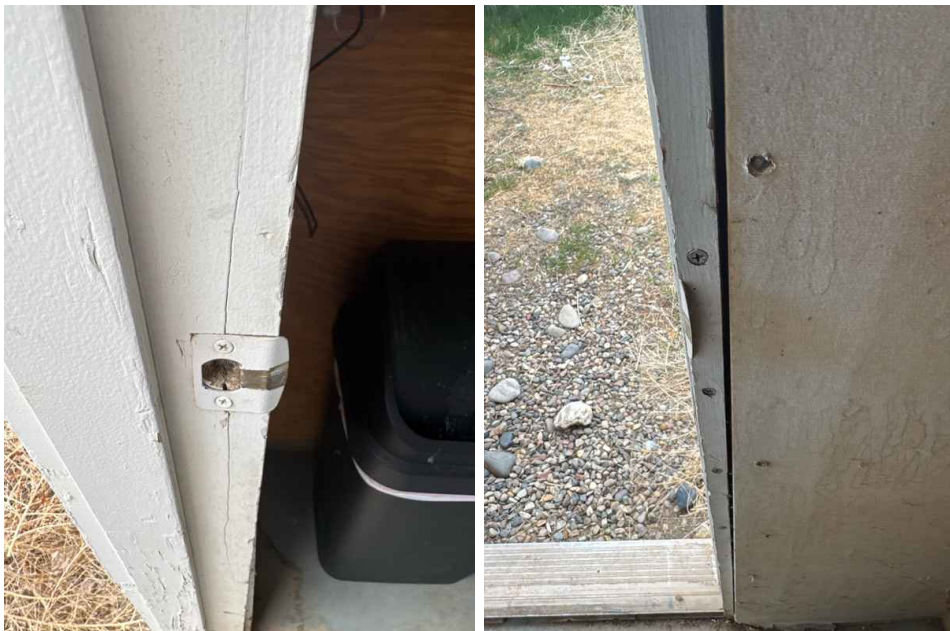
## 23.5.3 Outside Entry Door

**FRAME DAMAGE**

At some point, the door frame has been damaged. The frame should be replaced for security purposes.

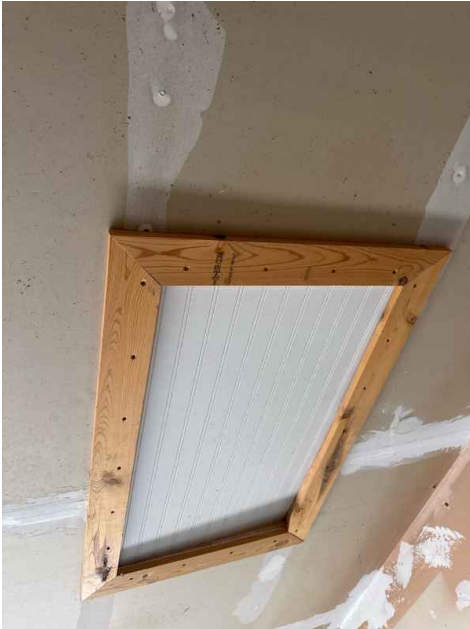
## 23.6.1 Garage Ceiling

**OPENINGS**

There is at least one opening in the firewall that creates an opening for fire travel. For safety reasons, this should be repaired.
