RE: Inspection Site  
Inspection Address

# Inspection Report

Inspection Site  
Inspection Address

Prepared by: Brothers' Inspection Inc.  
636 Shadowood Ct.  
Grand Junction, CO 81505  
970-640-0214

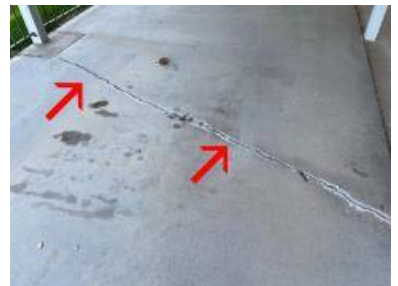
<i>Driveway Paving Material:</i>	Concrete. Gravel.
<i>Driveway Condition:</i>	<b>Attention Needed</b> - The driveway needs attention and minor repair to prevent further deterioration. The cracks in the driveway need to be sealed to prevent further damage. The freeze-thaw cycle may cause differential settlement and enlarge existing cracks.

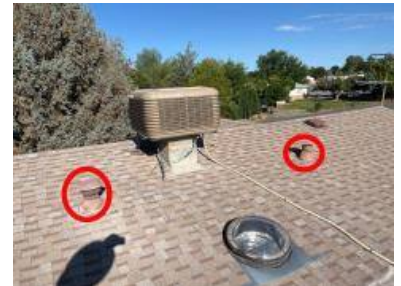
**Attention-** The gas fired vent is closer than 10 feet to the cooler. This is not ideal. Flue gases may get pulled back into the home.

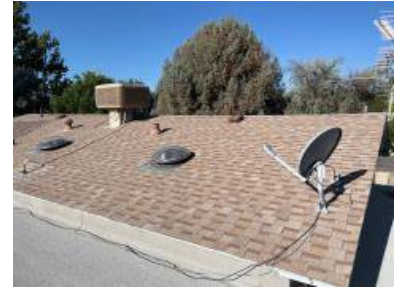
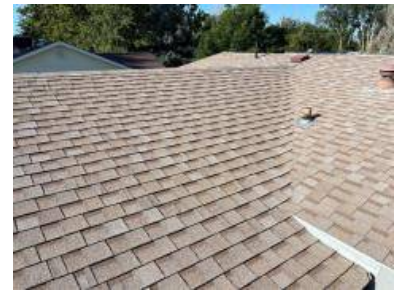
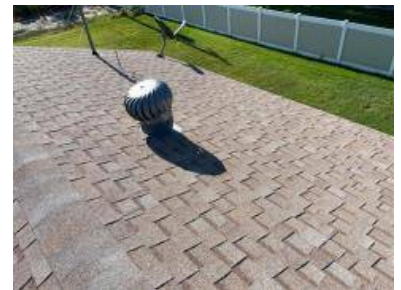
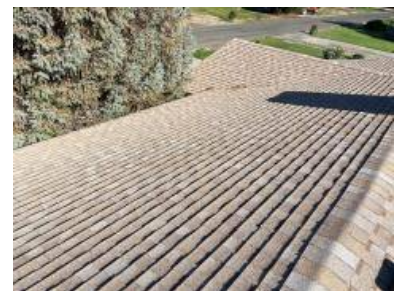
*Condition of Roof Covering*  
*Material: Asphalt*

**Attention Needed-** There is cracking throughout the rolled asphalt on the low sloped portions of the roof. Cracks can allow water entry. I recommend contacting a roofer.

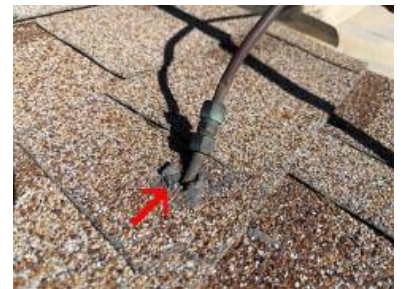
**Attention** - The roof penetrations will need to be resealed periodically.

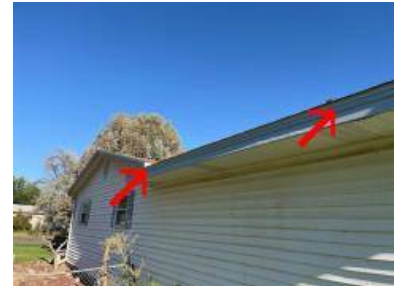
**Recommended** - There is no roof gutter system installed. A gutter system is recommended to control the flow of water around and away from the house.

**Attention** - Installation of downspout extensions would help carry the water further away from the foundation.

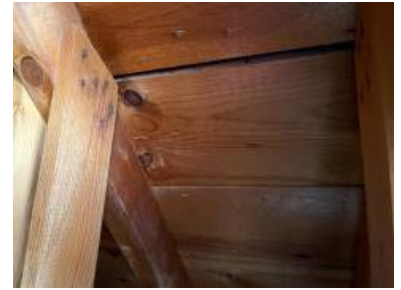
There is water staining on the underside of the roof decking or rafters. The stains are not currently wet nor do they have an elevated moisture content. **Note** - There is staining on the roof decking boards around the evaporative cooler. The area was dry during the inspection. It is recommended this area be monitored.

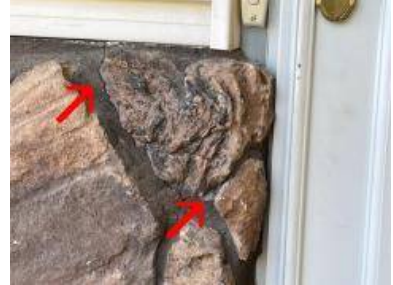
*Siding Condition:*

**Attention-** At least one piece of the stone veneer is loose.

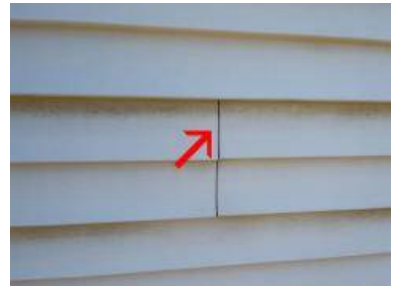
*Siding Conditions.*

**Attention-** The vinyl does not have the proper overlap.

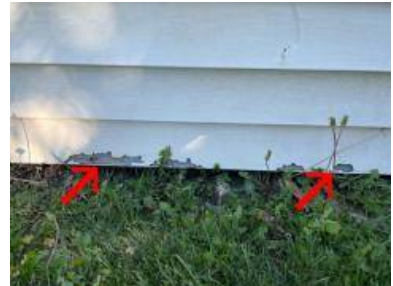
*Siding Comment:*

**Attention-** There is damage along the bottom edge of the vinyl.

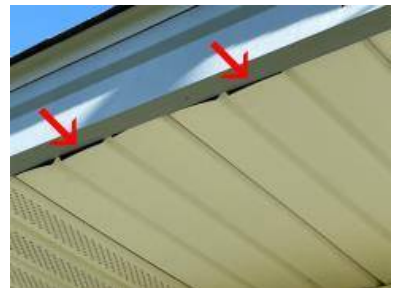
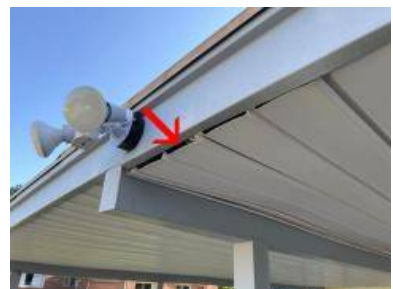
*Soffit/Eaves:*

**Attention** - Soffit/eaves appear to need some minor repair to prevent further deterioration.

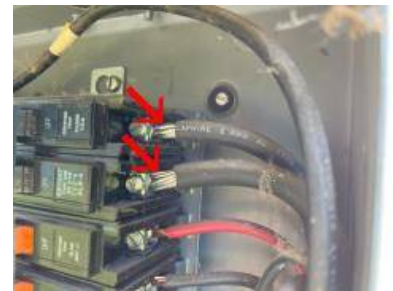
*Service Cable to Panel Type:*

Aluminum, No anti-oxidant paste was noted on the aluminum wire connections.

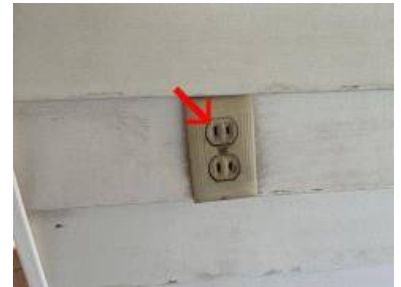
**Attention Needed-** The exterior outlet is not covered, not GFCI protected, and is ungrounded.

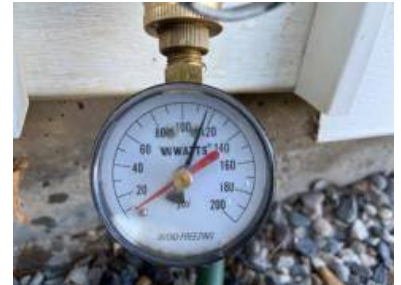
*Interior Supply Piping Size:* The interior water supply piping is 1/2" in diameter.  
*Interior Supply Piping Material:* The interior supply piping in the structure is predominantly copper.  
*Water Pressure:* There is a water pressure regulator valve correctly installed. This allows adjustment of the incoming water pressure. **Note-** The pressure regulator was installed past the exterior hose bib. The hose bib has pressures over 110 PSI.

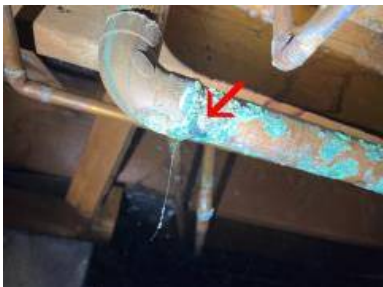
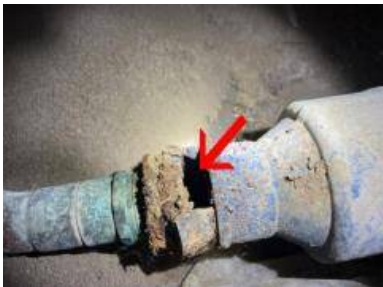
*Waste Piping Condition:*

**Action Necessary** - Some portion of the visible plumbing waste lines needs repair or replacement. There is an open joint or missing plug in the waste line that needs immediate replacement. There is evidence of a leak in the drain/waste piping system.

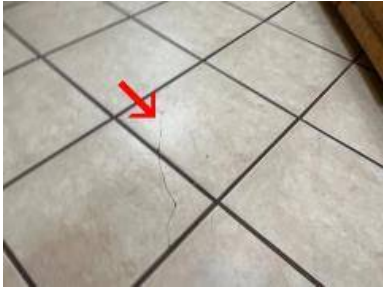
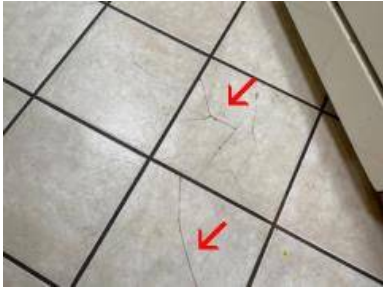
<i>Location:</i>	Main level rear of house.	
<i>Walls:</i>	Satisfactory - The walls in the kitchen appear to be satisfactory.	
<i>Ceiling:</i>	<b>Action Necessary</b> - There is a condition in the ceiling of this room that needs to be repaired. The skylight has evidence of a leak.	
<i>Floor:</i>	<b>Action Necessary</b> - The flooring in the kitchen is in need of repair. There are many cracked tiles. I did not determine the cause.

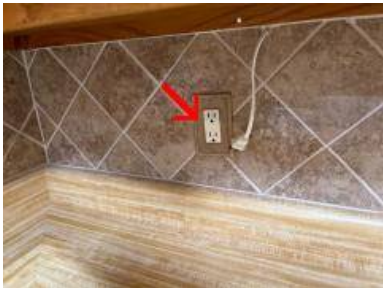
<i>Electrical Outlets:</i>	The 3-prong outlets are not grounded. This is an unsafe condition. <b>Recommended</b> - This kitchen does not have Ground Fault Circuit Interrupt outlets installed. The age of the structure may predate the required installation; however, for safety considerations, it is strongly suggested that one be installed at any location within 6 feet of a water source.

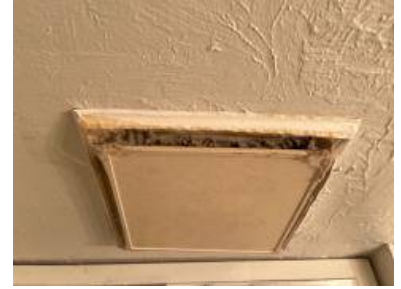
Satisfactory - There is an exhaust fan installed in this bathroom, and it is performing satisfactorily. Note - As part of maintenance, the cover and fan should be cleaned.

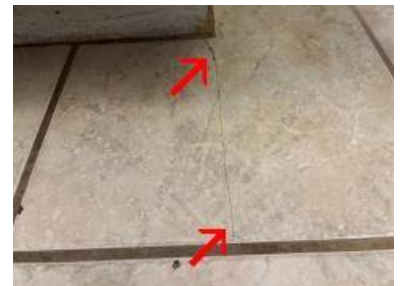
**Attention Needed** - The flooring in this bathroom is in need of attention to prevent further deterioration. The floor covering material is ceramic or glazed tile.

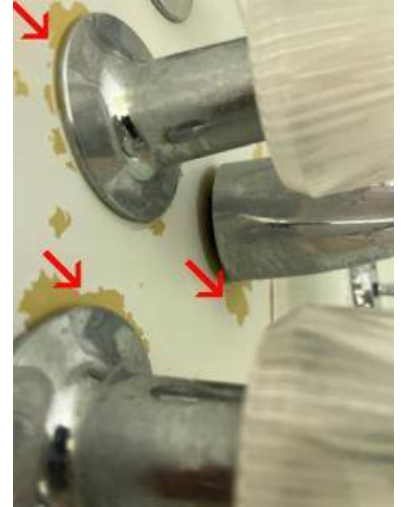
**Attention-** The faucet needs to be sealed around.

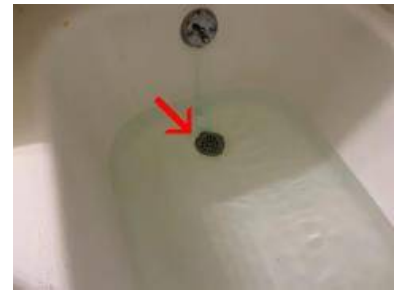
**Attention Needed** - The tub/shower drains, but it drains slower than expected. Services of a drain cleaning service company may be needed.

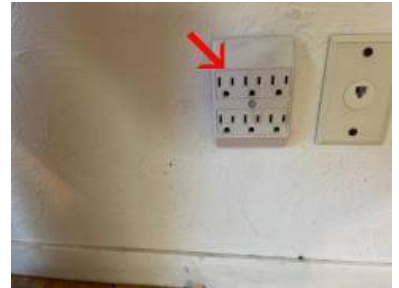
**Action Necessary** - At least one outlet tested in this bedroom is incorrectly wired or needs to be replaced. The 3-prong outlets are not grounded. This is an unsafe condition.

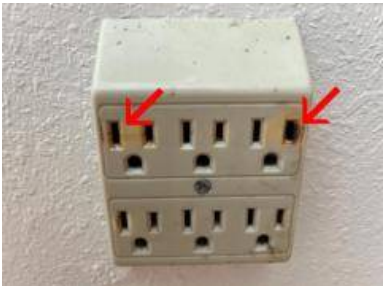
*Electrical Outlets:* **Action Necessary** - At least one outlet tested in this room is incorrectly wired or needs to be replaced. The noted 3-prong outlet is not grounded. This is an unsafe condition. Note - One or more outlets in this room are loose. Tightening up outlet hardware helps to ensure the wiring connections stay secure.

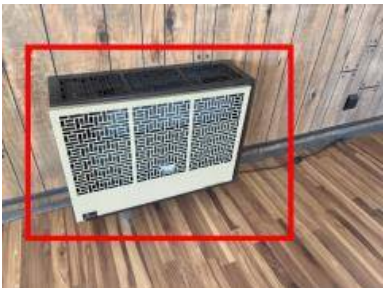
**Attention-** I was unable to get the empire heating unit to function. There is gas to the unit and the pilot was lit but the blower would not turn on using the installed thermostat.
