RE: Inspection Site
Inspection Address

Inspection Report

**Inspection Site
Inspection Address**

**Prepared by: Brothers' Inspection Inc.
636 Shadowood Ct.
Grand Junction, CO 81505
970-640-0214**

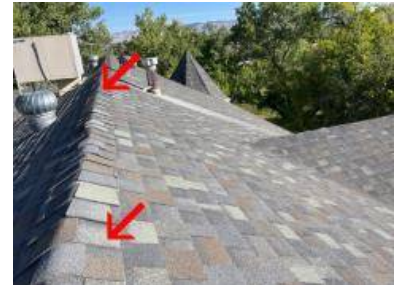
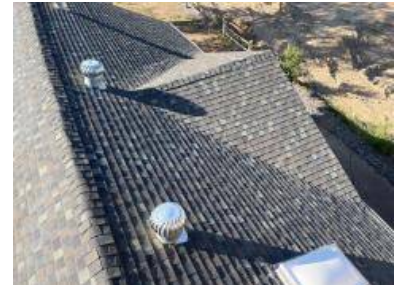
Attention Needed- Although a majority of the shingles are in satisfactory condition, the area above the garage has some damage due to ladder use. Because of this and several other concerns I recommend having a roofer come out to provide quotes for the necessary repairs.

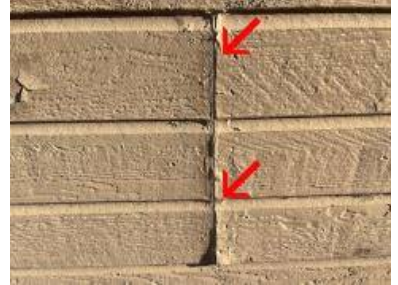
Note - Gaps in-between the ends of the boards can be periodically sealed with caulk or butt joint trim can be installed. This will help prevent moisture from affecting the siding boards.

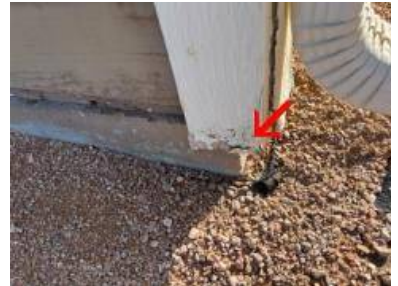
Attention - The trim needs some minor repair to prevent further deterioration. Some portion of the trim boards needs some painting to prevent further deterioration.

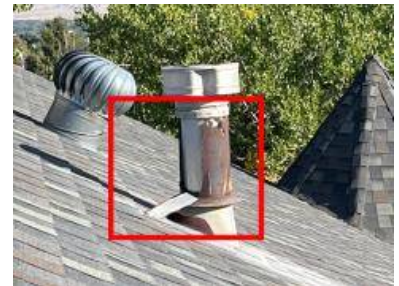
Gas-fired Appliance Flue/Vents: **Action Necessary** - Some visible portion of the flue/vent system appears to be installed improperly or is in a deteriorated condition. Action is necessary to correct this condition immediately.

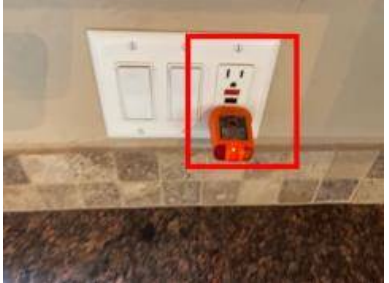
<i>Lighting:</i>	Satisfactory - The ceiling lights in the kitchen are in satisfactory condition.	
<i>Electrical Outlets:</i>	Attention Needed- Several outlets in the kitchen were ungrounded indicating some loose wiring. In addition, the GFCI outlets appear original. It is best practice to replace these every 20 years. These may be due for replacement.

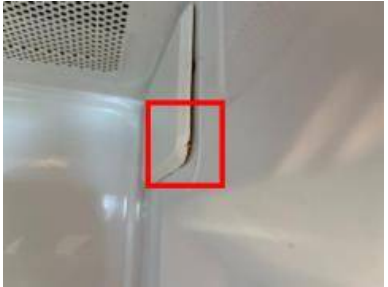
<i>Microwave Oven:</i>	Attention Needed- Arcing was noted inside the microwave when tested. The microwave should be replaced if this condition continues.

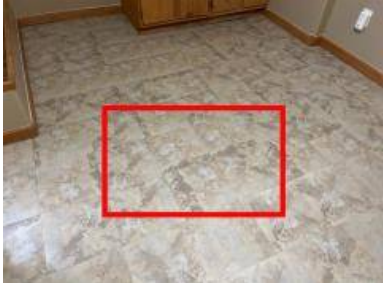
<i>Location:</i>	Basement.
<i>Walls:</i>	Satisfactory - The walls in the laundry room appear to be satisfactory.
<i>Ceilings:</i>	Satisfactory - The ceiling is satisfactory.
<i>Floor:</i>	<p>Attention Needed- Some of the flooring in the laundry room is loose and needs to be re-attached.</p>

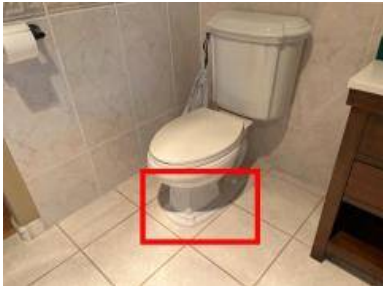
<i>Vanity Cabinet:</i>	Satisfactory - The vanity cabinet and top in this bathroom are satisfactory.	
<i>Basin and Drain Fixture:</i>	Satisfactory - The basin and drainage fixture appears to be satisfactory.	
<i>Faucet and Supply Lines:</i>	Satisfactory - Faucets and supply lines appear satisfactory. There are shutoffs installed for both hot and cold water pipes under the basin.	
<i>Toilet Condition</i>	Action Recommended - The toilet in the master bathroom needs repair. The toilet is not secure to the floor, allowing it to wobble or twist and possibly leak. Action should be taken to re-secure it to the floor.

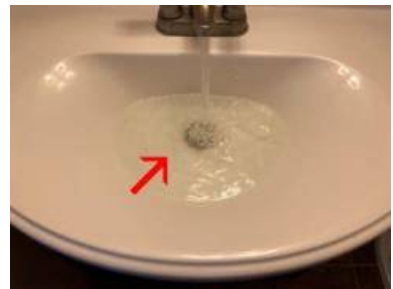
Basin and Drain Fixture: **Attention** - The basin or drainage fixture needs attention. The lavatory drains slowly. There may be some blockage either in the fixture or the drain line.

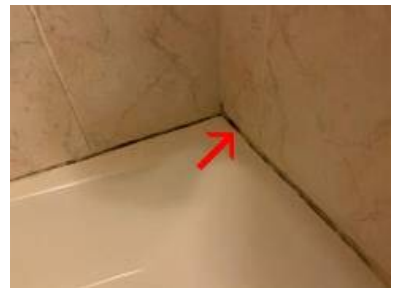
Caulking/Water Contact Areas: **Attention** - The caulking in the water contact areas appears to need attention. Damage may result if not corrected. The wall - tub or shower seam needs to be caulked to prevent moisture from entering the wallboard.

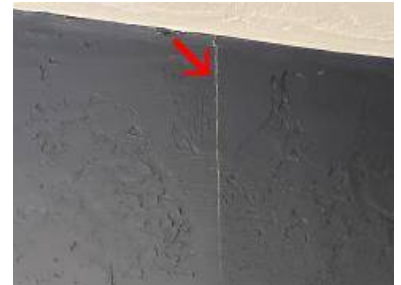
Satisfactory - The walls in the bedroom appear to be satisfactory. There is some minor cracking in the sheetrock. Most likely this is due to slight settlement or shrinkage.

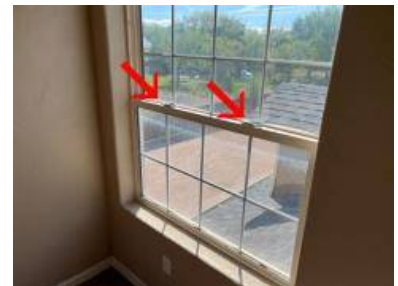
Location: Upstairs southeast corner.
Entry Door: **Attention** - The entry door or hardware for this bedroom needs some adjustment or repair for it to function properly. The door rubs. In addition, the knob and lock are worn and do not function as they should.
Closet: Satisfactory - The closet is functional and of average size.
Walls: Satisfactory - The walls in the bedroom appear to be satisfactory.
Ceiling: Satisfactory - The ceiling is functional and as I expected.
Light and Light Switch. Satisfactory - The light and light switch were functional at the time of the inspection.
Floor: Satisfactory - The floors are in satisfactory condition. The floor covering material is.
Windows: **Action Recommended** - At least one window or associated hardware in this bedroom needs repair. The spring or slide that holds the window in the up position is nonfunctional. It needs to be replaced. The window screens are missing from this window.

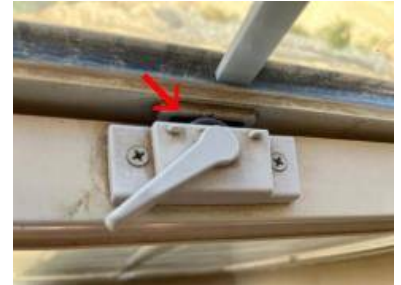
Closet: Satisfactory - The closet is functional and of average size.
Walls: Satisfactory - The walls in the bedroom appear to be satisfactory.
Ceiling: Satisfactory - The ceiling is functional and as I expected.
Light and Light Switch. Satisfactory - The light and light switch were functional at the time of the inspection.
Floor: Satisfactory - The floors are in satisfactory condition. The floor covering material is carpet.
Windows: **Attention Needed** - At least one window or associated hardware in this bedroom needs attention. Locking hardware needs repair or replacement.

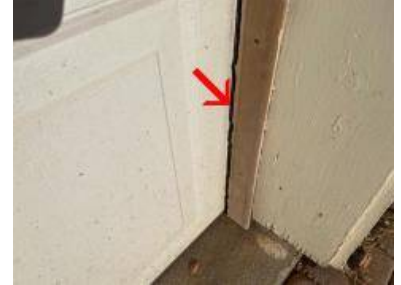
Attention Needed - The overhead door needs some minor repair. The overhead door weather seal needs some repair, or the overhead door needs adjustment.

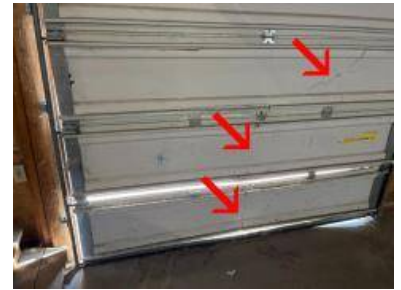
Action Necessary - The overhead door needs repair or replacement. At least one door panel needs to be replaced due either to deterioration or mechanical damage. North door.

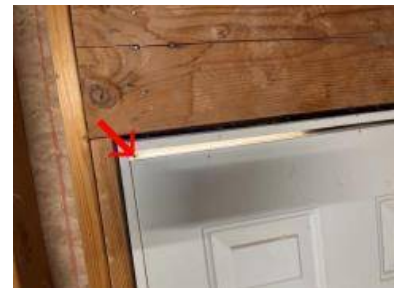
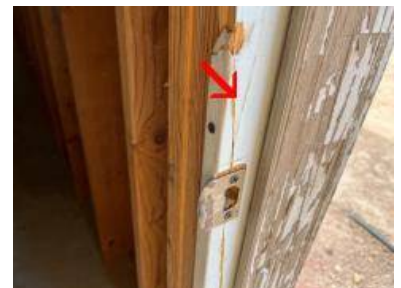
Attention Needed- The door rubs along the edge, the latch play needs adjustment in order to latch properly. In addition there is no deadbolt hole or latch plate installed.

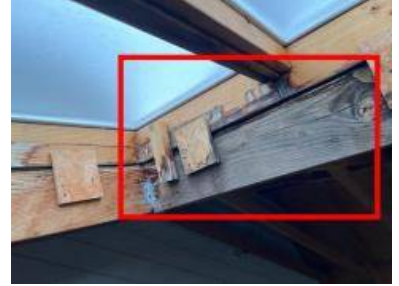
Attention Needed- There is evidence of leaking around the skylight. Some repairs are needed at the roof level.
