RE: Inspection Site  
Inspection Address

# Inspection Report

**Inspection Site  
Inspection Address**

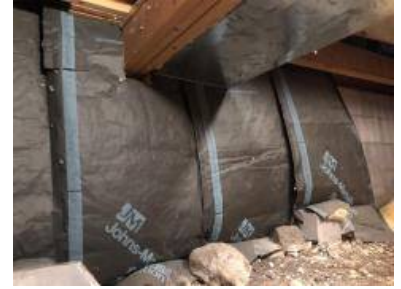
*Percent Interior Foundation Wall Exposed:* Very little of the stem wall was visible due to the wall being properly insulated.

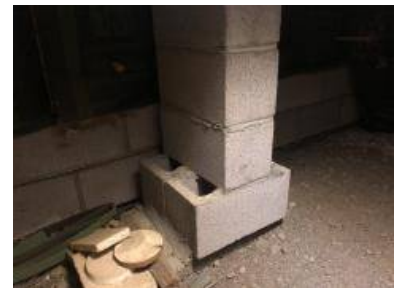
*Condition of Piers:* Satisfactory - The piers as installed appear to be adequate. No engineering analysis was completed.

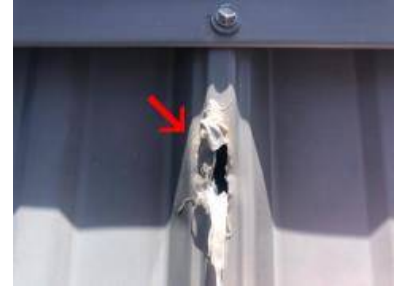
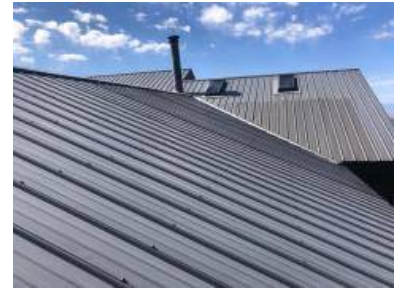
**Attention Needed** - There is minor damage above the garage that needs to be resealed to prevent moisture entry.

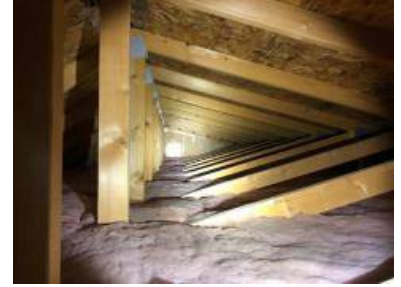
Satisfactory- No damage to any trusses or leaks noted in the attic cavity. Ventilation appears appropriate and there is adequate fiberglass batting for Insulation.

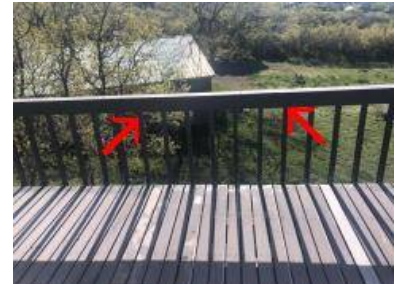
*Deck or Porch Railings:* Satisfactory - The railings as installed are functional. The spacing between balusters is 6". New construction allows only 4" spacing. This was instituted as a safety issue to prevent small children from getting caught between the balusters. **Attention-**The center of the main railing span should have a support post of some sort. It is a long distance with little support and moves quite a bit when pressed on.

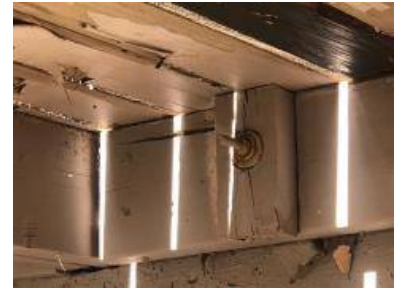
Satisfactory - The framing of the deck or porch was done in an acceptable manner. The deck frame is bolted to the rim joist of the structure.

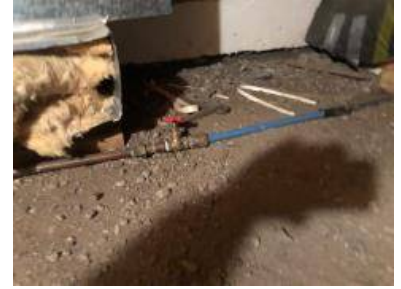
*Piping Material:* PEX fed from main home.

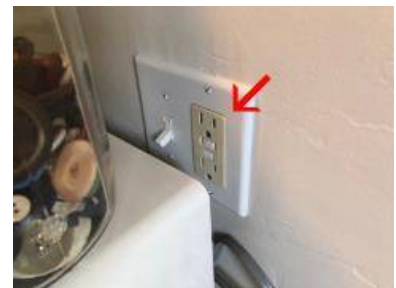
*Ground Fault Interrupt Outlets:* Satisfactory - There is a functional Ground Fault Circuit Interrupt outlet installed in the area of the bathroom vanity. **Note-** GFCI outlets should be replaced every 20 years. This one may be due for replacement.

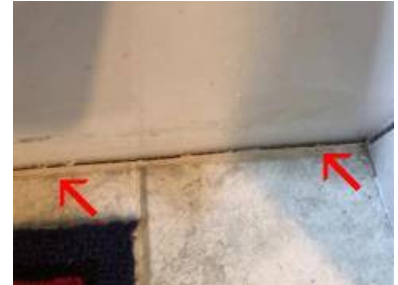
*Caulking/Water Contact Areas:* **Attention** - The caulking in the water contact areas appears to need attention. Damage may result if not corrected. The seam where the tub or the shower meets the flooring needs to be caulked to prevent damage.

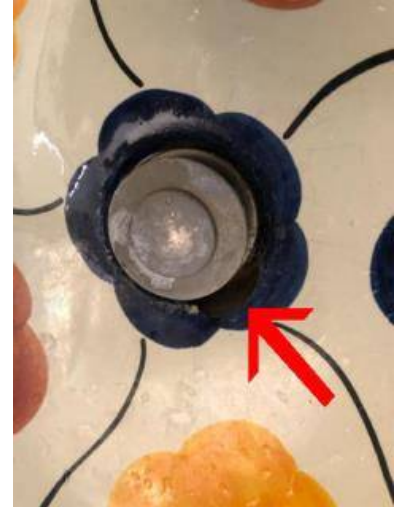
**Action Necessary** - The basin or drainage fixture is damaged or deteriorated to the point that action is necessary. The finish on the bowl is damaged, and it needs repair or replacement.

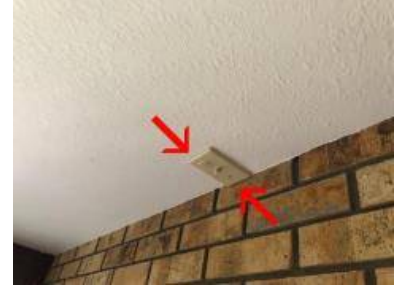
<i>Location:</i>	South side of home.
<i>Outside Entry Door:</i>	The outside entry door to the bedroom is satisfactory.
<i>Entry Door:</i>	Satisfactory - The entry door on the master bedroom is as I expected, and it is functional.
<i>Closet:</i>	Satisfactory - The closet is functional and of average size. The closet is lighted.
<i>Walls:</i>	Satisfactory - The walls in the bedroom appear to be satisfactory.
<i>Ceiling:</i>	Satisfactory - The ceiling is functional and as I expected.
<i>Light and Light Switch.</i>	Satisfactory - The light and light switch were functional at the time of the inspection. There is a ceiling switch installed. I was not able to verify its functionality.

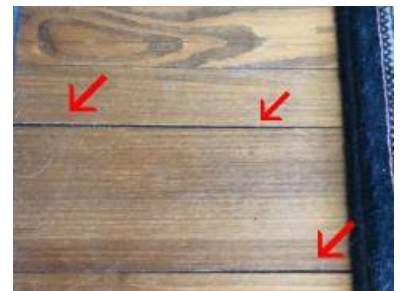
<i>Floor:</i>	Satisfactory - The floors are in satisfactory condition. The floor covering material is hardwood. <b>Note-</b> There is some minor separation between the flooring members in several areas.
---------------	-------------------------------------------------------------------------------------------------------------------------------------------------------------------------------------------------

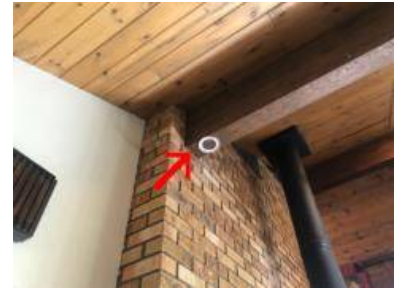
There is no smoke detector installed in this hallway. For safety reasons, you should consider installation of a battery operated or hardwired smoke detector.

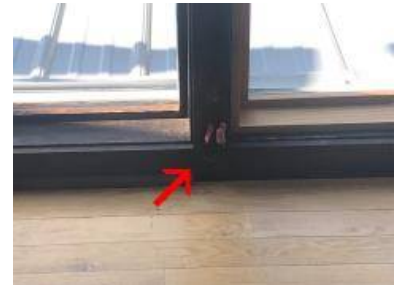
Yes- There is electric baseboard heat installed in the stairwell. One baseboard heater was removed near the window.

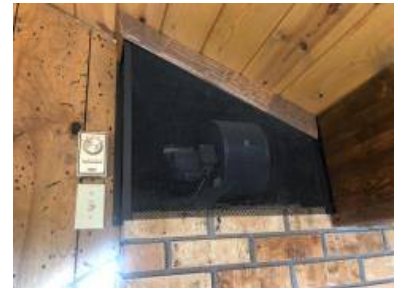
*Location:* Upper floor.  
*Walls:* Satisfactory - The walls in this room appear to be satisfactory.  
*Ceiling:* Satisfactory - The ceiling is functional and as expected.  
*Ceiling Fan:* **Attention-** The install height is very low and could potentially injure someone.  
*Floor:* Satisfactory - The floor in this room is in satisfactory condition. Limited visibility - Due to the floor covering and furnishings, the full floor is not fully inspected.  
*Windows:* Satisfactory - The windows and associated hardware in this room are all satisfactory.  
*Electrical Outlets:* Satisfactory - The outlets tested in this room are correctly wired and grounded. **Note -** There is at least one switched outlet in this room.  
*Heat Source Noted:* No- There is however a heat fan inside the brick. It will pull air down through the home to the bottom floor to circulate the warmer air.

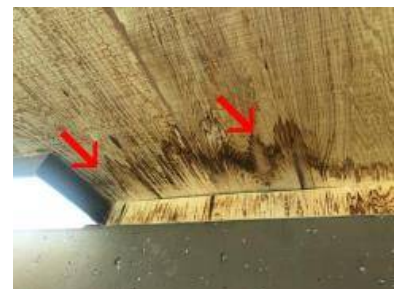
*Location:* South side of home.  
*Entry Door:* Satisfactory - The entry door to this room is functional.  
*Outside Entry Door:* **Attention-**The knobs are in need of repair on both Outside entry doors. In addition neither door has a deadbolt installed. This is important for security purposes.  
*Walls:* Satisfactory - The walls in this room appear to be satisfactory.  
*Ceiling:* **Attention Needed** - There is a condition in the ceiling that needs attention. There is evidence of an unrepaired stain on the wall caused by a prior moisture leak.

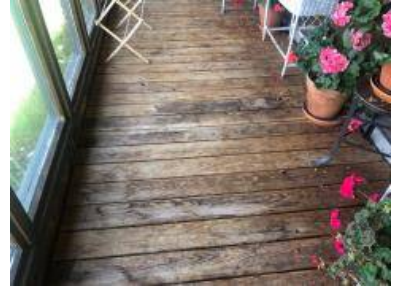
**Attention Needed** - The floor in this room is in need of some attention. The flooring appears to be wood laid on gravel. There is much movement in the flooring and contact with the soil is not ideal.

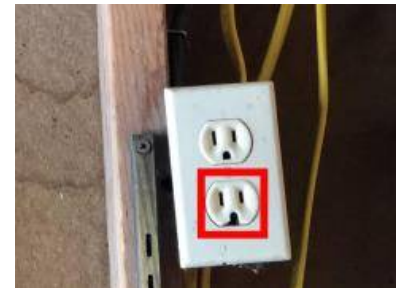
<i>Comment:</i>	<b>Attention-</b> Any outlets with cracked ground plugs should be replaced.

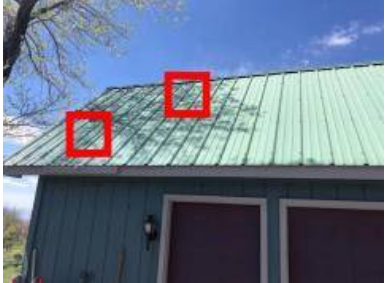
- Garage Foundation:* Satisfactory - The visible portions of the foundation under the garage appear to be functional.
- Garage Roof Condition:* Satisfactory - The detached garage roof covering is in functional condition. **Attention Needed-** Some of the screws in the metal roof appear to be backing out. These should be tightened to prevent leaks and damage to the roof.
