BROTHERS' INSPECTION INC

## RESIDENTIAL REPORT

1234 Main Street  
Grand Junction, CO 81505

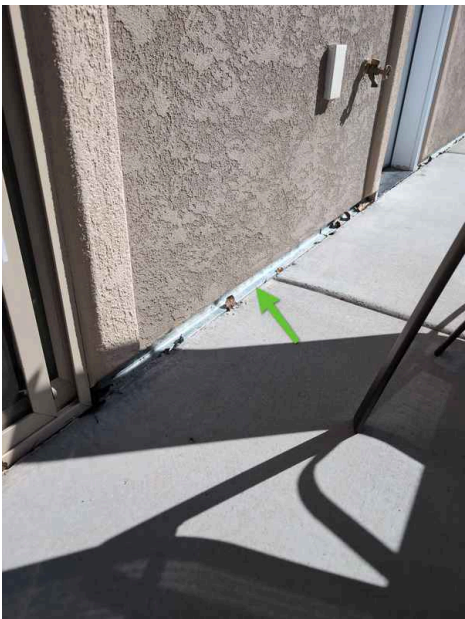
The foundation walls are insulated and flashed. This helps increase the thermal efficiency of the home. It also limits visual inspection of the foundation materials.

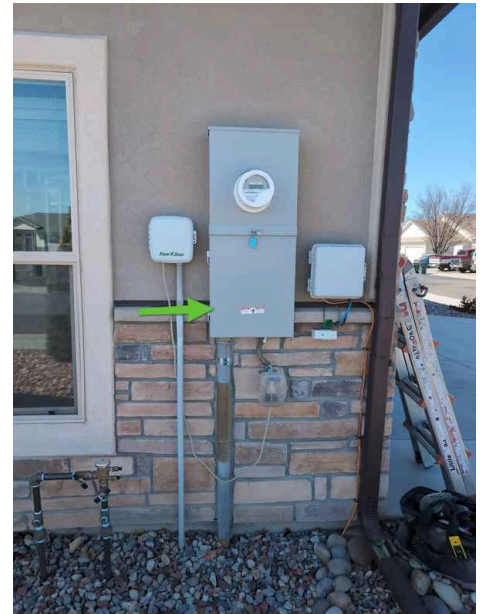
#### Main Distribution Panel: Panel Location

Left side of the house.

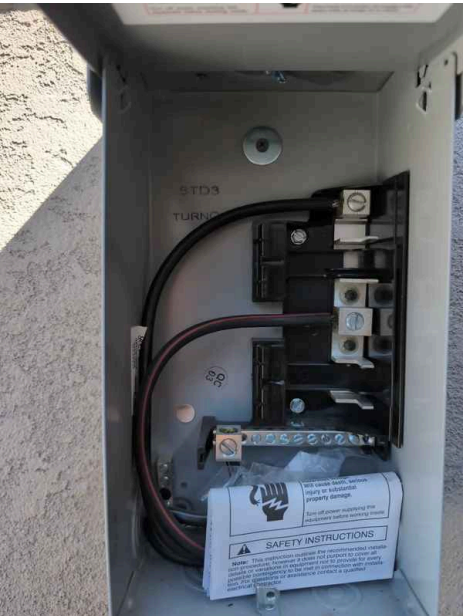
The hot tub panel not in use but appears to be in sound condition.

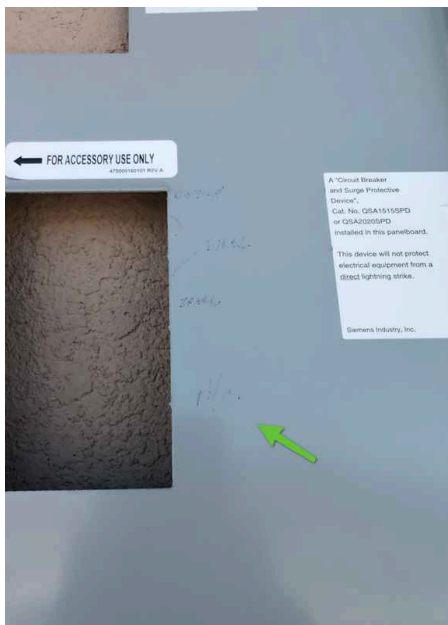
Identification of the breakers and the appliances or areas they control are clearly marked. This inspection does not verify the accuracy of this legend.

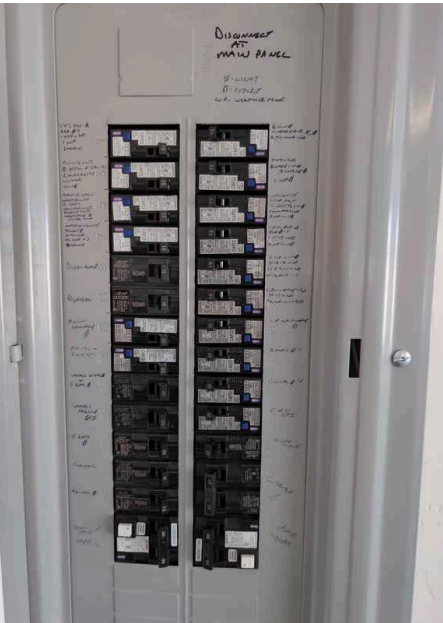
Identification of the breakers and the appliances or areas they control are clearly marked. This inspection does not verify the accuracy of this legend.

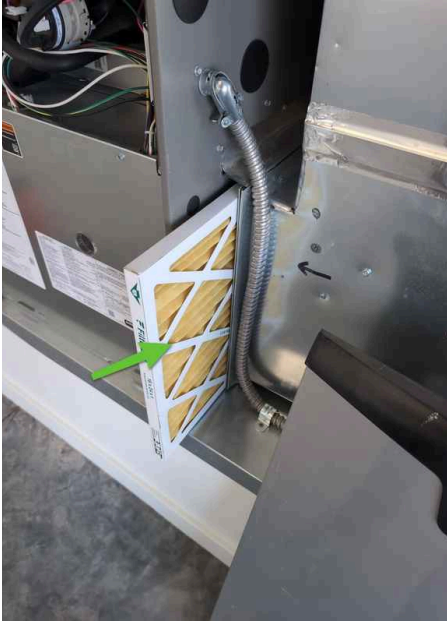
The filter is clean and correctly installed. It is recommended that the filter(s) be changed every 30-45 days.

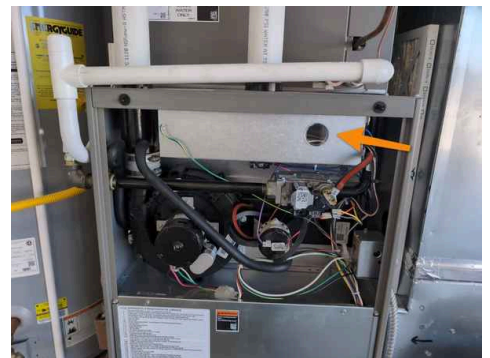
The heat exchanger is a high efficiency 90% sealed combustion chamber. Therefore, there is very limited visibility.
