BROTHERS' INSPECTION INC

## RESIDENTIAL REPORT

1234 Main Street  
Grand Junction, CO 81505

08/26/2026 9:00AM

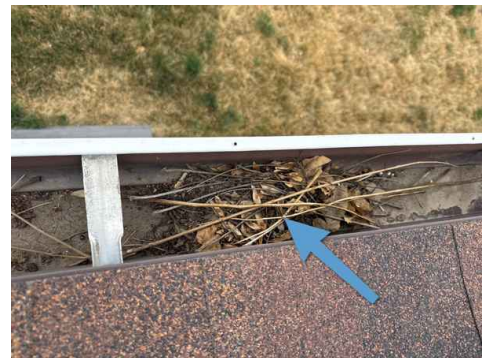
Debris has accumulated in the gutters. Recommend cleaning to facilitate water flow.

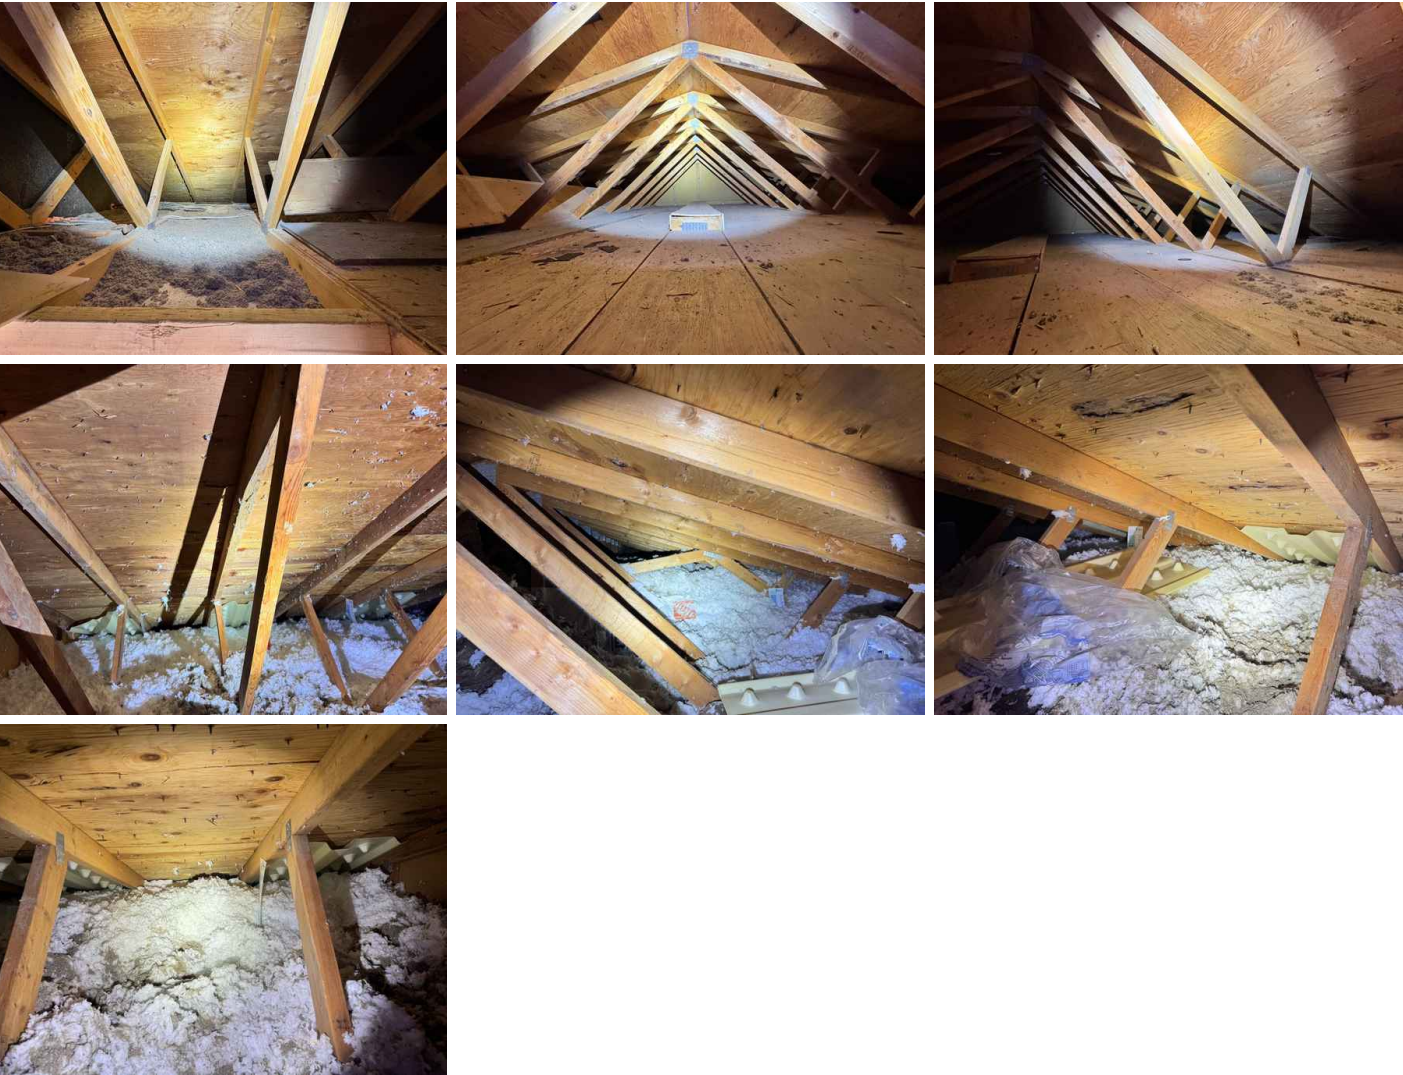
**Evidence of Leaks : Evaporative Cooler Stains**

There is staining on the roof decking boards around the evaporative cooler. The area was dry during the inspection. It is recommended this area be monitored. The current owners can be asked if they are aware of any previous or ongoing issues.

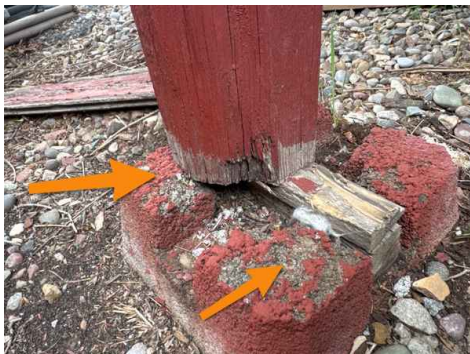
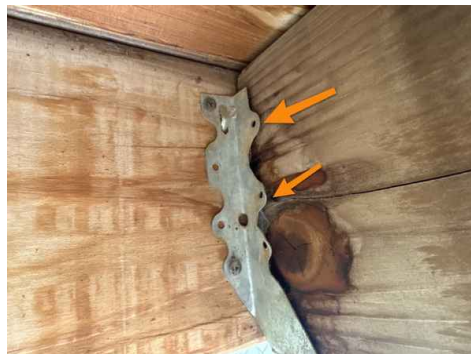
One of more areas of the deck support appears unstable. This could cause a safety hazard and further deterioration of the deck. Recommend qualified deck contractor evaluate and repair.

No screws in hanger

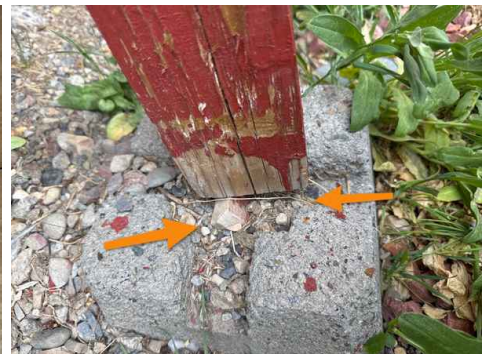
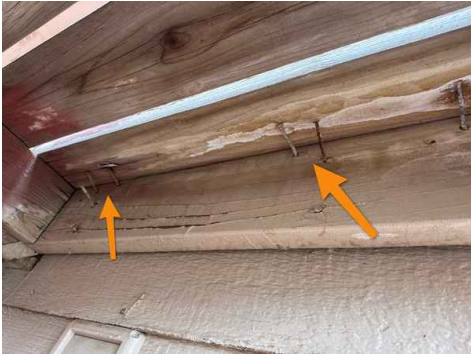
Nails backing out

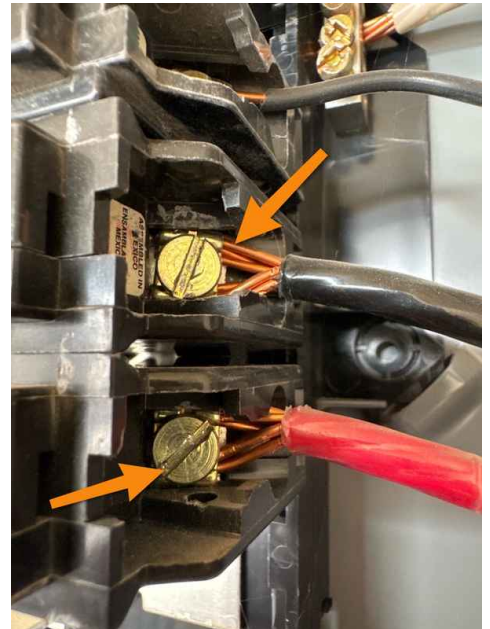
**WRONG BREAKER TYPE**

There is a multi strand wire, feeding a breaker that appears to be intended for single strand copper wire. You should consult an electrician to determine if this is allowable per current standards.

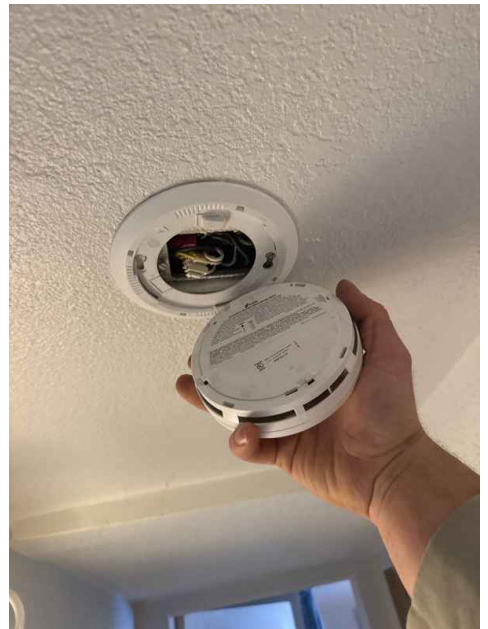
**NOT POWERED**

The detectors is only battery powered. It would be beneficial to connect it to power to a secondary source.

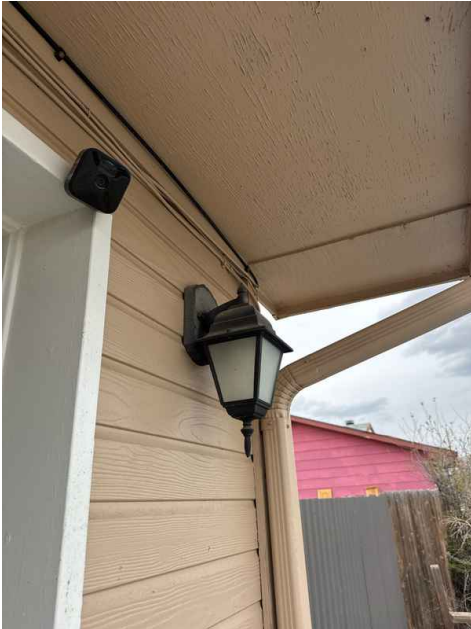
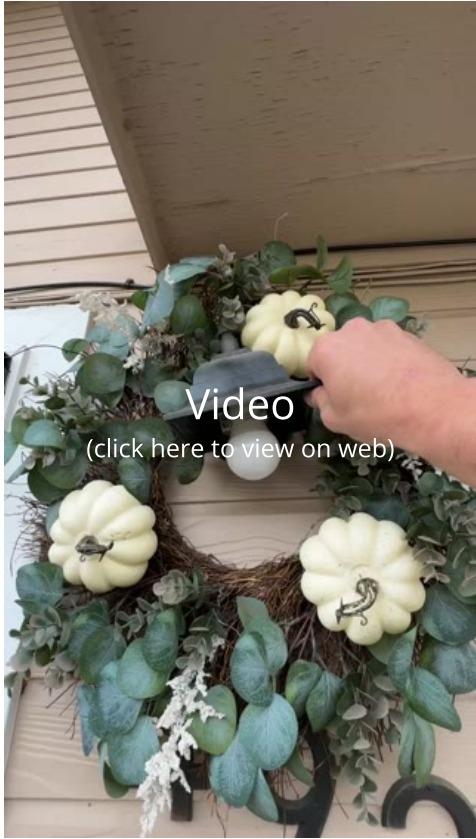
## 7.5.1 Exterior Lighting

**ANCHORED POORLY**

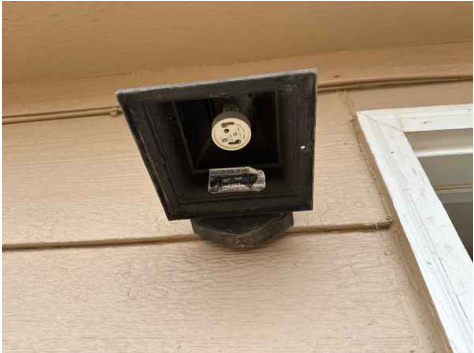
7.5.3 Exterior Lighting  
**COVER MISSING**

At least one light is missing its cover.

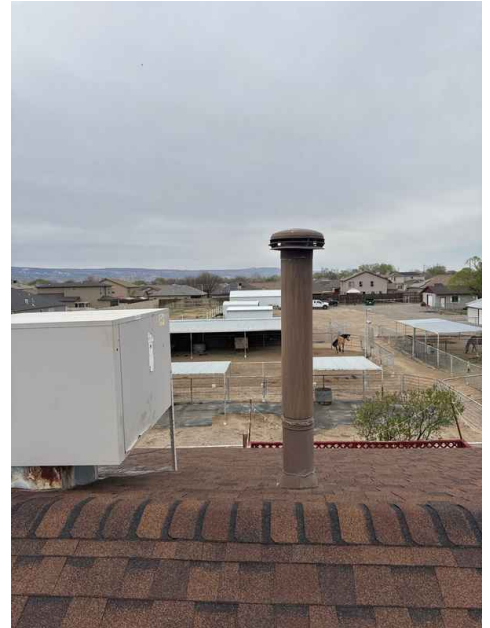
#### **TOO CLOSE**

The vent for the water heater exhausts near the evaporative cooler. Any vent or exhaust within 10 ft. Of an operable door, window, or cooler should be 3 ft above the opening. This is to prevent exhaust or gases from entering the home.

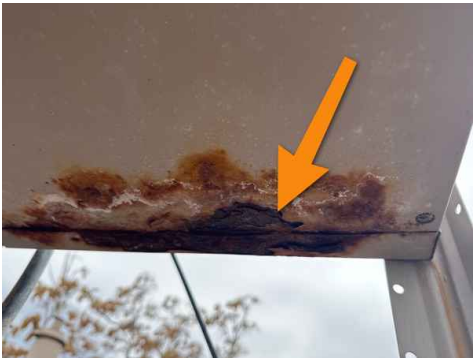
**CORROSION-INTERIOR/EXTERIOR**  
There is minor corrosion/rust to the interior and/or exterior of the unit. Eventually, this will cause a leak or render the unit unusable. Paint or anti-corrosion measures may increase the lifespan of the unit. This is considered typical maintenance for an evaporative cooler.

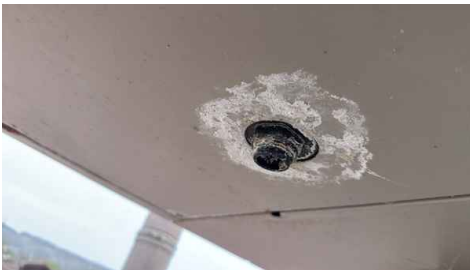
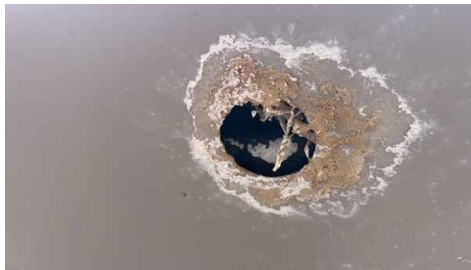
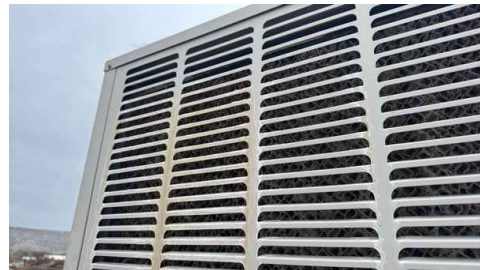
### OVERFLOW

There is evidence that the cooler is overflowing. The float valve may need adjustment. An HVAC professional can be contacted to make changes.

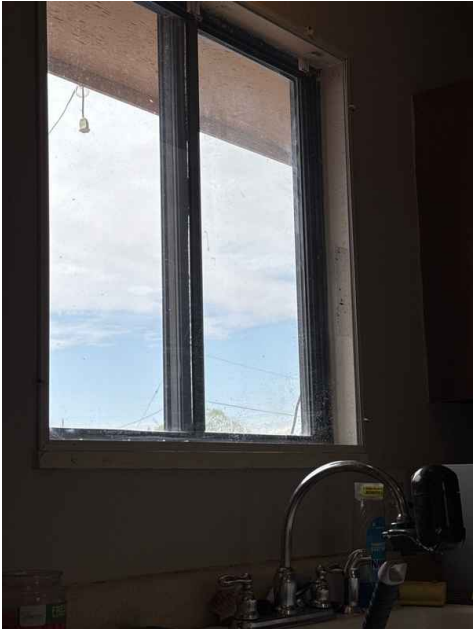
Window  
**SEALED**

The windows are painted shut or otherwise sealed.

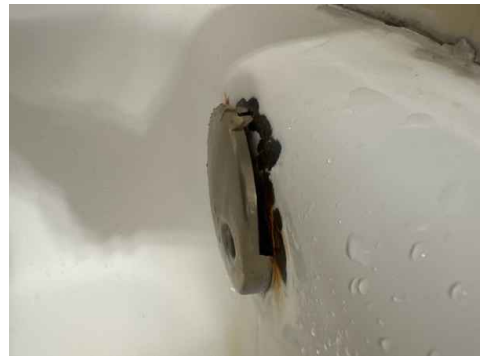
**OVERFLOW FLIPPED**

The overflow valve has been flipped. This is preventing the water from stopping at the correct level. It should be returned to its original position.

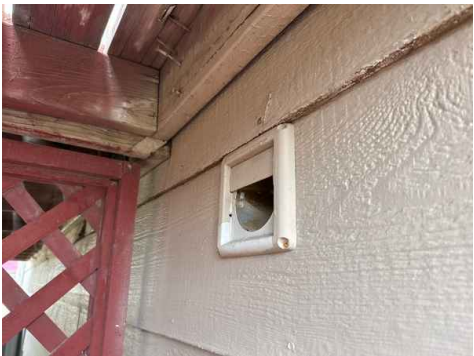
Several of the exterior louvers are missing and in need of replacement.

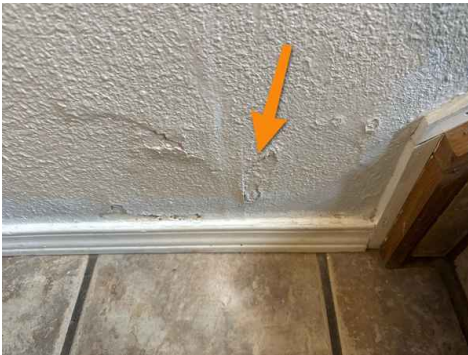
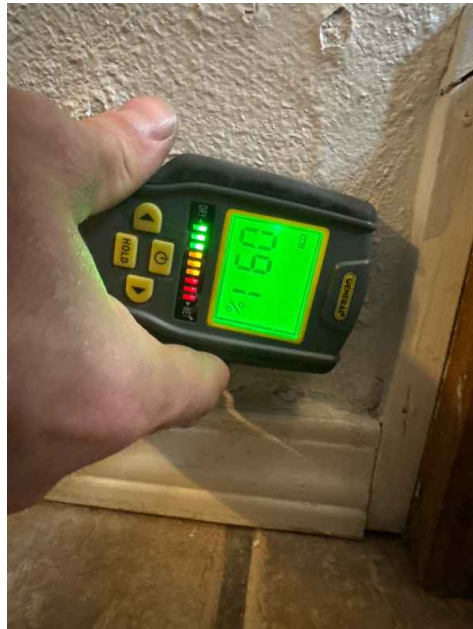
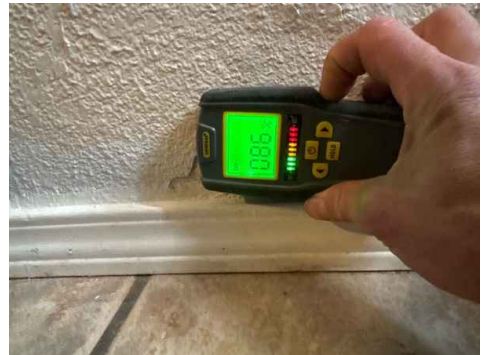
### 21.5.1 Walls

#### MOISTURE FROM FOUNDATION

Due to the presence of moisture in the concrete at the base of the foundation, the section of drywall near the stairs has some moisture damage. Moisture was detected in the drywall. Some clearance should have been allowed to prevent this. In addition, this level of concrete moisture is concerning. It may very well be coming from an exterior source.

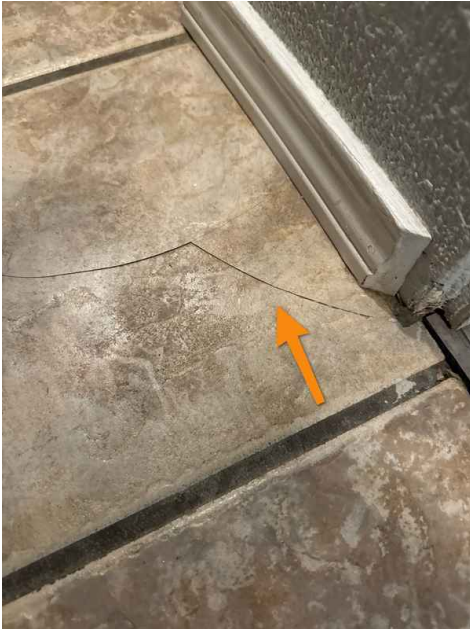
### 21.7.1 Floor

#### TRAFFICKED TILES

There are broken tiles in high traffic areas. This is can be an indication the mortar bed is deteriorating.

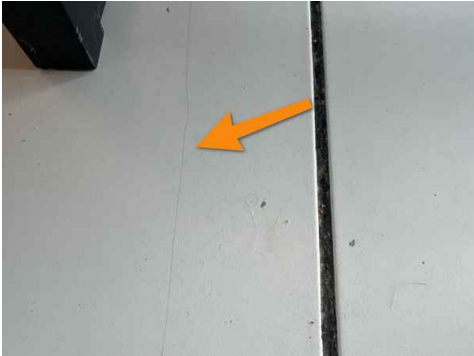
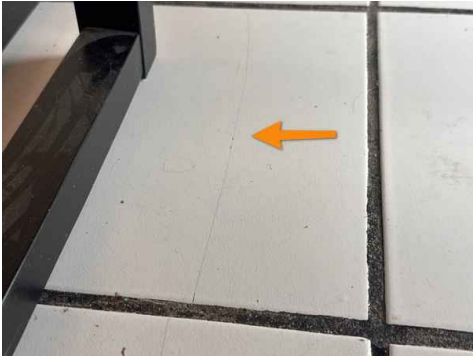
22.5.1 Floor  
**CRACKED TILES**

There are several cracked tiles in the dining room room. This may indicate that the mortar bed is failing and eventually the tiles may need to be replaced.

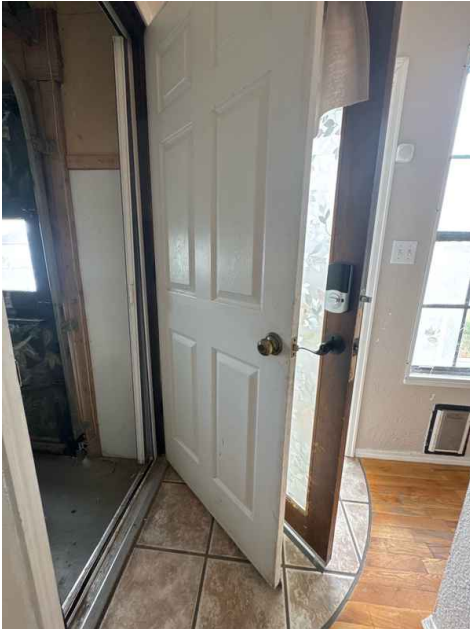
### 23.9.1 Fire Rated Entry Door

#### **NOT FIRE RATED**

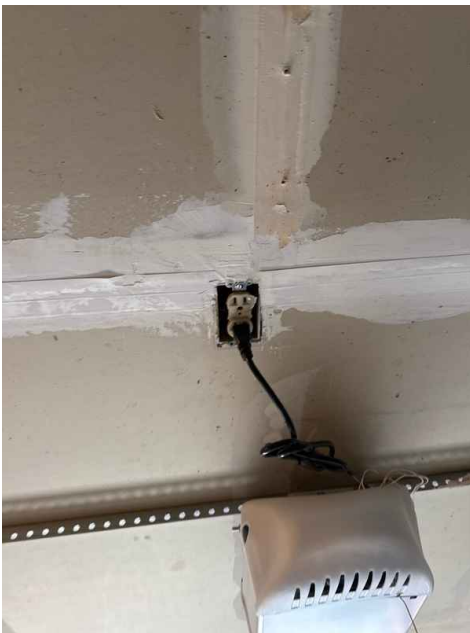
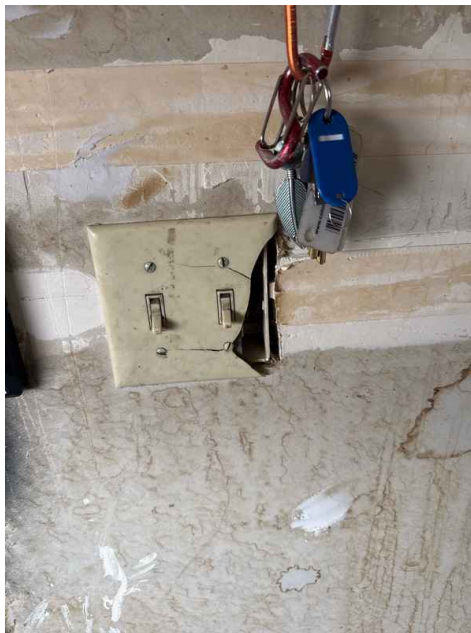
### 23.12.1 Electrical Service to Garage

#### **COVER**

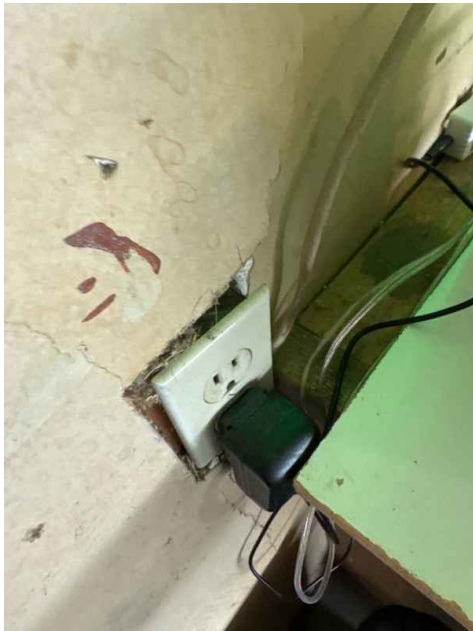
### 23.12.2 Electrical Service to Garage

#### **LOOSE OUTLETS**

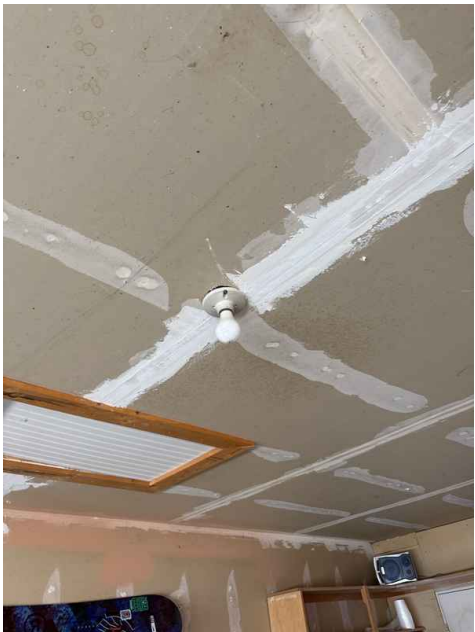
23.12.3 Electrical Service to Garage

**DAMAGED OUTLET**
