BROTHERS' INSPECTION INC

## RESIDENTIAL REPORT

1234 Main Street  
Grand Junction, CO 81505

08/26/2026 9:00AM

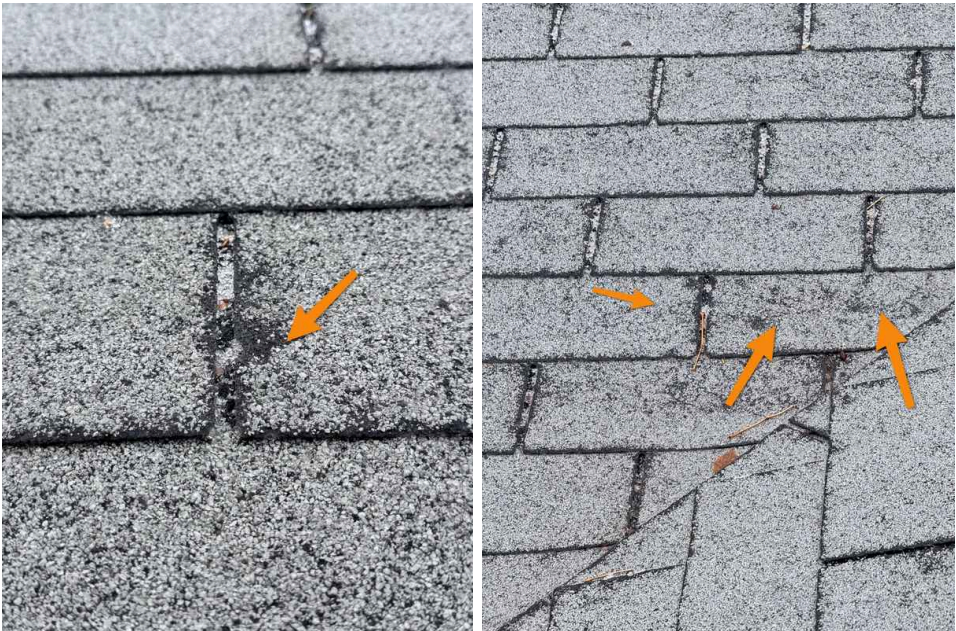
Some moderate granular loss was present on the edge of many of the shingles. This indicates an older roof that is nearing the end of its usable life.

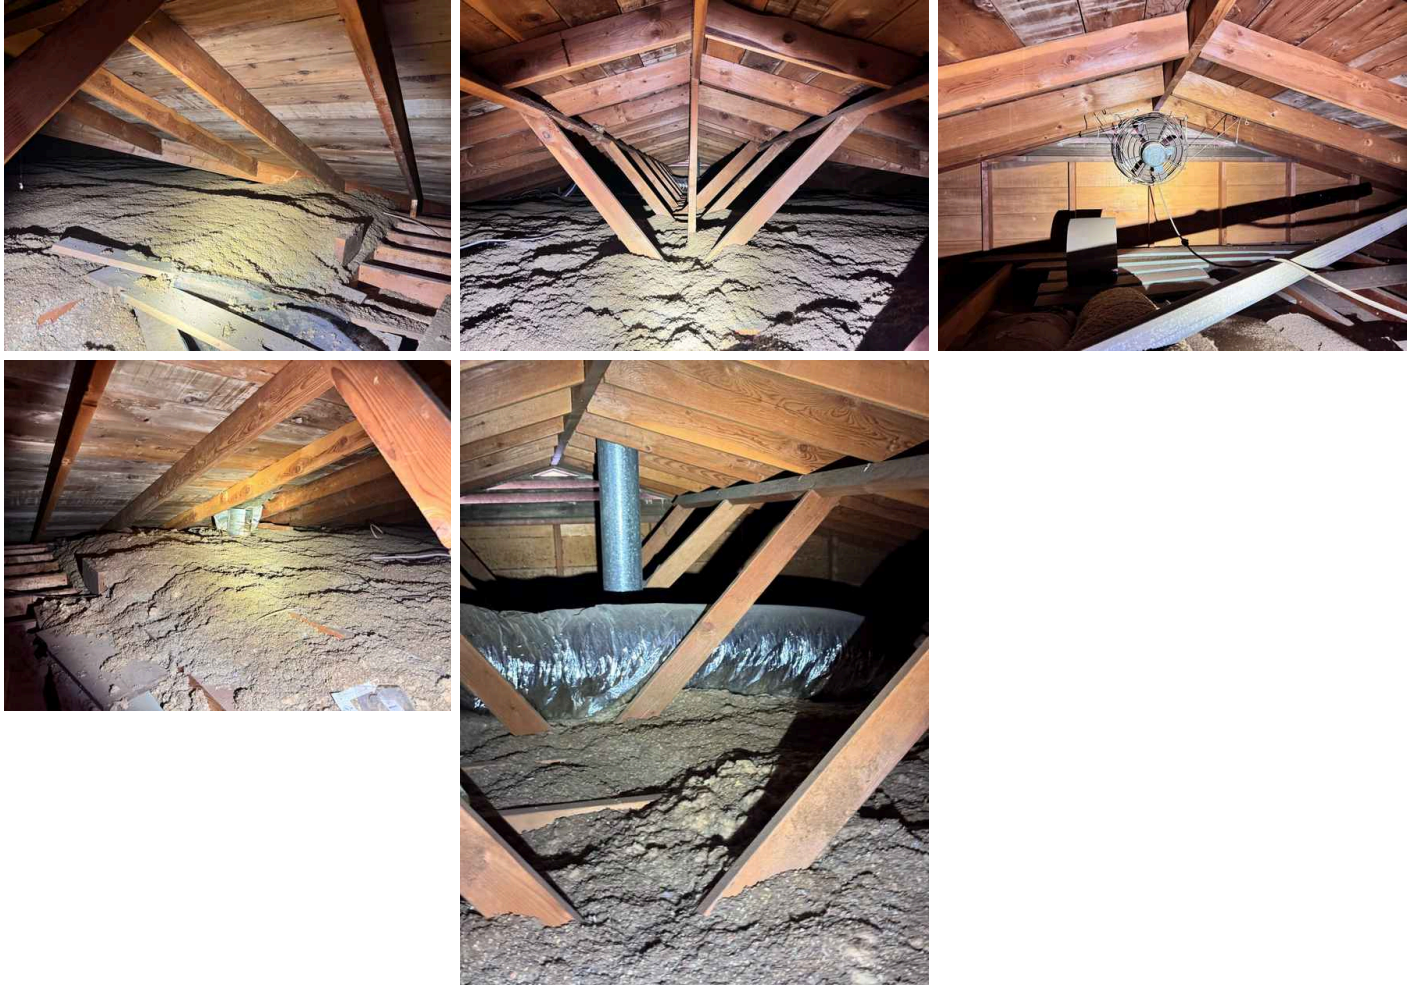
The roof framing appears to be in functional condition overall.

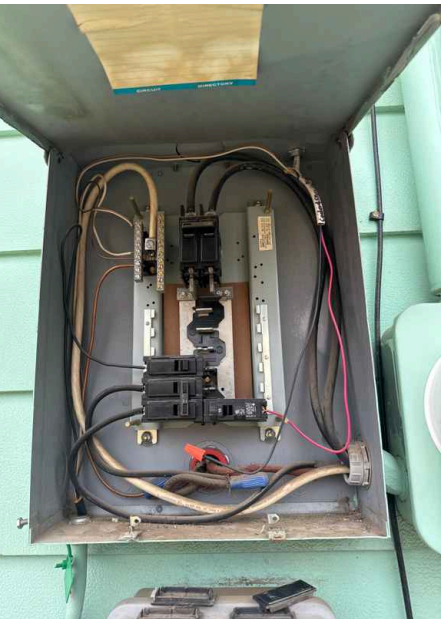
Overhead/Satisfactory - The masthead/supports/meter housing/cable entrance to the structure appear to be correctly installed.

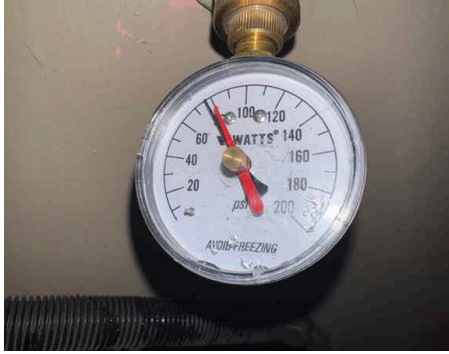
Water pressure from 40 to 80 pounds per square inch is considered within normal/acceptable range.

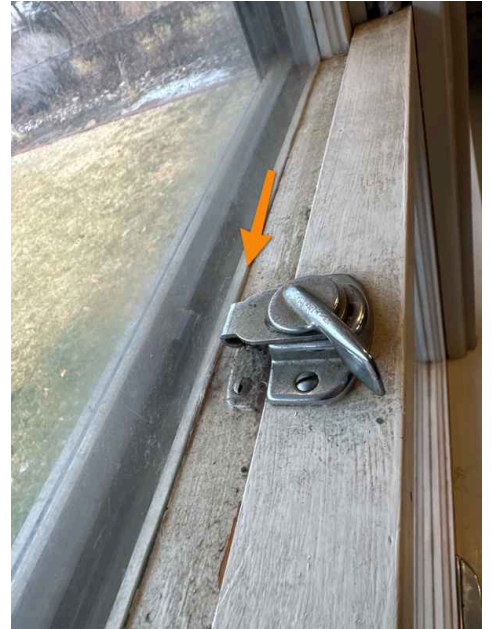
**LOCK ADJUST**

The locking hardware needs to be realigned to function appropriately.

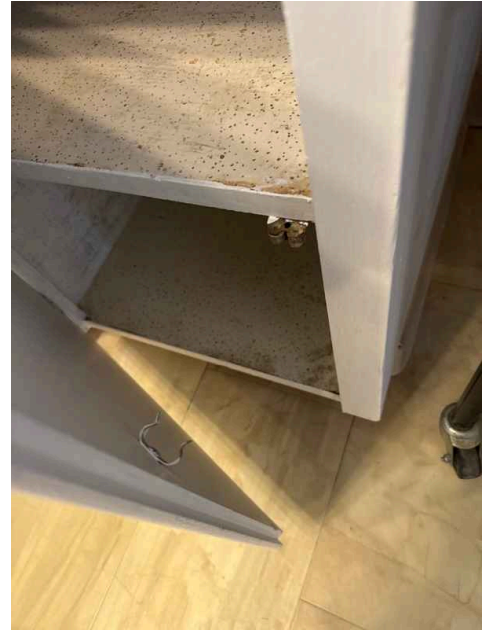
Several of the latches need adjustment so that the doors will stay shut.

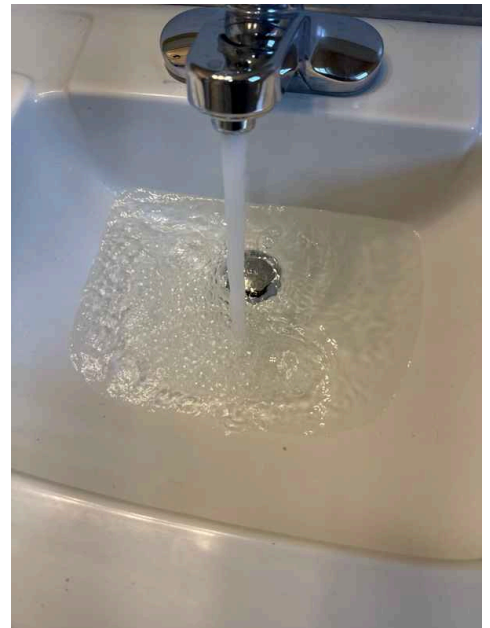
### SLOW DRAIN

The lavatory drains slowly. There may be some blockage either in the fixture or the drain line. The trap may need to be cleaned out or this may be an issue that requires professional attention from a plumber.
